Destructive M6.2 Petrinja Earthquake (Croatia) in 2020—Preliminary Multidisciplinary Research

Abstract: On 28 December 2020, seismic activity in the wider Petrinja area strongly intensified after a period of relative seismological quiescence that had lasted more than 100 years (since the well-known M5.8 Kupa Valley earthquake of 1909, which is known based on the discovery of the Mohorovičić discontinuity). The day after the M5 foreshock, a destructive M6.2 mainshock occurred. Outcomes of preliminary seismological, geological and SAR image analyses indicate that the foreshocks, mainshock and aftershocks were generated due to the (re)activation of a complex fault system—the intersection of longitudinal NW–SE right-lateral and transverse NE–SW left-lateral faults along the transitional contact zone of the Dinarides and the Pannonian Basin. According to a survey of damage to buildings, approximately 15% of buildings were very heavily damaged or collapsed. Buildings of special or outstanding historical or cultural heritage significance mostly collapsed or became unserviceable. A preliminary analysis of the earthquake ground motion showed that in the epicentral area, the estimated peak

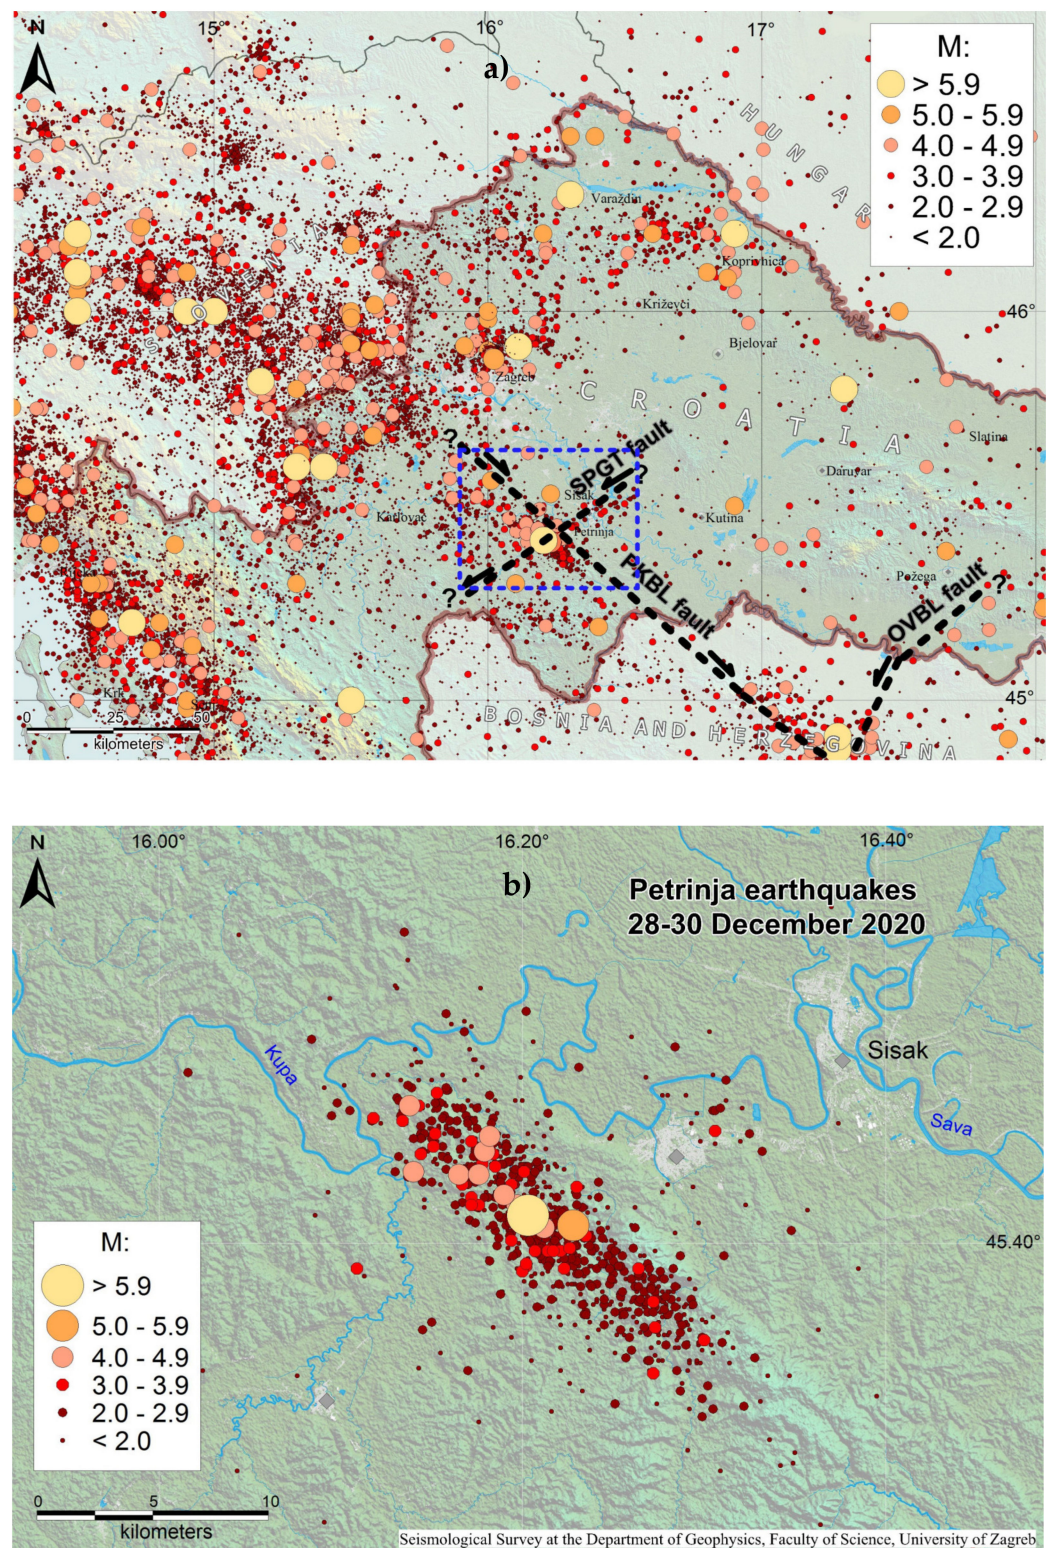
Figure 1. (a) The spatial distribution of earthquakes in Croatia (373 BC–2019, according to the Croatian Earthquake Catalogue (CEC), of which an updated version was first described in [4], with the Pokupsko-Petrinja epicentral area indicated (blue rectangle). Thick, black-dashed lines mark regional active faults: PKBL=Pokuplje-Kostajnica-Banja Luka right-lateral fault, SPGT=Sisak-Petrinja-Glina-Topusko left-lateral fault and OVBL=Orlava-Vrba-Banja Luka left-lateral fault; and (b) Pokupsko-Petrinja epicentral area with the distribution of the epicentres of the 28 to 30 December 2020 seismic sequence.

In less than three days after the main quake, almost 2000 aftershocks followed. Until 15 January 2021, there were nine M4+ aftershocks, of which the strongest was of magnitude 5.0 (Figure 1).

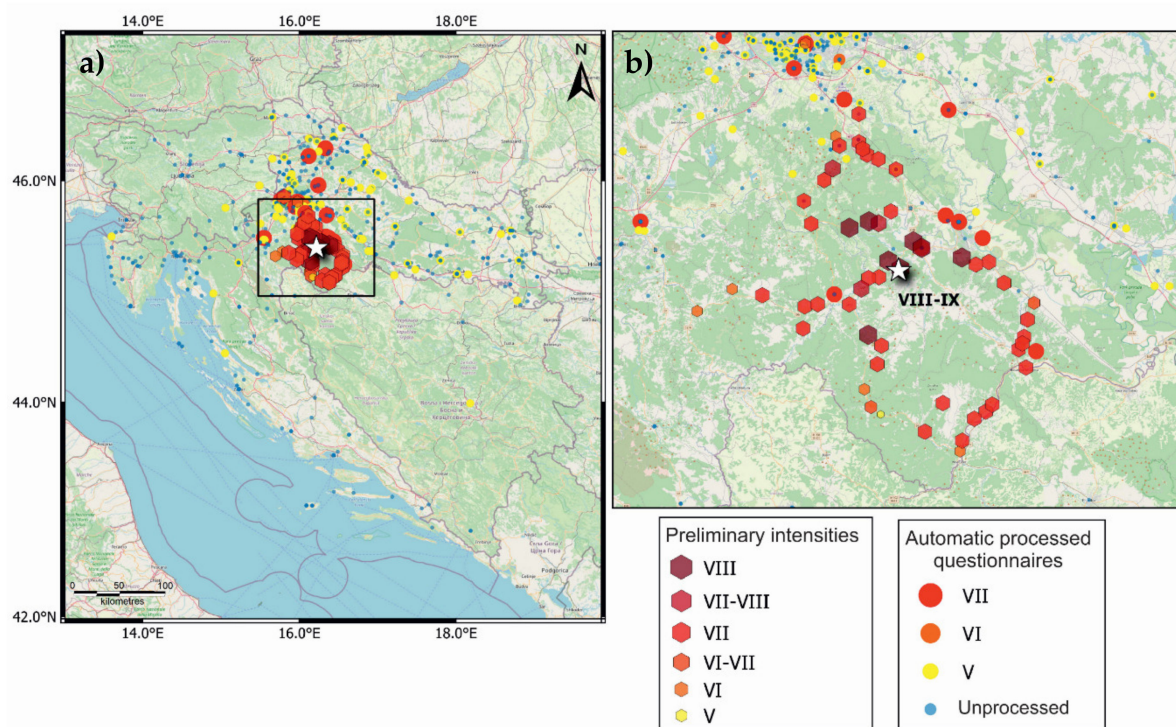
Figure 3. (a) A preliminary intensity map for the M6.2 Petrinja 2020 earthquake, which was obtained by automatic processing of questionnaires (circles) and by a macroseismic field survey (preliminary values, which are marked by hexagonal shapes); and (b) Intensities in the wider Petrinja area, which is indicated by a rectangle in (a) [8].

The M6.2 earthquake, which hit the area around Petrinja on 29 December 2020, was felt throughout Croatia and in the surrounding countries, with the highest intensity estimated as VIII–IX °EMS scale. A preliminary intensity map is shown in Figure 3 [8].

One part of the results was obtained by automatic processing of questionnaires, and the other was obtained on the basis of data that were collected in the field. The intensities, the values of which are marked in various colours (see the legend), are rated according to the European Macroseismic Scale (EMS). Unprocessed questionnaires are indicated with blue circles.

In contrast to the macroseismic isoseismal map of the 1909 event (Figure 2), the highest intensities extend in the NE–SW direction (Figure 3). This direction is almost perpendicular to the direction of the maximal intensity isoseist (pleistoseist) in the case of the Kupa Valley 1909 earthquake.

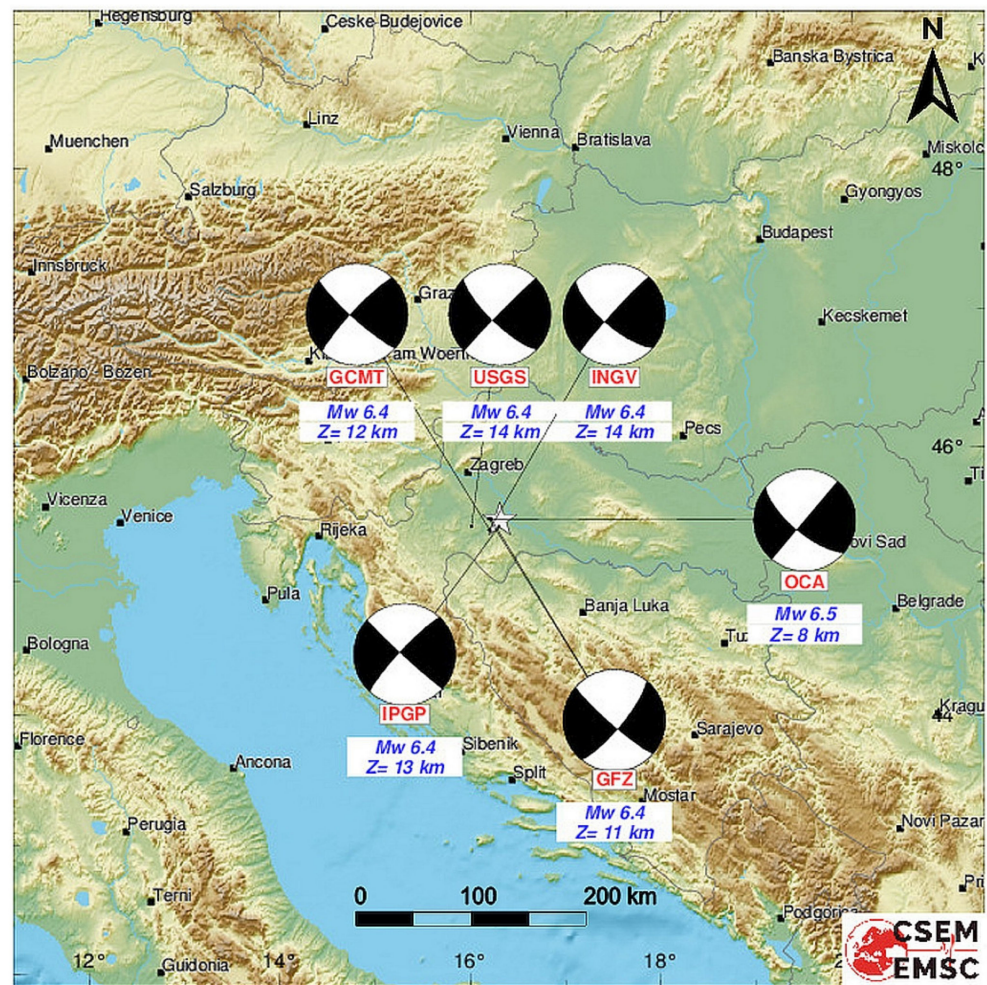
Figure 4. Quick moment tensor solutions of the M6.2 mainshock on 29 December 2020 at 11:19 UTC (source: CSEM–EMSC [9]).

The quick moment tensor solutions (QMTSs) that were released online (CSEM–EMSC, [9]) immediately after the foreshock, mainshock and strongest aftershock (Figure 4) indicated that all the events were caused by a clear strike-slip movement of the subvertical fault(s).

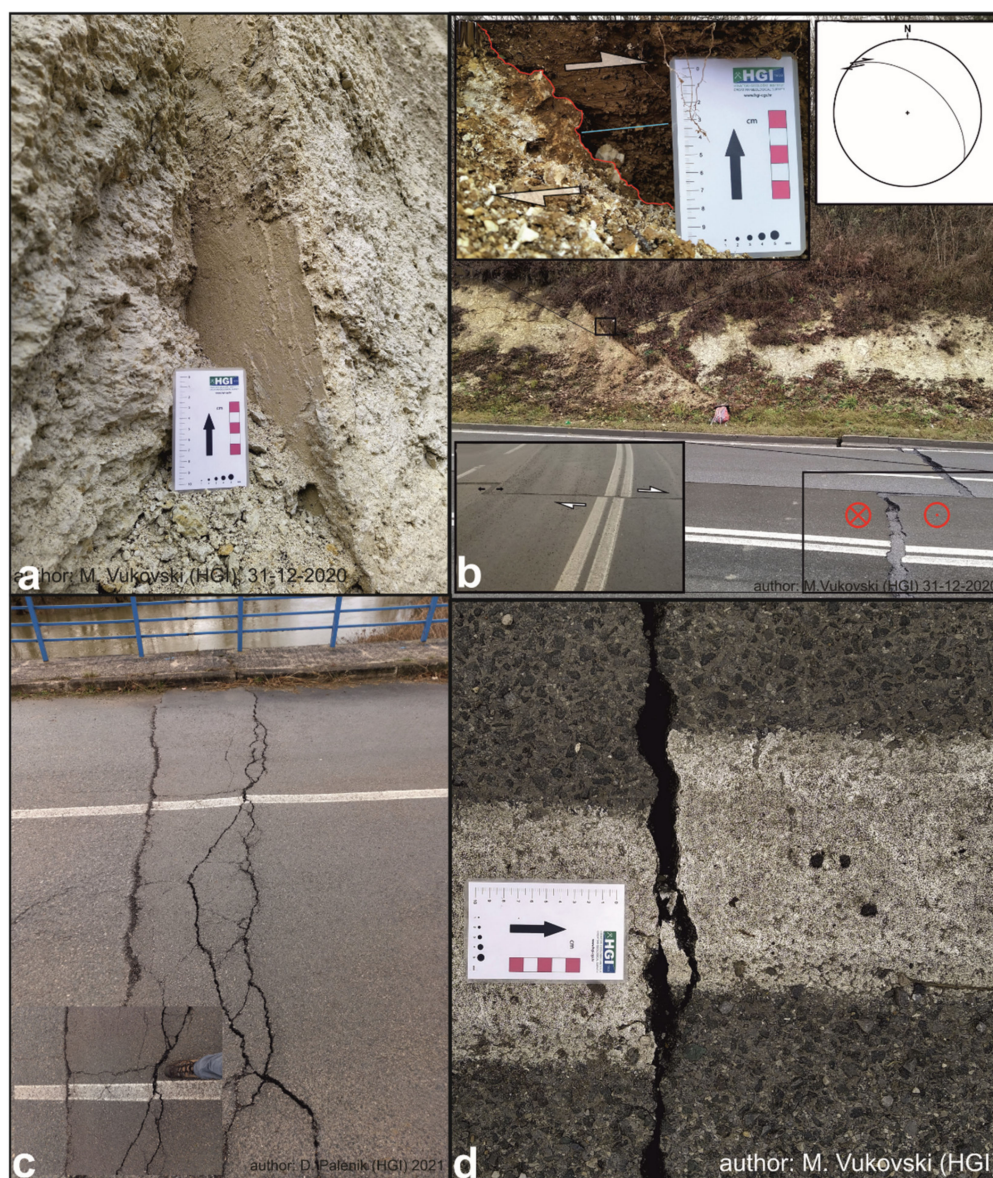
Figure 6. (a) The dextral coseismic displacement along the NW–SE striking subvertical fault plane in an abandoned quarry SW of Župić (WGS: 45.4229/16.2243); (b) Dextral coseismic displacement across a road west of Župić. Note fresh sub-horizontal striations in the soil (WGS: 45.4239/16.2226). Insets show the fault details with marked displacement and the fault surface projection on the lower hemisphere; (c) Sinistral displacement of a bridge NE of Glina (WGS: 45.3697/16.1183); and (d) Sinistral displacement on the road W of Petrinja (WGS: 45.4449/16.2590). The locations of the field photographs are presented in Figure 5.

Both left-lateral (sinistral) and right-lateral (dextral) coseismic surface movements were recognized along the fault lines in the wider epicentral area (Figure 6).

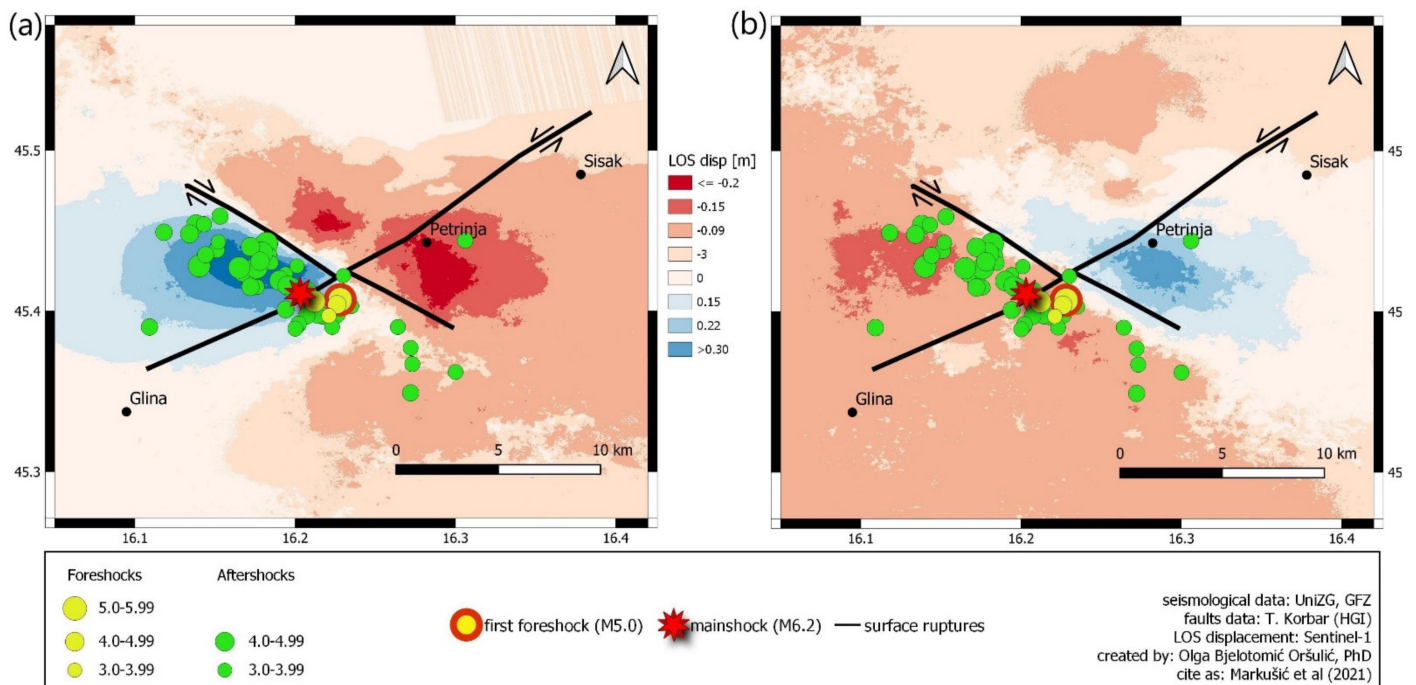
Figure 8. Line of sight (LOS) displacements for (a) Sentinel-1A ascending orbit T146, which has an amplitude of 74 cm and (b) Sentinel-1B descending orbit T124, which has an amplitude of 53 cm.

The results of the SAR analysis (Figure 8) clearly show a fault zone that stretches from NW to SE, which is identified as the Pokupsko Fault, and it corresponds entirely to the geological data. The SE extension of the fault, which is not marked by clear surface ruptures, is also visible. In addition, the strike of the Petrinja Fault (NE to SW) is also recognized although it cannot be clearly identified by SAR analysis, which is likely due to the resultant vector of the dextral and sinistral movements along the fault system. The resultant vector is the largest in the eastern and western quadrants of the fault system; thus, the Petrinja earthquake 2020 resulted in clear east–west lateral extrusion of the faulted blocks that were delineated by the activated faults.

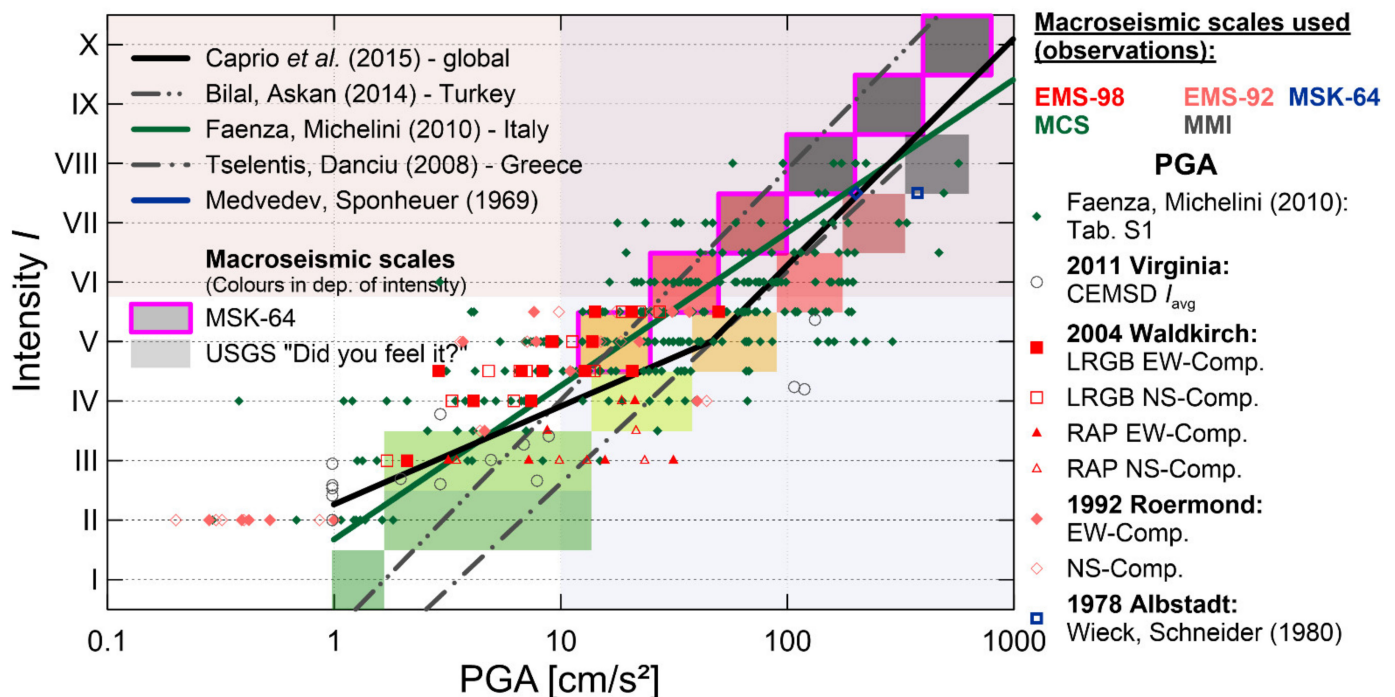
Figure 9. Example of a comparison of the peak ground acceleration (*PGA*) measurements for the 1978 Albstadt, 1992 Roermond, 2004 Waldkirch and 2011 Virginia earthquakes and the database of Faenza and Michelini in 2010 [47].

to intensities of VII (damaging) and VIII (heavily damaging) °EMS, respectively. By considering the relationship between *PGA* and the intensities according to the EMS-98 [43] and MCS [46] (subjective) intensity scales, e.g., as shown in Figure 9 [47], a mean *PGA* values of 0.3 g could be related to intensity IX (violent) °MCS or EMS scale. Furthermore, mean *PGA* values of 0.1 g could be related to an intensity of VIII °MCS or EMS scale, and a *PGA* of 0.07 g to an intensity of VII °MCS or EMS scale. The two intensity scales, namely EMS-98 and MCS, correlate in a straightforward manner with the earthquake M6.2 event with a *PGA* of 0.25 g that struck Sisak-Moslavina County in 2020 at intensities of VIII (heavily damaging, severe) to IX (destructive, violent) °MCS/EMS.

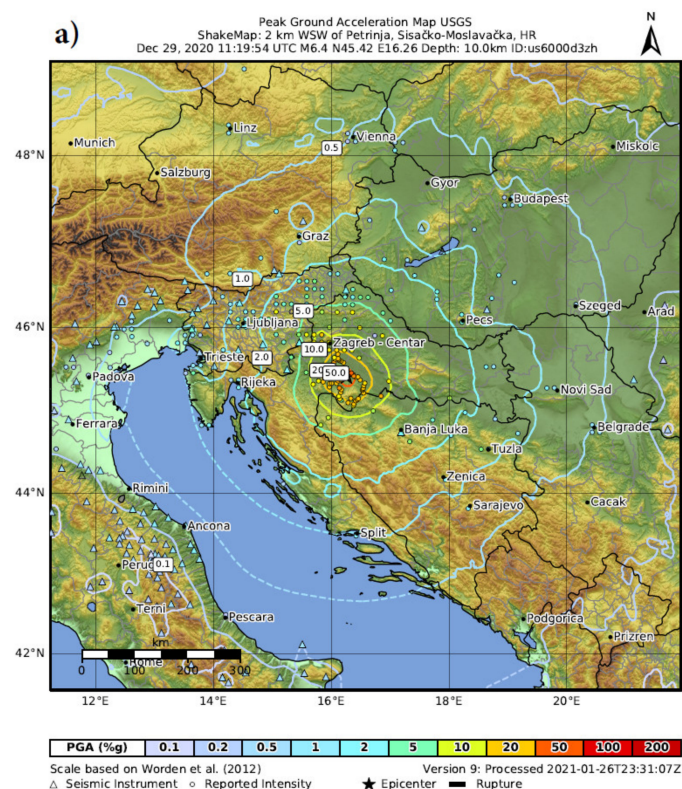
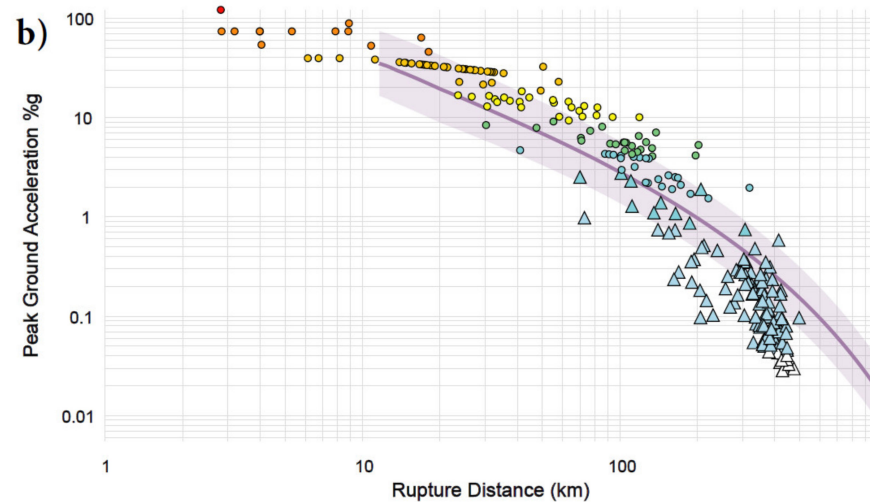
Figure 12. USGS Shake Map analysis: (a) The peak ground acceleration map and (b) GMPE peak ground acceleration predictions (thick purple line) and observations (seismic stations—blue triangles, Did You Feel It DYFI—coloured circles) in consideration of local site effects [59].

Following the destructive 29 December 2020 M6.2 earthquake near Petrinja, ShakeMap, which was developed by the U.S. Geological Survey (USGS), rapidly mapped earthquake ground motions [59] and portrayed the distribution and severity of shaking in the area (Figure 12). The peak ground acceleration was estimated to be approximately 0.5 g in an area approximately 5 km from the epicentre, 0.2 g at distances of 20–30 km and 0.1 g at a distance of 50 km (Figure 12a). Comparison of predictions and observations of a PGA scaling with rupture distance were estimated by GMPE Peak Ground Acceleration prediction (Figure 12b) considering local site effects [59].

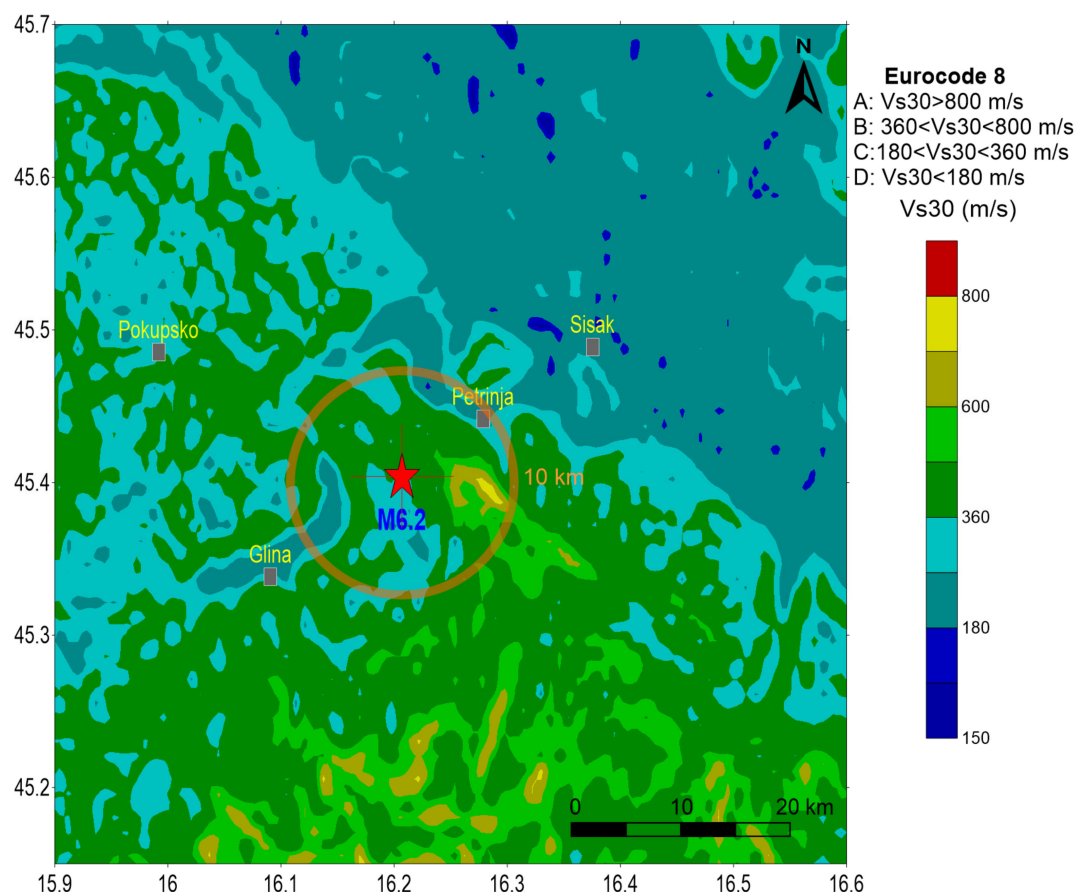
Figure 14. Available V_{S30} map that is based on topographic slope [69]. The red star represents the location of the M6.2 Petrinja 2020 earthquake (M_w 6.4 by USGS). The orange circle represents a 10 km distance from the epicentre.
