# Destructive M6.2 Petrinja Earthquake (Croatia) in 2020—Preliminary Multidisciplinary Research

Source / Izvornik: **Preliminary Multidisciplinary Research, 2021, 13**

Journal article, Published version

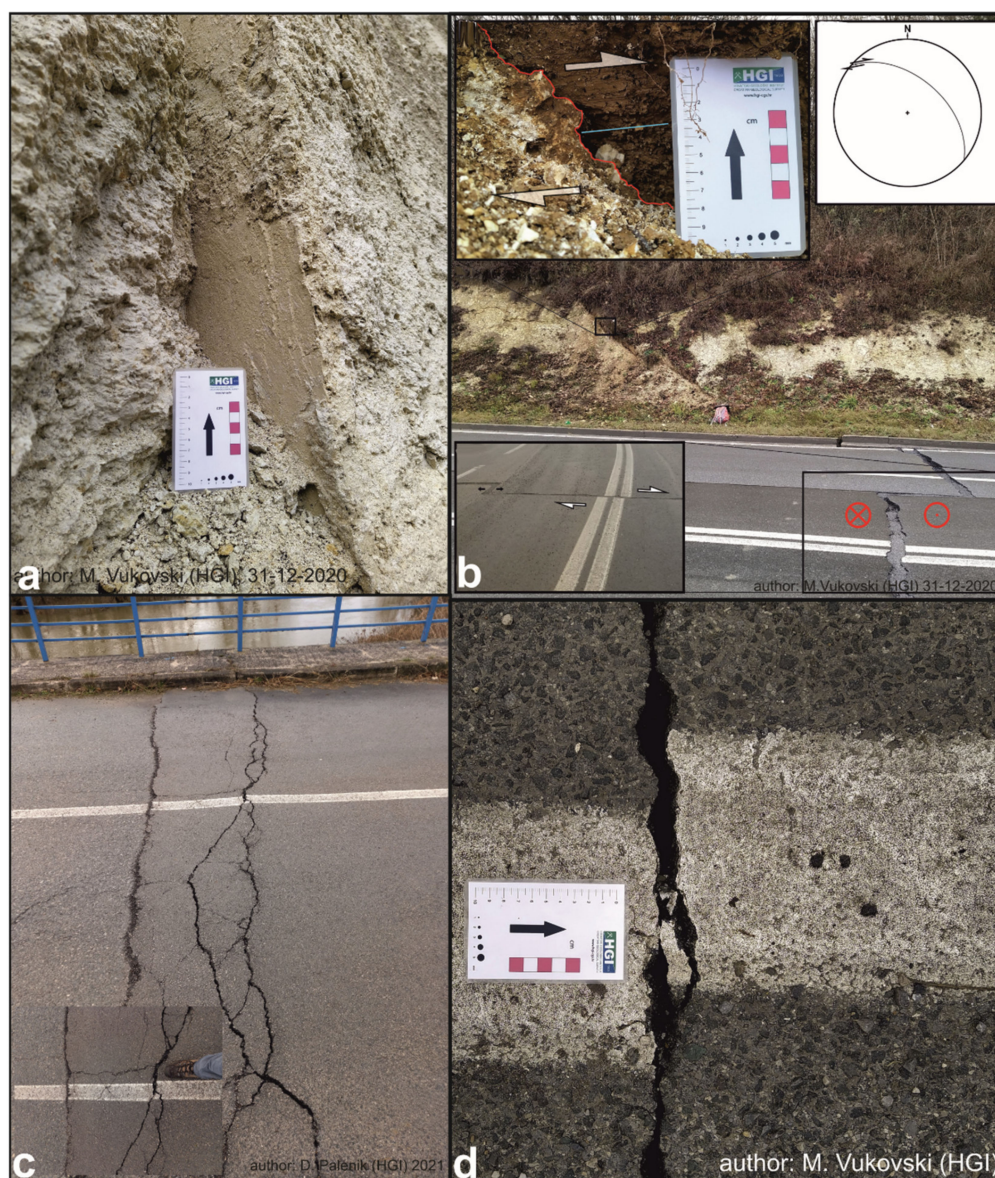
**Figure 6.** (a) The dextral coseismic displacement along the NW–SE striking subvertical fault plane in an abandoned quarry SW of Župić (WGS: 45.4229/16.2243); (b) Dextral coseismic displacement across a road west of Župić. Note fresh sub-horizontal striations in the soil (WGS: 45.4239/16.2226). Insets show the fault details with marked displacement and the fault surface projection on the lower hemisphere; (c) Sinistral displacement of a bridge NE of Glina (WGS: 45.3697/16.1183); and (d) Sinistral displacement on the road W of Petrinja (WGS: 45.4449/16.2590). The locations of the field photographs are presented in Figure 5.

Both left-lateral (sinistral) and right-lateral (dextral) coseismic surface movements were recognized along the fault lines in the wider epicentral area (Figure 6).

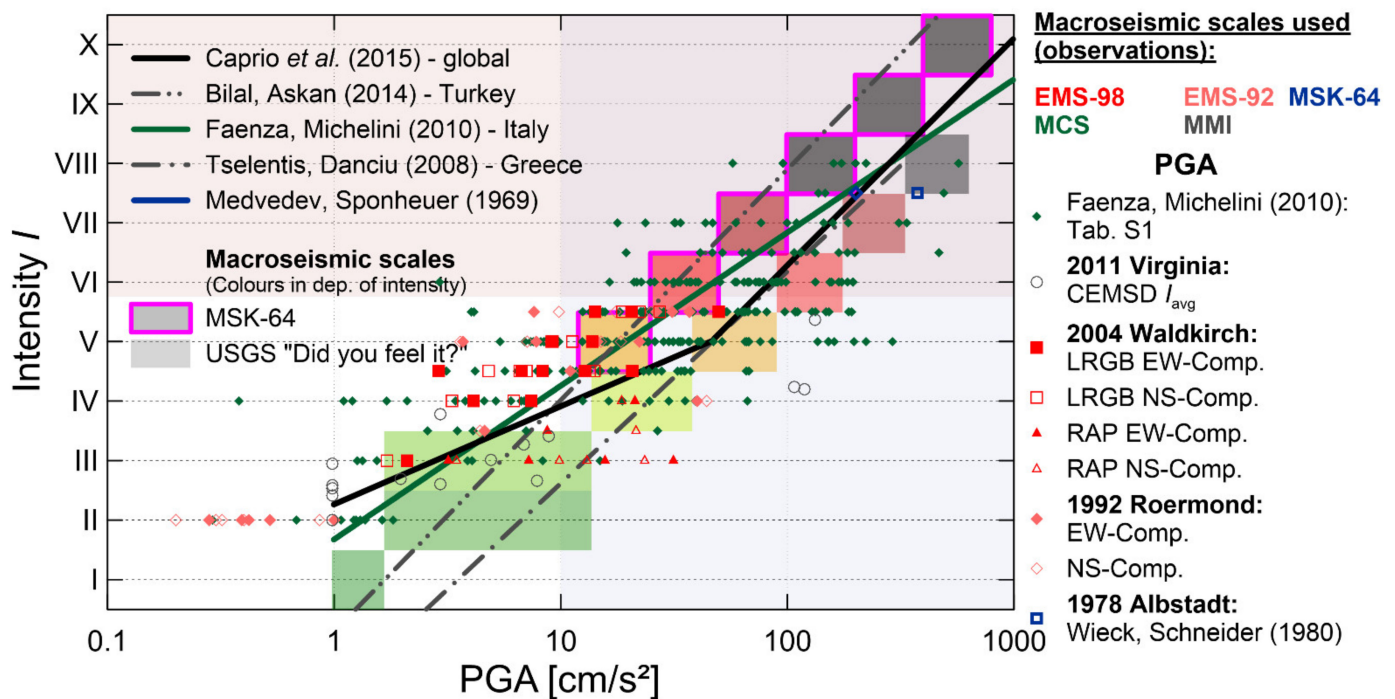
**Figure 9.** Example of a comparison of the peak ground acceleration (*PGA*) measurements for the 1978 Albstadt, 1992 Roermond, 2004 Waldkirch and 2011 Virginia earthquakes and the database of Faenza and Michelini in 2010 [47].

to intensities of VII (damaging) and VIII (heavily damaging) °EMS, respectively. By considering the relationship between *PGA* and the intensities according to the EMS-98 [43] and MCS [46] (subjective) intensity scales, e.g., as shown in Figure 9 [47], a mean *PGA* values of 0.3 g could be related to intensity IX (violent) °MCS or EMS scale. Furthermore, mean *PGA* values of 0.1 g could be related to an intensity of VIII °MCS or EMS scale, and a *PGA* of 0.07 g to an intensity of VII °MCS or EMS scale. The two intensity scales, namely EMS-98 and MCS, correlate in a straightforward manner with the earthquake M6.2 event with a *PGA* of 0.25 g that struck Sisak-Moslavina County in 2020 at intensities of VIII (heavily damaging, severe) to IX (destructive, violent) °MCS/EMS.

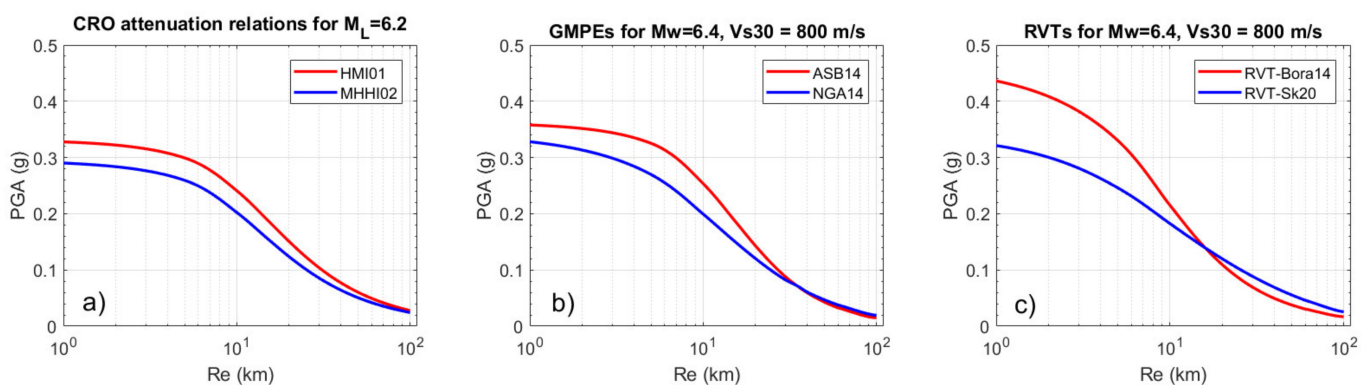
**Figure 13.** Estimation of the distance scaling  $PGA$  for rock ( $V_{S30} = 800$  m/s) based on (a) available Croatian attenuation relations HMI02 and MHHI02, (b) GMPEs from ASB14 that were derived for Pan-European sites and NGA14 (NGA West-2 GMPEs) from BSSA14 and CY14 (with weights of 0.5 for each), and (c) Random Vibration Theory models that were derived by Bora14 for the RESORCE-2012 database and RVT-Sk20 for the BSHAP database.

We tested USGS ShakeMap using the attenuation of the peak horizontal acceleration in the Dinarides area relations that were developed by Herak et al. ([60], HMI01) and Markušić et al. ([61], MHHI02) to the level of the average rock or very stiff soil sites (Figure 13a). We also selected three global, empirical ground-motion equations (GMPEs) that might be applicable to this region: (1) the hypocentral distance model of Akkar et al. ([62], ASB14), which was derived using pan-European datasets and two NGA-WEST 2 models (referred to as NGA14) with weights of 0.5; (2) the model of Boore et al. ([63], BSSA14) and (3) the model of Chiou and Youngs ([64], CY14), which was tested by Šalić et al. [65] for the Western Balkan BSHAP strong motion dataset (Figure 13b). Additionally, we tested the Bora et al. ([66], RVT-Bora14) model, which uses random vibration theory (RVT) to predict Fourier amplitude spectra and the duration of ground motion to estimate the response spectra from the RESORCE-2012 strong motion database of the SIGMA project. The same RVT method was used by Skendrović ([67], RVT-Sk20) on the analogue recordings in the BSHAP strong motion database [65,68] and was used in this preliminary analysis, together with the Bora14 model, for comparison (Figure 13c). Since this is a preliminary analysis and we do not have a full seismotectonic analysis of the fault mechanism, GMPE estimations were made for a strike-slip fault with a 90-degree dip using a point source distance model ( $R_e = R_{JB}$  and  $R_{hyp} = R_{rup}$ ), similar to [65]. For consistency and comparison, all PGA-distance models in Figure 13 are scaled to the epicentral distance  $R_e$ .

The preliminary analysis showed that for the  $M_{6.2}$  (or  $M_w 6.4$ ) earthquake in the epicentral area (1 km) for the rock site ( $V_{S30} = 800$  m/s), the estimated  $PGA$  values from the Croatian attenuation relations are 0.327 g (HMI01) and 0.290 g (MHHI02), those from the GMPE models are 0.317 g (ASB14) and 0.298 g (NGA14), and those from the RVT models are 0.436 g (Bora14) and 0.321 g (Sk20). These values are reasonably comparable with USGS ShakeMap rock predictions in the epicentre [59], namely 0.3 g. However, in comparison to Figure 12, site effects significantly influence the amplification of seismic ground motion. According to the Croatian Seismic Hazard Map [32] for the 95- and 475-year return periods (accepted as a part of the National Annex to Eurocode 8), the Petrinja area is located in a relatively moderate seismic hazard zone: 0.08 g (95 yrp) and 0.16 g (475 yrp) peak ground accelerations. The estimated  $PGA$  values in Figure 13 for  $M_w 6.4$  and for the close epicentral area (up to 10 km) substantially exceed the seismic hazard 95- and 475-yrp values. However, they are comparable with 0.33 g for 1000 yrp. This proves the significance of this earthquake within the known historical seismicity in this area. More important is the question of what type of impact this earthquake will have on future seismic hazard calculations not only for the epicentral area but also for the Zagreb city area, within which over 1 million people live.

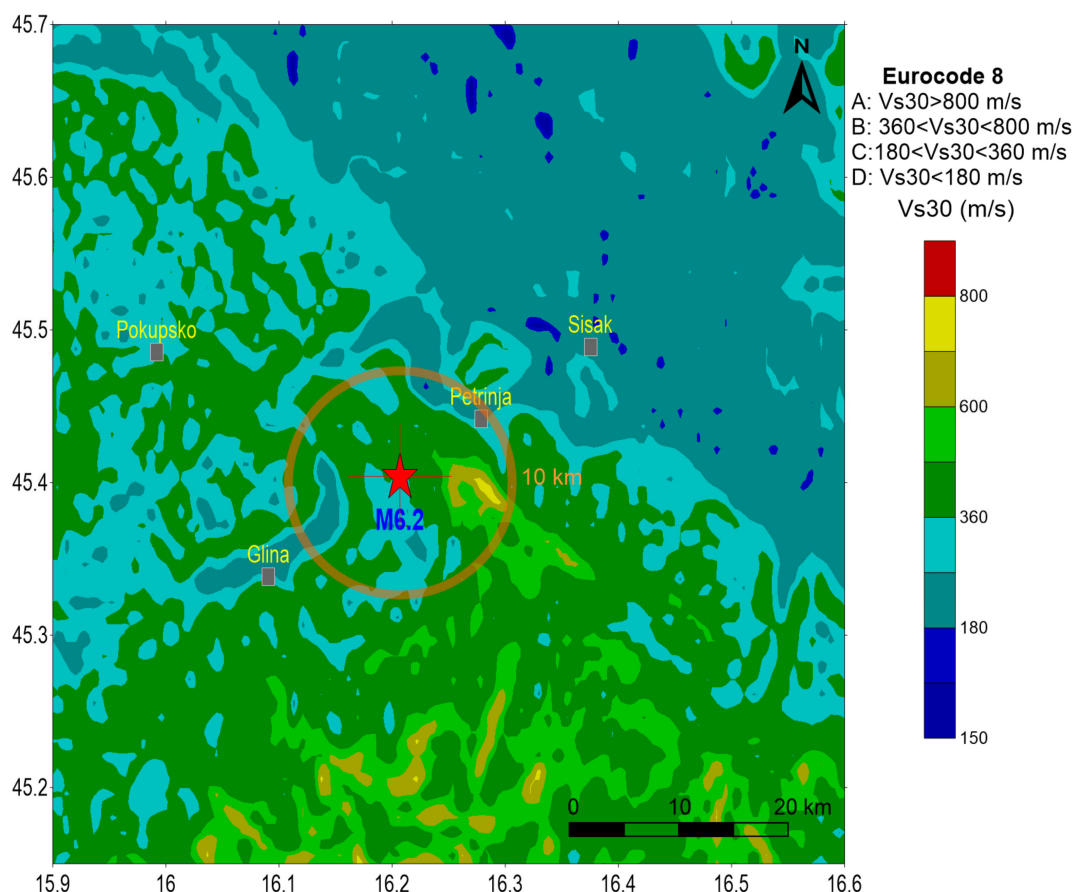
**Figure 14.** Available  $V_{S30}$  map that is based on topographic slope [69]. The red star represents the location of the M6.2 Petrinja 2020 earthquake ( $M_w$  6.4 by USGS). The orange circle represents a 10 km distance from the epicentre.
