Residential building stock in Serbia: classification and vulnerability for seismic risk studies

Source / Izvornik: **Bulletin of earthquake engineering, 2023, 21, 4315 - 4383**

Abstract

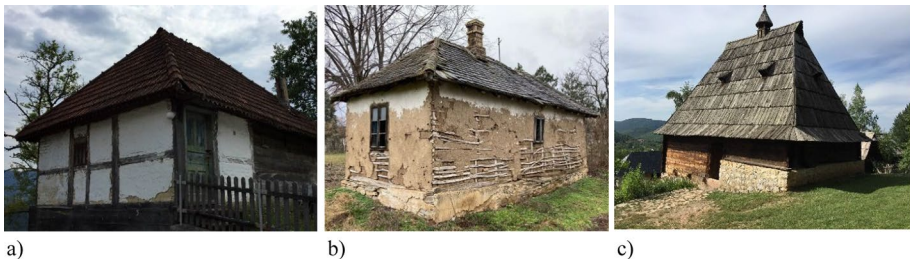
Fig. 9 Wooden building typology(W)—examples from Serbia: **a** a single-storey timber frame (*bondruk*) house close to Valjevo; **b** a single-storey rural house (*čatmara*) in the Nemenikuće village, and **c** a wood log rural house (*brvnara*), Zlatibor

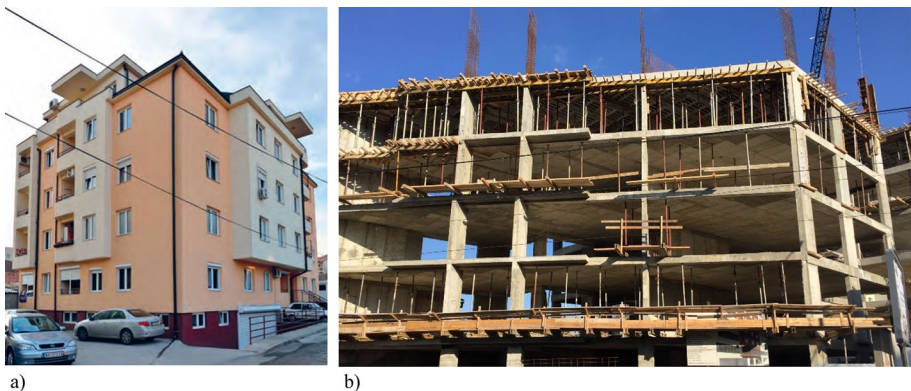
Fig. 14 Cast-in-situ RC frame-wall building typology—type RC2: **a** a 4-storey multi-family residential building in Belgrade (Jovanović Popović et al. 2013c) and **b** an RC2 building under construction in Belgrade

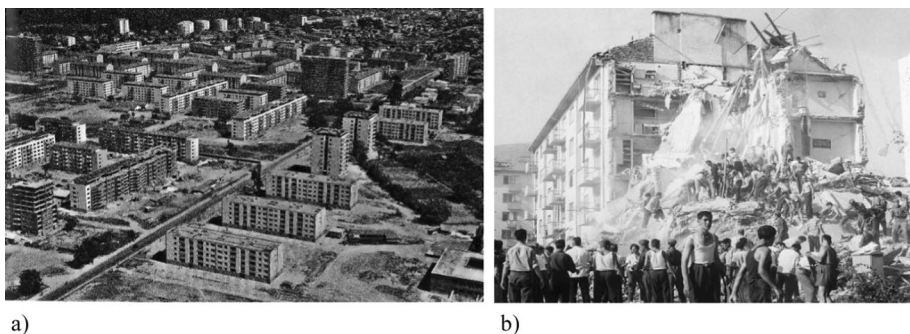
Fig. 17 Damage of masonry buildings (type M3) in the 1963 Skopje earthquake: **a** Karpoš building complex with 40 3–5 storey URM apartment buildings, and **b** a partially collapsed building No.13. (Source: Milutinovic 2022)

Performance of type M3 buildings in the earthquake can be illustrated on the example of the Karpoš residential complex in the western part of Skopje, which was constructed in the 1950s (Berg 1964), Fig. 17a. The complex comprised of 40 buildings, with the height ranging from 3 to 5 floors. The buildings were designed according to standardized designs, with load-bearing walls provided only in one direction (either longitudinal or transverse). One of the densely populated 5-storey buildings (labelled No. 13) partially collapsed and caused 159 fatalities (Fig. 17b). Various damage patterns were observed in these buildings, ranging from in-plane shear cracks to horizontal offset at floor levels (Berg 1964). Detailed reports on post-earthquake surveys of these buildings are available (Milutinović 2022).

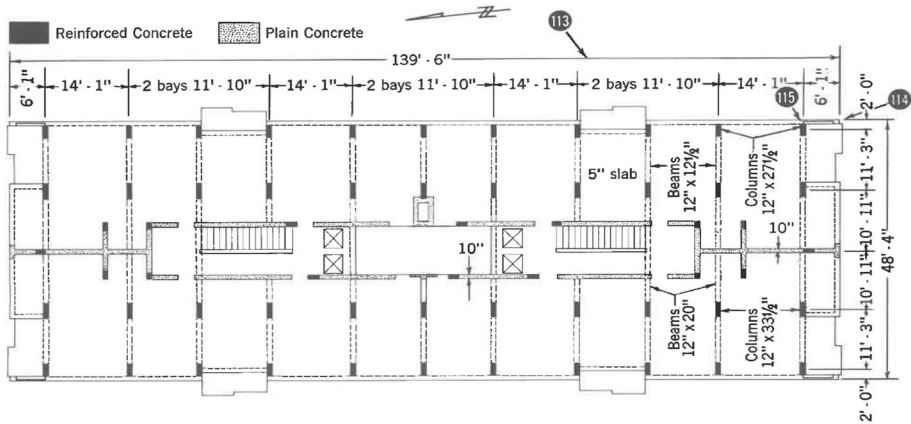
Fig. 18 Floor plan of Karpoš Tower, Skopje (Berg 1964)

Three 14-storey RC apartment buildings in the Karpoš residential complex (called the Karpoš Towers) were also exposed to the 1963 Skopje earthquake (Berg 1964). The buildings had a cast-in-situ RC frame system with RC floors and can be classified as RC1-type buildings according to the proposed classification. The buildings had a rectangular plan, 43 m long and 15 m wide (Fig. 18). Lateral load-resisting system in the transverse direction consisted of parallel RC frames, at approximately 4.0 m spacing. The frames were discontinued at the stairwells. Plain concrete structural walls were provided in the longitudinal direction along two interior gridlines and around the stairwells. Rectangular RC columns had 70 cm by 35 cm cross-sectional dimensions, 6 longitudinal reinforcing bars

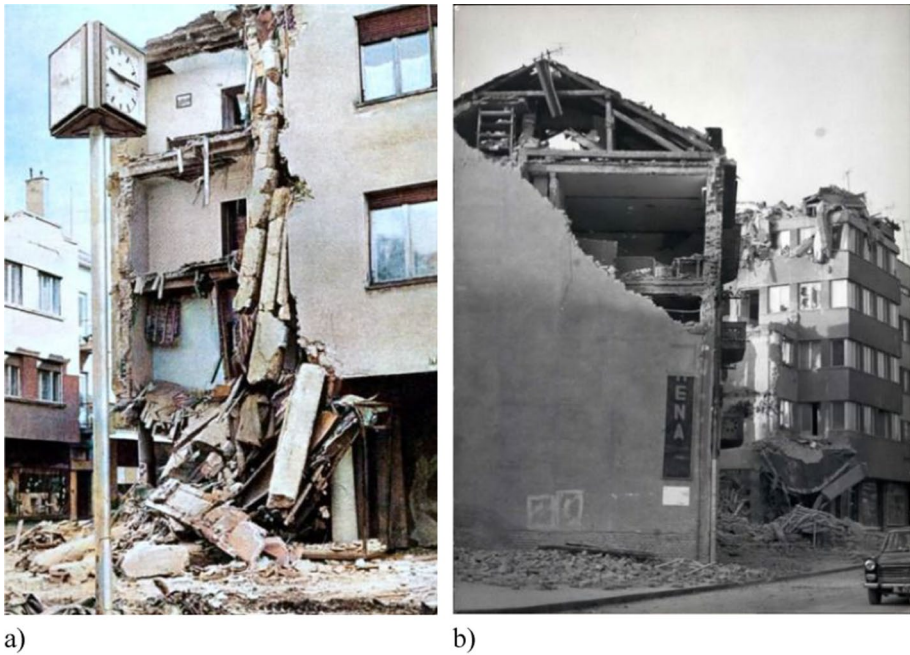
Fig. 21 Examples of type M2 residential URM buildings in Banja Luka affected by the 1969 earthquakes: **a** a partial collapse of the building with wooden floors (Banja Luka 2009) and **b** collapse of a gable wall (Blic 2019)

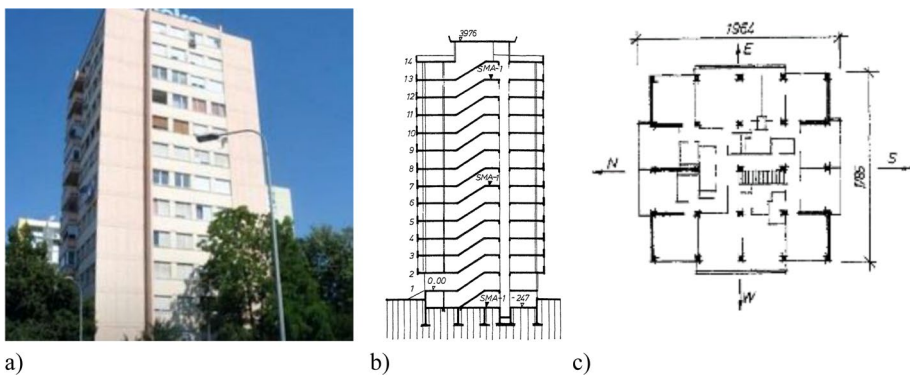
Fig. 22 An example of type RC3 prefabricated RC building in Banja Luka: **a** exterior view of a 14-storey residential building; **b** elevation, and **c** typical floor plan (Jurukovski et al. 1988)

was not located in an earthquake-prone area according to the official seismic hazard map (UNIDO 1983). Buildings with RC structural walls, including two 14-storey towers which were the tallest buildings in Banja Luka at the time of these earthquakes, experienced either insignificant damage or remained undamaged (Fig. 22). However, a few of the IMS prefabricated RC buildings without structural walls experienced significant non-structural damage of the partition and façade walls and had to be repaired. Some of these buildings

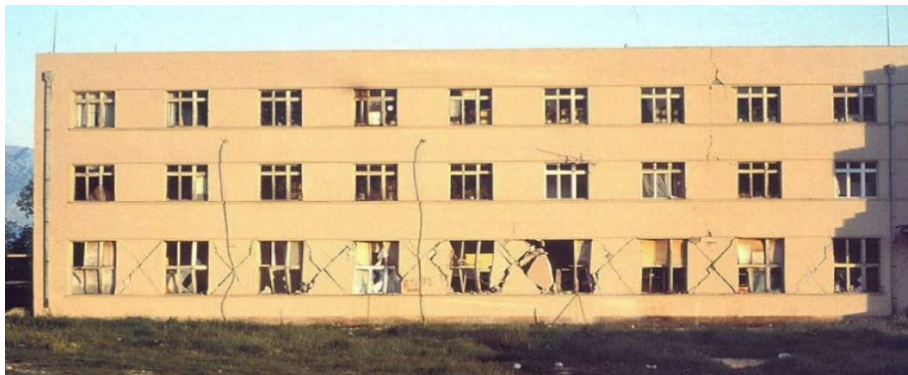
Fig. 25 Budva Town Hall—an example of a type M3-M building damaged in the 1979 Montenegro earthquake (M. Fischinger)

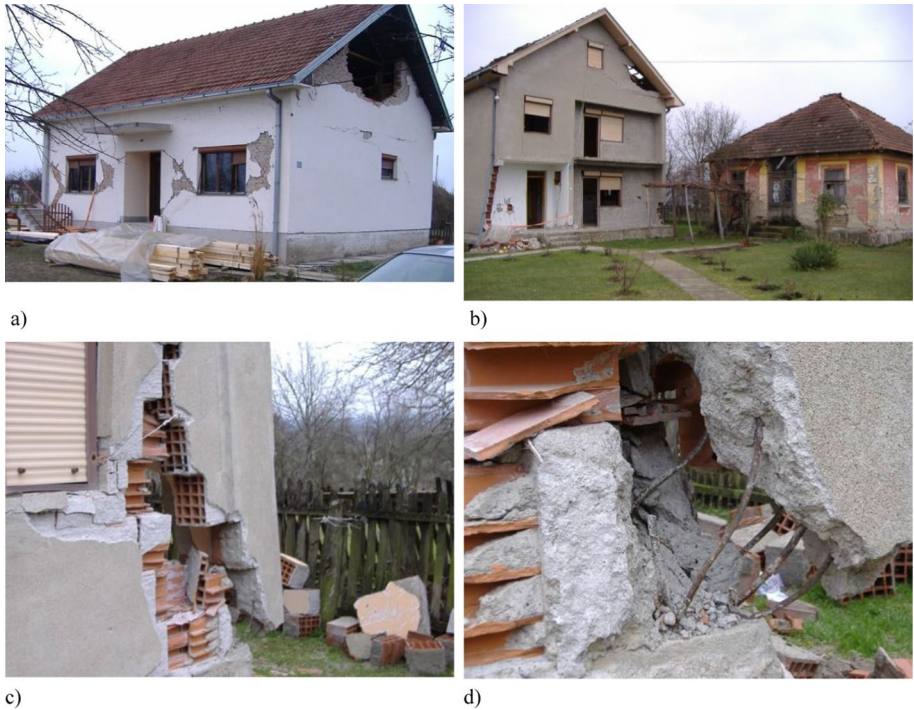
Fig. 28 Rural single-family masonry buildings affected by the 2010 Kraljevo, Serbia earthquake: **a** a severely damaged type M2 building; **b** a damaged inadequately confined M4 type building (left) adjacent to an undamaged old timber-frame (bondruk) building; **c** and **d** damage at the corners of the building shown in figure **b** due to construction flaws (Manić and Bulajić 2014)

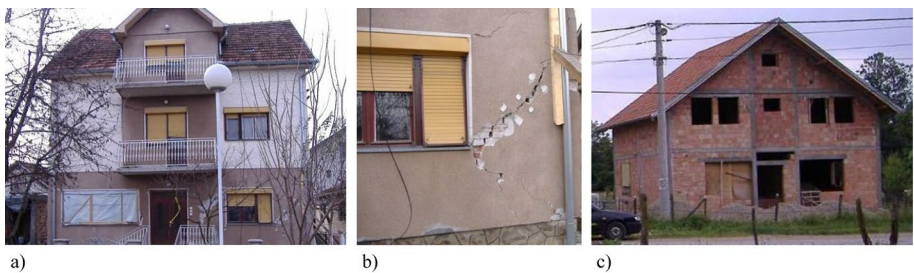
Fig. 29 Performance of type M4 single-family buildings in the 2010 Kraljevo, Serbia earthquake: **a** a partially confined building (ground floor unconfined and upper floors confined); **b** damage of the same building at the ground floor level, and **c** a fully confined M4 type building under construction remained undamaged (Manić and Bulajić 2014)

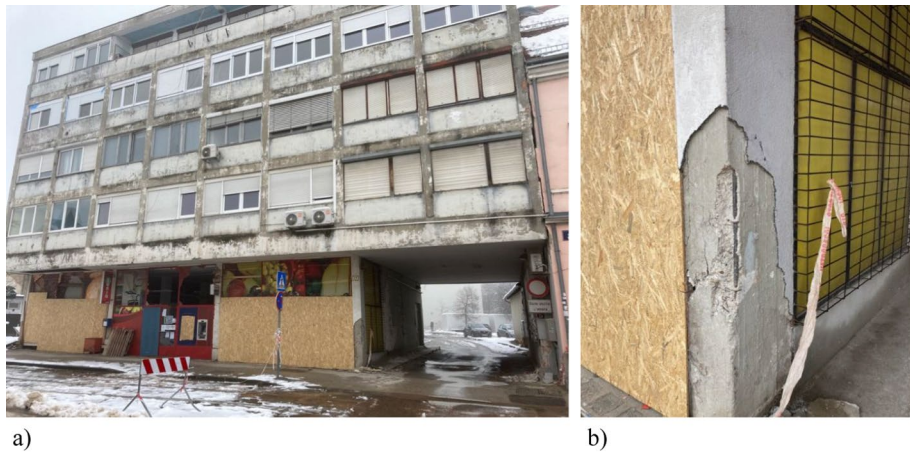
Fig. 33 Damage of type RC1 residential building in Petrinja, Croatia due to the December 2020 earthquake: **a** exterior view showing open ground floor space which used as a store before the earthquake, and **b** a detail of the damaged RC column (SUZI-SAE 2021)

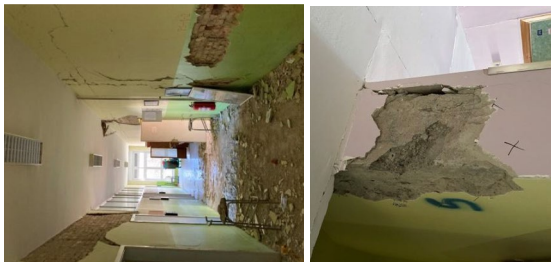
<p>Example</p>	<p>Cracking of interior infill walls; spalling of plaster; damage at the infill-frame interface; cracking of RC columns</p>	<p>Retirement home, Petrinja (SUZI-SAPEE) December 29, 2020 Petrinja, Croatia earthquake $M_W = 6.4, I (\text{°MCS}) = 9$</p>

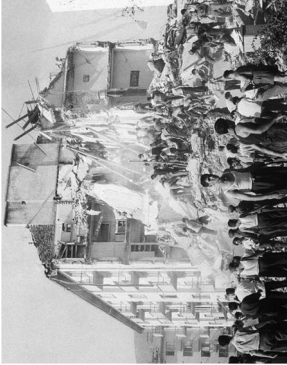
Example	Partial collapse of building No. 13, which had load-bearing masonry walls only in one direction (Berg 1964)	Karpoš residential complex, Skopje (Militinović, 2022) 1963 Skopje earthquake $M_w = 6.0$, $I (^{\circ}MCS) = 9$
