Seismic Performance Assessment of the 18th Century Jesuit College in Dubrovnik's Old City

Uzair, Aanis; Abrahamczyk, Lars; Vrban, Ante; Penava, Davorin

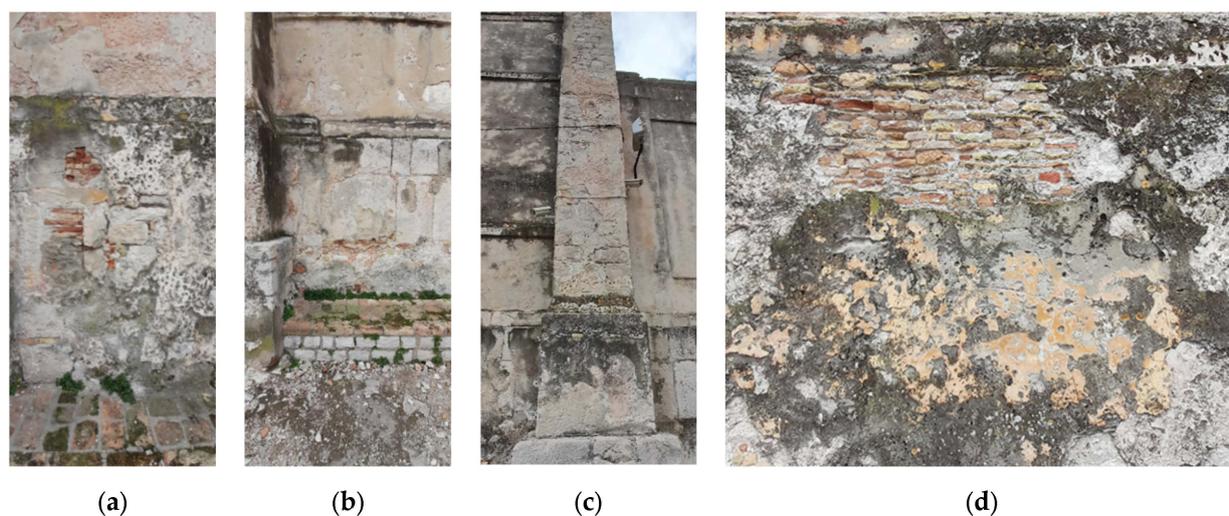
Figure 3. The non-uniform material composition of the external walls and columns: (a) wall with irregularly integrated bricks and stones; (b) wall with integrated layers of brick and stone on top of each other; (c) column brickwork; (d) exposed external wall portion made of bricks (illustration source: Davorin Penava).

Historical construction on the Adriatic coast (Dalmatia) mainly consists of stone buildings (churches, cathedrals, palaces, family houses, residential buildings, etc.) with different textures (quality) of masonry influencing the material characteristics (see Figures 1 and 3). The Jesuit College is classified as an unreinforced irregular stone masonry building that belongs to vulnerability class B in compliance with EMS-98 [24]. The masonry wall texture consists of irregularly crafted natural stone (predominant) or Roman brick units (seldom), alternately laid out in lime mortar (fully grouted). In addition to the available materials, ruins of the 1667 earthquake were also used in the reconstruction process. The non-homogeneous material composition is attributed to the different construction periods as well as the strengthening measures carried out in localized regions over the years. An intensive experimental program was carried out on the quality of walls in Dalmatia, particularly in the Old City of Dubrovnik, as described in the research project report [25]. The compressive strength of lime mortar ($f_m \leq 2.5$ MPa), the unit's compressive strength ($5.0 \leq f_b \leq 35$ MPa; $f_{b,min} = 5.0$ MPa), the masonry's compressive strength ($2.0 \leq f_c \leq 4.0$ MPa), and elastic modulus ($1715 \leq E \leq 3210$ MPa) are determined based on the gathered information [26].

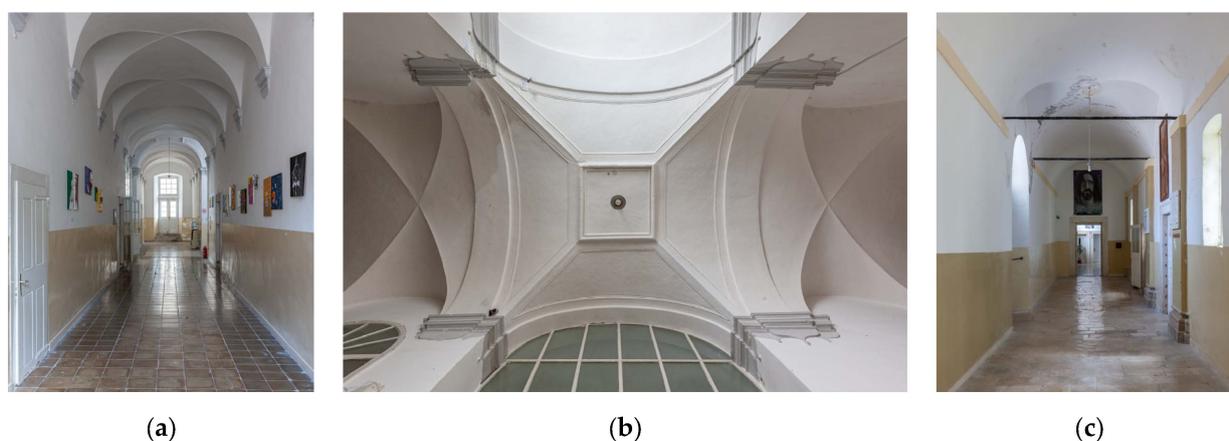
Figure 4. Different types of floor vaults: (a) Cross ribbed; (b) Intersection of different types of vaults; (c) Vaults reinforced with iron tie-rods (Photographic Collection of the Institute of Art History, Zagreb, photo by: Paolo Mofardin).

The building has a footprint of 57 m × 32 m with a total area of approximately 1690 m². The ground, first, second, and third stories have an approximate inter-story height of 2.92 m, 5.30 m, 4.0 m, and 3.35 m, respectively. The wall height reaches up to a maximum of 22 m with the thickness varying within a range from approximately 70 cm to 105 cm. The roof structure is predominantly made of wood with no precise information available regarding the material properties. The wooden floors are covered with a light concrete cover of approximately 7 cm and are braced by wooden beams (depth range of 12 cm to 26 cm) either supported over the corbels or embedded into the adjacent walls. The cross-ribbed, cloister, and barrel vaults made of stone masonry support the floor system and represent one of the most important structural and architectural features of the building (see Figure 4). The complex geometry of the vaults is formed by multiple arch assemblies enchainned together into a continuous surface. The iron tie-rods provide auxiliary support to the vaulted structure and walls against out-of-plane deformations. The presence, location, and position of tie rods indicate intervention activities (i.e., retrofitting, strengthening, etc.) throughout the building's history [27].

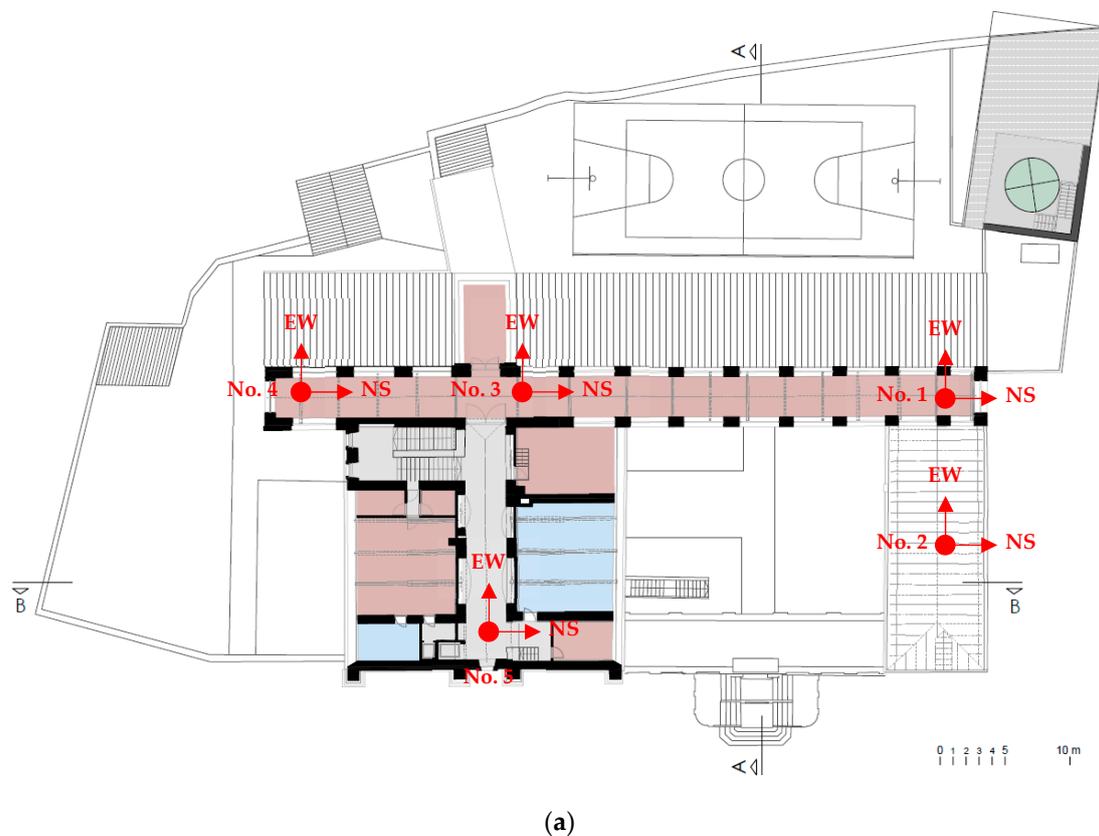
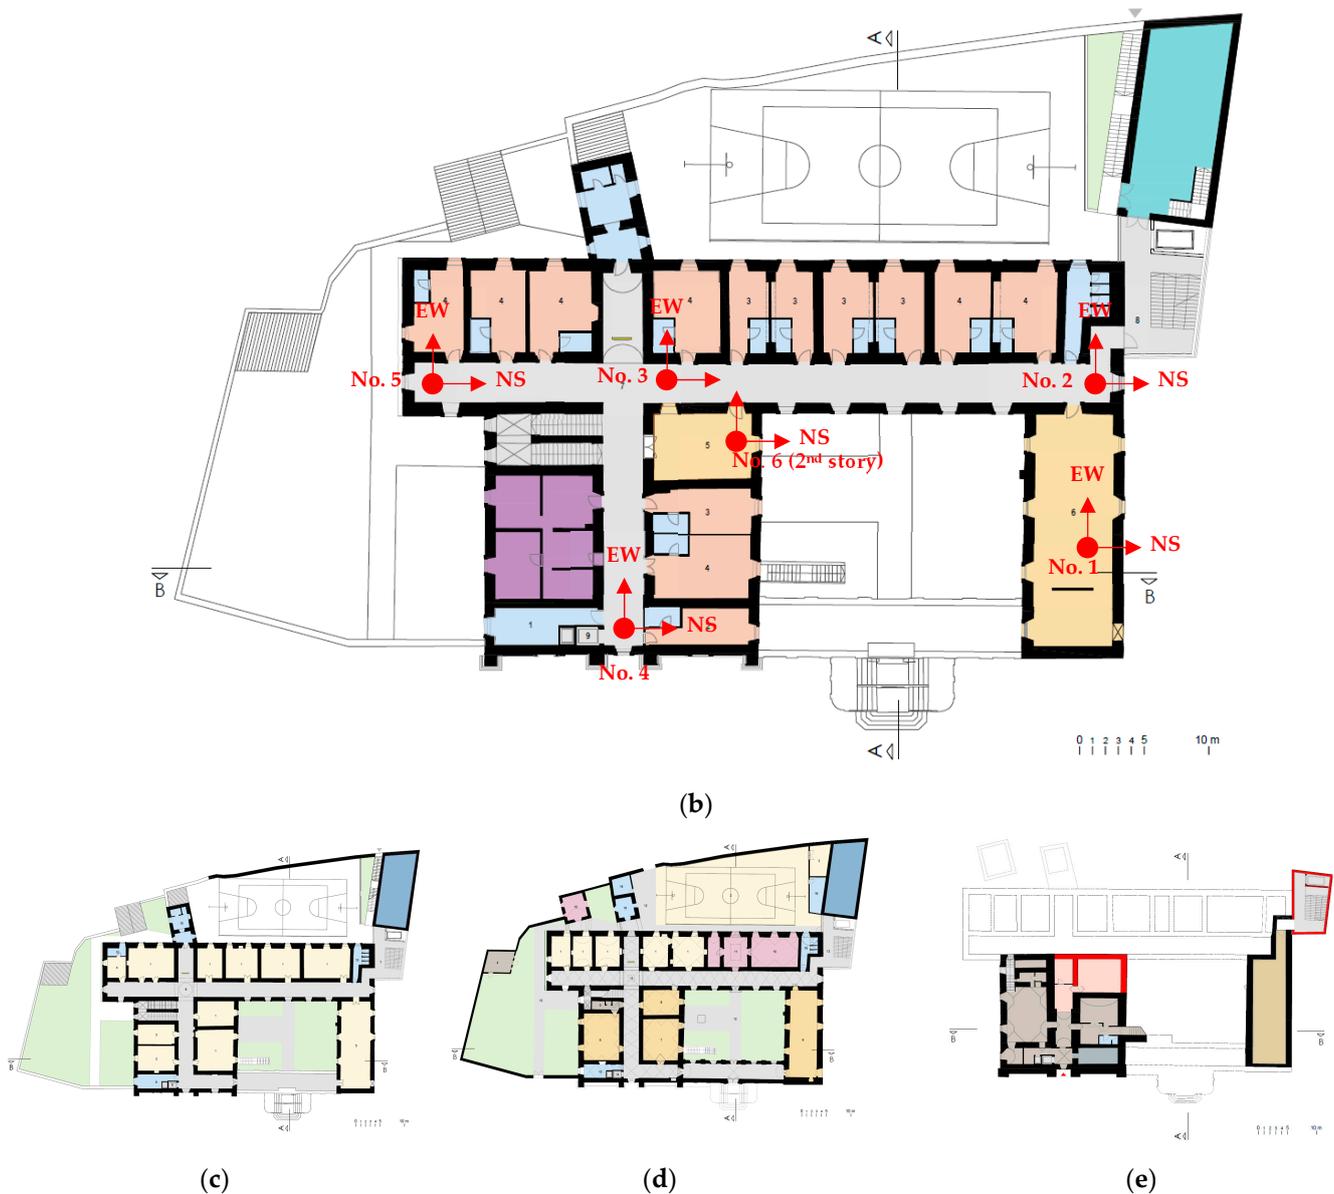
Figure 5. Building plan with an overview of the sensor layout and direction (red): (a) 3rd story (attic); (b) 2nd story; (c) 1st story; (d) ground story; (e) basement.

In addition to an overview of the sensor layout, Figure 5c–e provides an insight into the structural (stone) masonry wall disposition and irregularity of the building construction. The positions for the measurements were selected across the building to possibly verify the interconnectivity between different wings of the building (structural wholeness). The calculated coefficient of variation is approximately 34% for the 2nd story and 12.5% for the 3rd story (EW and NS) (see Table 1). The overall variation coefficient is approximately 30% for the EW direction and approximately 20% for the NS direction, which indicates irregular behavior of different parts of the building, variation in material properties, structural weaknesses, and material degradation. The natural periods of the building, based on the overall average frequencies, are 0.16 s in EW, and 0.13 s in NS, i.e., longer direction, respectively.

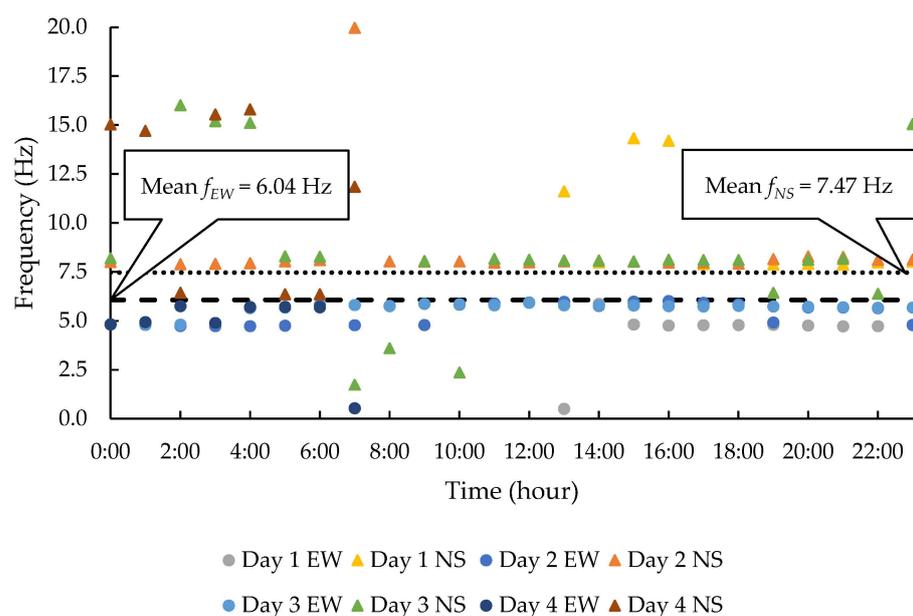
**Figure 6.** Natural frequencies of the Jesuit College obtained from the continuous measurements at the 2nd story, position no. 6 (see Figure 5b) [22,28].

Figure 6 shows the variation in the natural frequencies of the building based on continuous measurements with overall mean frequencies as reference values. The occasional discrepancies occurred due to external factors and were not considered in the analysis of vibrational characteristics ($4 \text{ Hz} < f < 10 \text{ Hz}$).

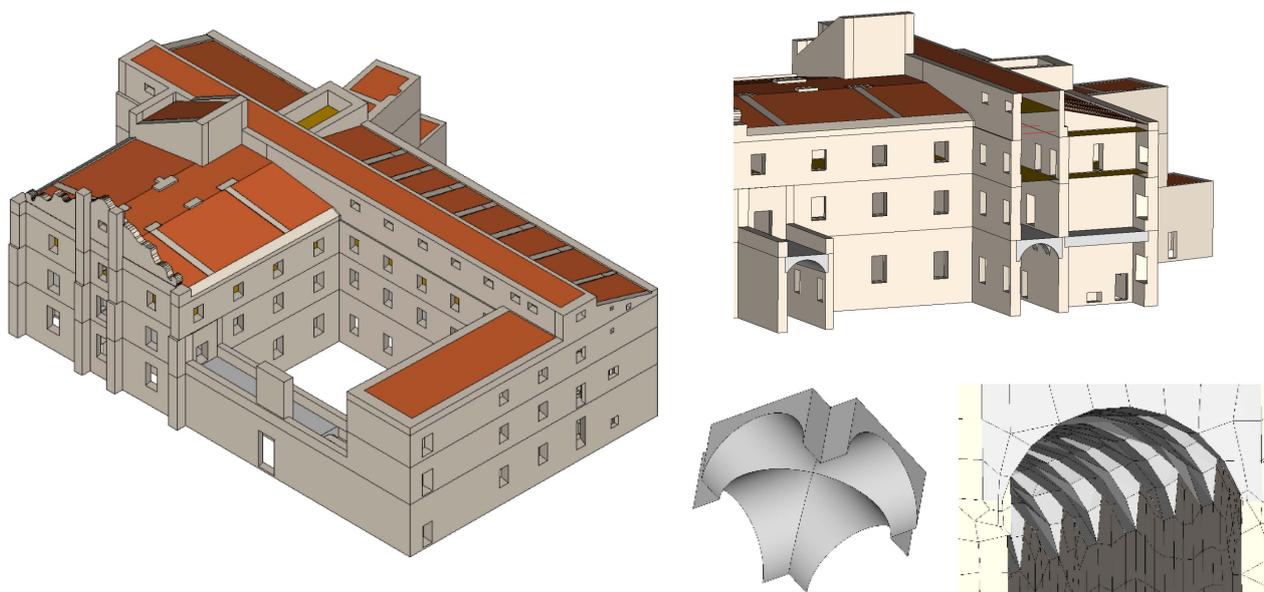
Figure 7. Finite element model of the case study building.

The building is modeled and analyzed using the finite element software DIANA v10.7 (see Figure 7) [29]. The influence of adjacent structures and the interaction among building sections built in different years is neglected based on a careful examination indicating separate entities rather than structural wholeness (representing constraint). The structural model is simplified further by excluding the basement since its contribution to the fundamental period is negligible. The walls and vaults are modeled using solid elements and elastic isotropic material properties. The initial material properties used for the finite element model are based on field investigations as well as an extensive literature review of similar masonry types (see Table 2) [30–34]. The timber floors and roof structure are modeled as isotropic shell elements allowing the transfer of bending effects due to the gravitational loads and in-plane stresses simulating the level of rigidity associated with a flexible diaphragm. The in-plane stiffness of the wooden structure and its components are represented by material properties taken from the literature with similar structural configurations [35,36]. The stiffness contribution of the spiral staircase is neglected in modeling since the surrounding walls are considerably rigid. The iron tie-rods are included as regular truss elements carrying a pre-stressing tensile force and allowing deformations only along the element axis.

The finite element model mesh consists of 4-node hexahedral and quadrilateral volumetric elements for the solids and flat shell elements, respectively. The basic mesh element size is 0.5 m with a 65% transition smoothness for the edges and corners shaped by connecting members, i.e., vaults, wooden floors, etc. The mesh density is determined through a parametric calibration in conjunction with the convergence analysis of the dynamic response. The goal is to find the mesh density that provides a satisfactory level of accuracy in the model's prediction of the dynamic response, without unnecessarily high computational cost. This optimal point is typically where the model's results have "converged", meaning that additional increases in mesh density lead to only minor improvements in accuracy. This approach is necessary because the dynamic response of historical masonry structures can be sensitive to the level of detail represented in the model. For instance, local behavior like stress concentrations requires a finer mesh to be accurately captured. Therefore, the mesh density needs to be calibrated to ensure it is sufficient for the specific analysis objective while maintaining reasonable computational efficiency. The final mesh has a total of 119,306 nodes from which 2659 are restricted at the base; 184,821 elements are distributed as 173,628 solid; 11,176 shell; and 17 truss elements.

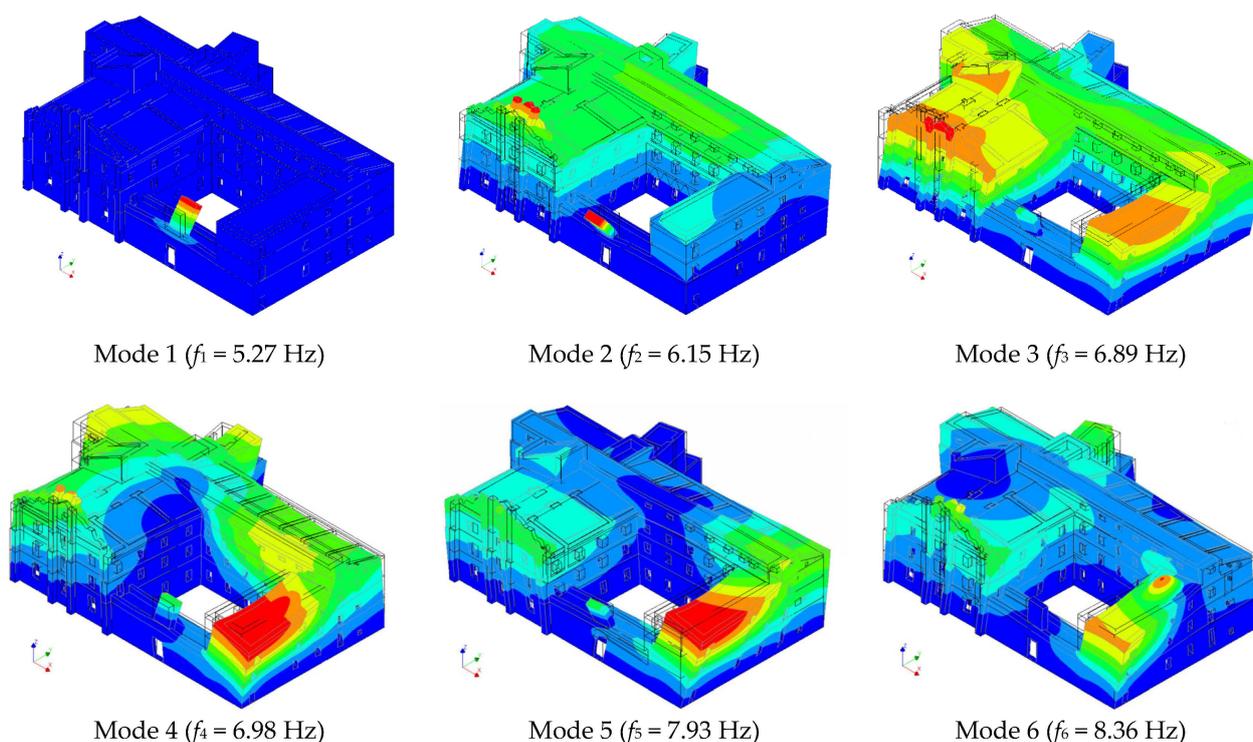
Figure 8. Mode shapes obtained from the free vibration eigenvalue analysis.

The cumulative effective mass for the first six free vibration modes corresponds to approximately 70% in the NS and 72% in the EW directions. The accumulation of higher mass participation requires the calculation of a large number of modes, i.e., approximately 250 modes are required to accumulate 90% mass participation in both horizontal directions. The mode shape 1 ($f_1 = 5.17$ Hz) represents a local vibration mode of the clock tower, indicating high expected deformations at a relatively low frequency. Mode shape 2 ($f_2 = 6.05$ Hz) shows the global mode shape in the EW direction with 61% cumulative mass participation.

Mode shape 3 ($f_3 = 6.78$ Hz) represents the global mode shape in the NS direction with an effective mass participation of 56%. It is important to note that neither of the global mode shapes represents pure translation in either horizontal direction, accompanied by a significant translational motion in the orthogonal direction (see Figure 8). In the case of mode shapes 4–6, the concentrated deformations in various parts of the structure show potentially vulnerable zones even though these modes do not contribute significantly to the global dynamic response due to their relatively low mass participation.

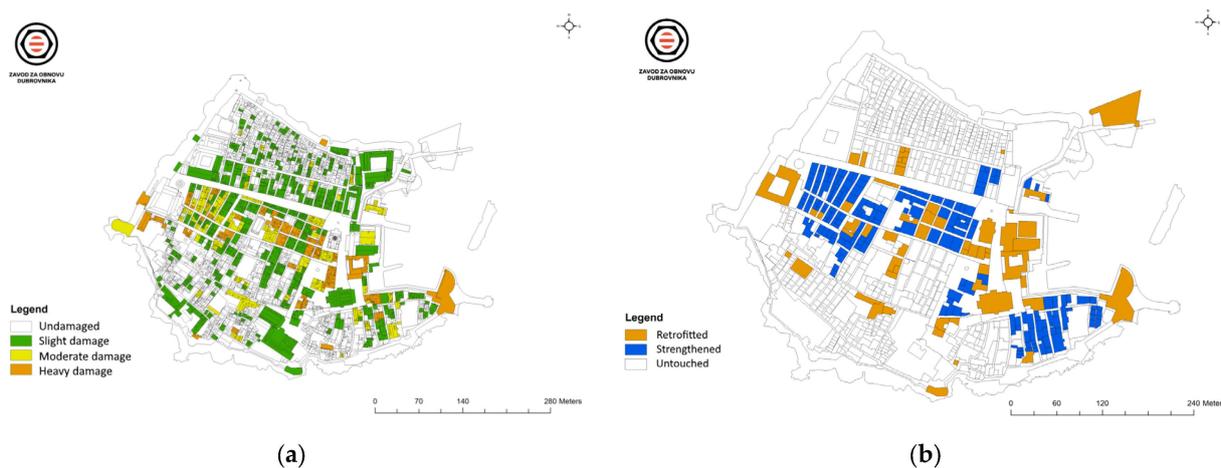
Figure 10. The Old City of Dubrovnik following the 1979 M7 Montenegro earthquake: (a) state of damage to buildings; (b) seismic intervention to buildings available at [46].

To mitigate the effect of earthquakes, retrofitting programs were initiated in the 1980s to repair and strengthen the heritage buildings in Dubrovnik (see Figure 10b). The last significant earthquake in the region occurred in 1996 near Ston VIII–IX (°MCS), and in Dubrovnik it manifested itself with an intensity of V–VI (°MCS) [47], causing minor damage to buildings in the Old City. The region remains an area of high earthquake risk (see Figure 11), emphasizing the importance of a continuous effort toward strengthening cultural heritage assets.

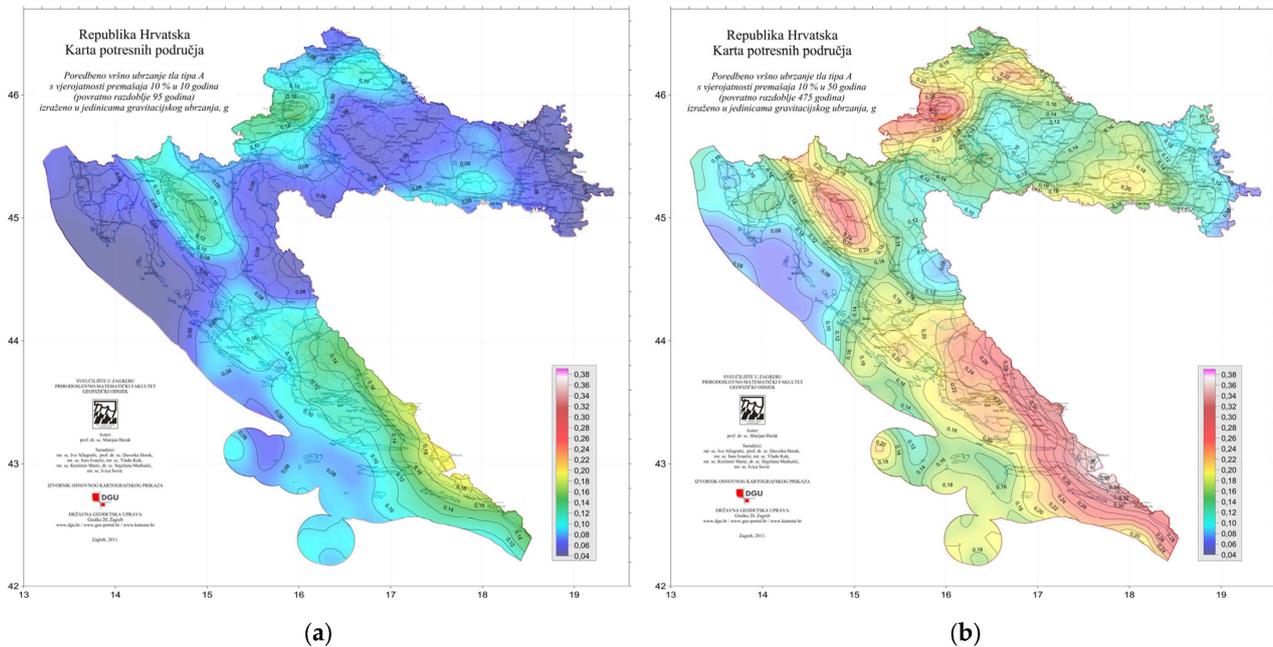
Figure 11. Seismic hazard map of the Republic of Croatia showing comparative peak ground acceleration of type A with a probability of exceeding (a) 10% in 10 years (95 years return period); (b) 10% in 50 years (475 years return period), expressed in the units of gravitational acceleration g [48].

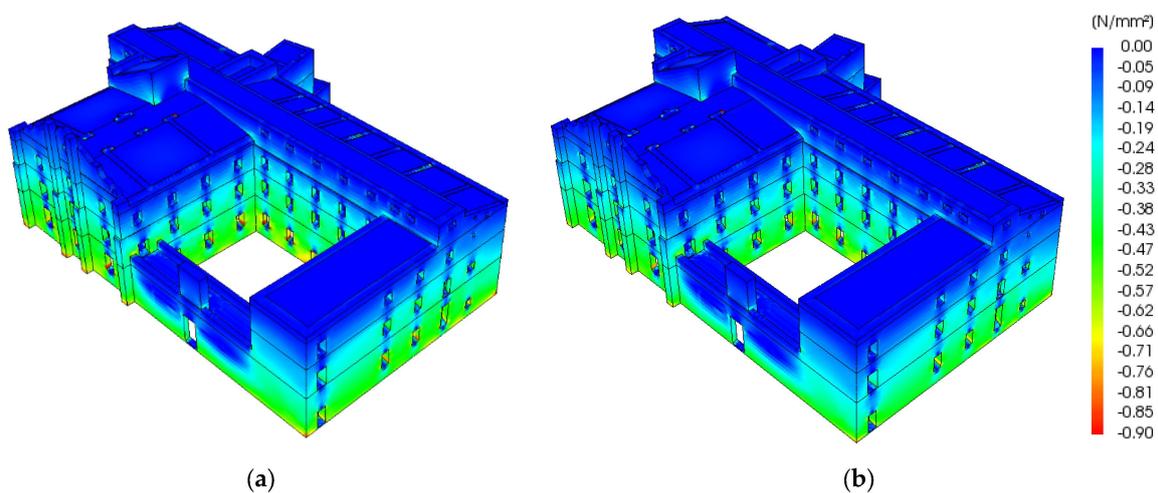
Figure 12. Vertical stresses due to the gravity load combinations applied following the code requirements: (a) Load combination LC₁; (b) Load combination LC₂.

corresponding to the limited knowledge level (KL₁). The assignment of limited knowledge class is based on the non-availability of in situ material characteristics. Except for a few internal walls, the stress concentration at the base of the building is well under the compressive elastic stress limit indicating adequate compressive strength against crushing failure (indicated in Figure 12).

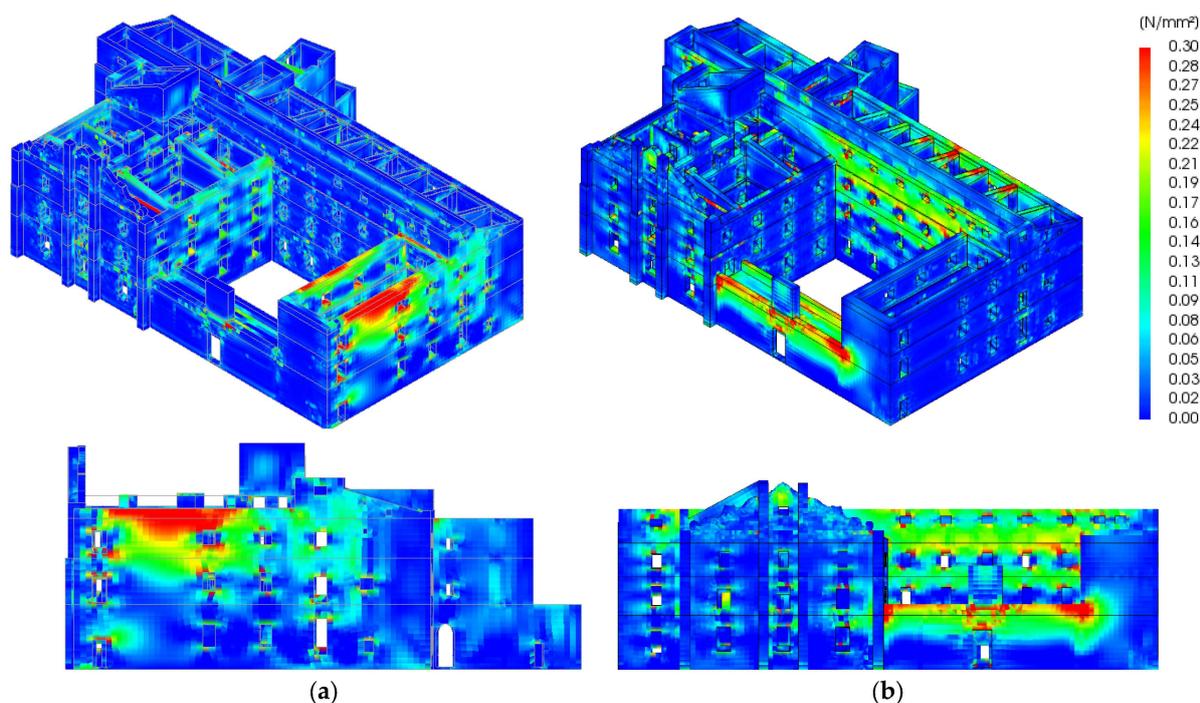
Figure 13. Tensile stresses in the walls resulting from the seismic load combinations: (a) Load combination LC_3 ; (b) Load combination LC_4 .

The tensile stresses are shown in Figure 13 where the legend is bounded such that the red color represents the regions where maximum tensile stress exceeds the elastic stress limit and cracking is expected to occur. In the case of LC_3 , high tensile stresses are observed around the corners of the opening and near the wall–floor connections in the west wing. In the case of LC_4 , parts of the front façade show considerable tensile stresses due to out-of-plane deformations, especially in the upper portions of the wall where the cantilever motion is not restricted (gable wall). Wall segments in the west façade show relatively smaller stresses in comparison to the east façade because of the fewer openings and torsional motion caused by the irregularity of the building in-plan. The sway motion of the west- and east-wing façade causes stress concentration at the reentrant corners. An evaluation corresponding to the seismic action level corresponding to the different seismic zones in Croatia shows that the tensile stresses stay below the elastic tensile limit until the peak ground acceleration (a_{gR}) is 0.10 g. However, the capacity is exceeded for a_{gR} equal to 0.20 g in localized regions, such as openings and critical corners identified from the modal analysis.

The numerical results indicate numerous wall segments in the building that experience stresses higher than the elastic tensile limit of 0.30 MPa. Critical zones with high tensile stresses due to the out-of-plane bending of the walls are identified to provide recommendations for strengthening and retrofitting. These include the facade walls of the west wing, the north façade of the south wing where there is an intersection with the east and west wings, the base of the clock tower, the piers between adjacent wall openings, the walls of the hallway in the south wing, the south-wing facade, and the west-wing façade. Out-of-plane bending is observed at the west- and south-wing walls. The out-of-plane bending is primarily attributed to the absence of moment stabilizing elements, flexible diaphragms, and the minimal torsional effects caused by inherent eccentricity. The wall sections between adjacent openings are prone to shear stress concentration due to the relatively small slenderness ratios (see Figure 15, indicated by red colors).

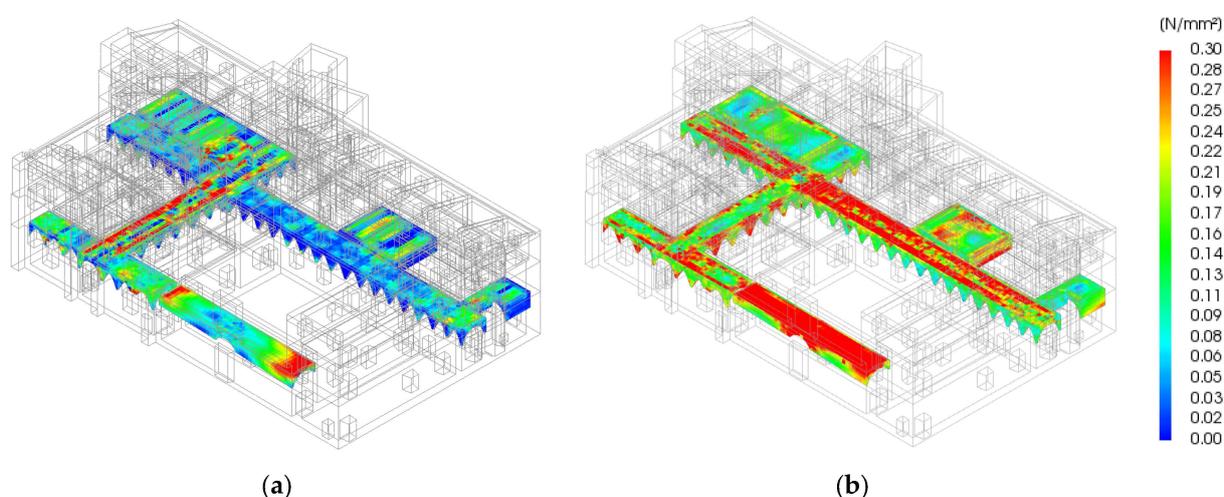
Figure 14. Tensile stresses in the vaults resulting from the seismic load combinations: (a) Load combination LC₃; (b) Load combination LC₄.

High tensile stresses are also observed in the masonry vaults near the wall connections and along the longitudinal direction of the vault in the east-wing hallway (see Figure 14). The development of stress follows along the length of the cross vault in the hallway of the south wing. The same response is observed at the entrance of the north wing and additionally in localized regions along the entire length of the vault, preventing the lateral walls to bend separately out-of-plane. Higher stresses are generated when the vault is oriented perpendicular to the direction of the seismic forces. Tensile stresses also develop in the vaults of the north wing near the connection with the east- and west-wing façade due to the tensile force generated by the east- and west-wing façades when the earthquake occurs in the EW direction. In general, the orientation of the barrel vault with respect to the seismic action plays a crucial role in the overall resistance where low-stress concentration is observed except for the sides which are relatively weaker due to the relatively smaller thickness.

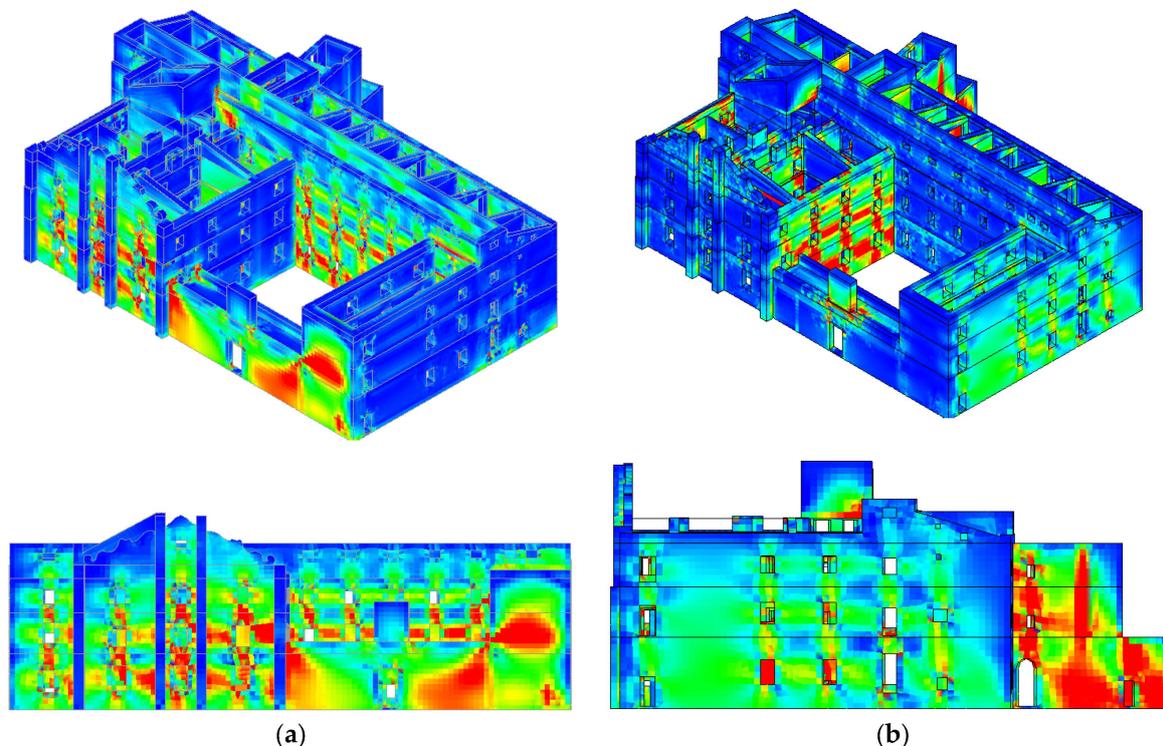
Figure 15. In-plane shear stresses resulting from the seismic load combinations: (a) Load combination LC₃; (b) Load combination LC₄.

In-plane shear stresses for the seismic load combinations are shown in Figure 15. In the case of LC₃, concentrated diagonal shear stresses are observed between adjacent openings of the front façade and at the corners of the north-wing walls. The front and back façade of the south wing also indicate shear stresses with diagonal trajectories concentrated in the wall sections between adjacent openings. Similar results are obtained for the stresses originating from LC₄, with the particularity that the stresses are higher at the walls of the east wing because of comparatively higher mass leading to the concentration of seismic forces.

The floor system is supported by stone masonry vaults representing one of the most important structural and architectural features of the building, distributing lateral loads and the minimal torsional effects to the adjacent walls as shear forces. The complex geometry of the vaults is formed by multiple arch assemblies enchainned together into a continuous surface. The analysis indicates the principal tensile stresses, which are higher than the material tensile stress limit in some parts of the structure in the case of a peak ground acceleration higher than 2.94 m/s^2 (i.e., in the hallway cross vaults oriented perpendicularly to the main direction of the seismic action between the vault and the lateral walls, see Figure 14; at the long walls that lack the transverse-resistant elements to prevent the out-of-plane movement, see Figure 15).

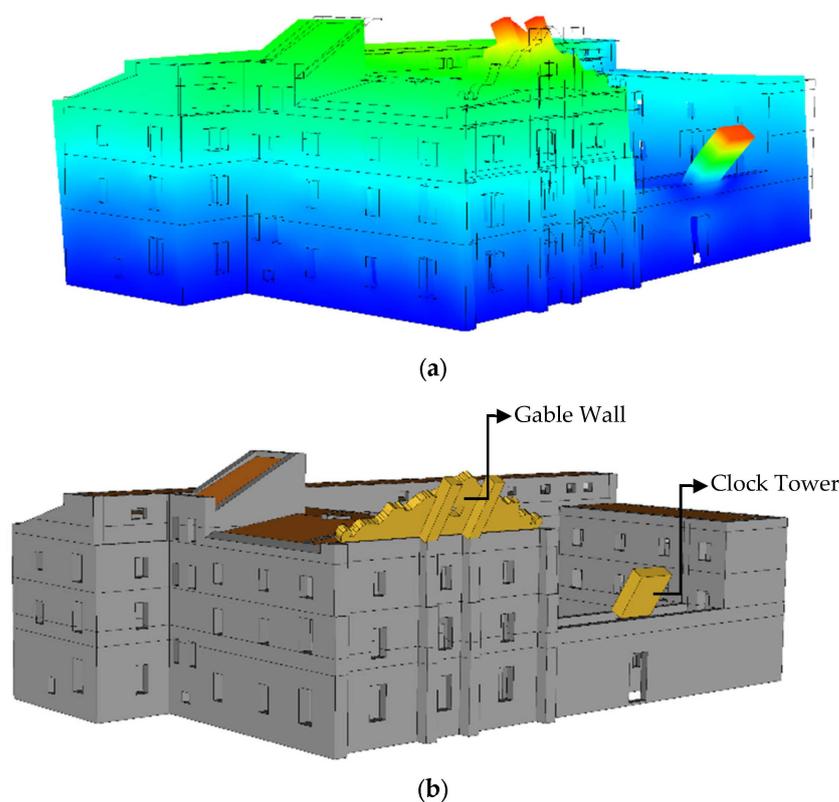
Figure 16. Out-of-plane failure mechanism: (a) Identification of vulnerable areas using modal analysis; (b) Kinematic block of the gable wall and clock tower.

The clock tower situated at the entrance of the building as well as the free-standing gable wall located at the top of the front façade, exhibit considerable deformations even when subjected to low frequencies, making them particularly vulnerable to out-of-plane bending (see Figure 16a). Geometrical characteristics of the macro-element involved in the overturning are defined using the unsupported height and by assuming no connection to the orthogonal walls (see Figure 16b). The Croatian National Annex to Eurocode 8 requires the verification of damage limitation and ultimate limit states with a peak ground acceleration equal to 0.301 g and 0.156 g, respectively [50].

In the case of the clock tower with a height of 4.95 m, the relatively low value of the horizontal load multiplier indicates that a peak ground acceleration of 0.05 g is sufficient to activate the local mechanism, rendering the wall vulnerable to excessive deformations/bending. The local mechanism is activated at a slightly higher peak ground acceleration of 0.09 g in the case of the gable wall with a height of 6.18 m. The non-compliance corresponding to both limit states indicates high vulnerability even at low peak ground acceleration levels (see Table 5).
