# Seismic Performance Assessment of the 18th Century Jesuit College in Dubrovnik's Old City

**Abstract:** The seismic performance assessment of heritage architecture presents many challenges due to the restrictions set forth by the conservation principles to protect the associated social and cultural values. These buildings are typically characterized by unreinforced masonry walls connected by tie-rods, vaults, and wooden floors. The era of construction dates to the time when seismic design regulations were largely unknown, making heritage structures potentially vulnerable to earthquake damage. This study presents the seismic performance assessment of the Jesuit College located in the southern part of the Old City of Dubrovnik. A series of field surveys were conducted to qualitatively examine the material composition and obtain geometrical details in part of the Croatian Science Foundation research project IP-2020-02-3531 entitled “Seismic Risk Assessment of Cultural Heritage in Croatia—SeisRICHerCRO”. The structural response is thoroughly investigated by means of a complex finite element model calibrated using the frequencies determined from ambient vibration measurements and mat

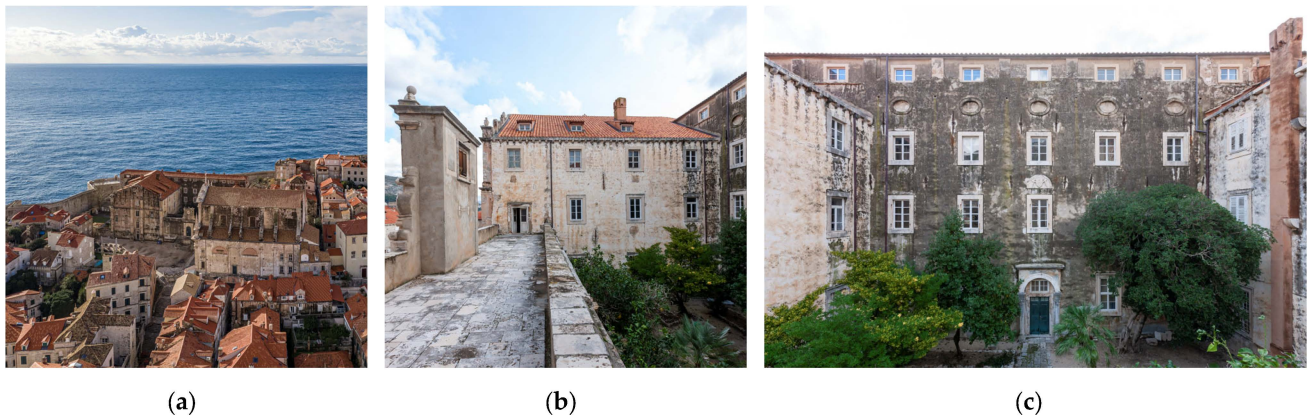
**Figure 1.** Overview of the Jesuit College: (a) On the location within the Old Town; (b) East wing; (c) South wing (Photographic Collection of the Institute of Art History, Zagreb, photo by: Paolo Mofardin).

The Jesuit College is located in front of the monumental Jesuit Stairway and was originally designed by the Jesuit brother Serafino Fabrini, featuring Late Baroque Era architecture and decorative elements [22,23]. The construction started in 1662 and initially included a central church surrounded by a college. Halted by the great Dubrovnik earthquake in 1667, the development and expansion were undertaken by various architects and took more than a century to be completed in 1765 (see Figure 2). Today, the building hosts a Catholic gymnasium and is primarily used for educational purposes.

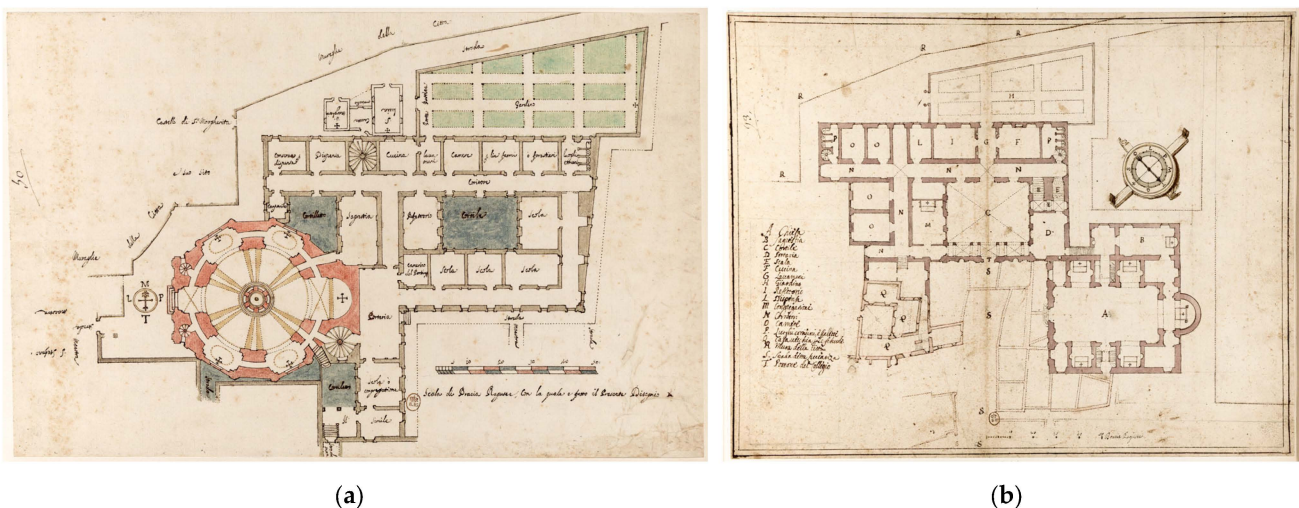
**Figure 2.** Architectural drawings of the Jesuit college by (a) Serafino Fabrini in 1659; (b) Henri Laloju in 1699, from the National Library in Paris [23].

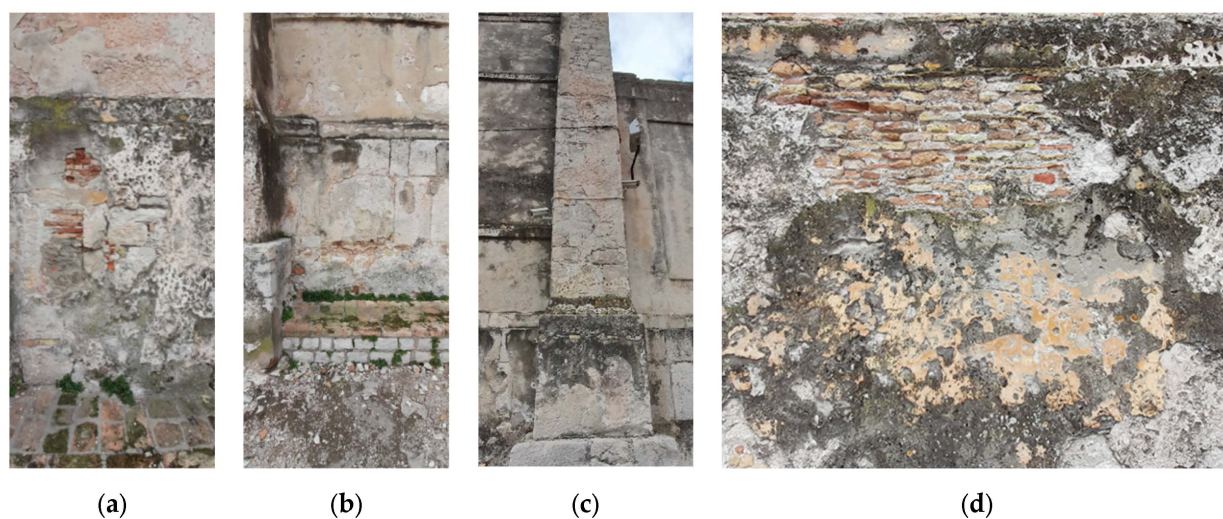
**Figure 3.** The non-uniform material composition of the external walls and columns: (a) wall with irregularly integrated bricks and stones; (b) wall with integrated layers of brick and stone on top of each other; (c) column brickwork; (d) exposed external wall portion made of bricks (illustration source: Davorin Penava).

Historical construction on the Adriatic coast (Dalmatia) mainly consists of stone buildings (churches, cathedrals, palaces, family houses, residential buildings, etc.) with different textures (quality) of masonry influencing the material characteristics (see Figures 1 and 3). The Jesuit College is classified as an unreinforced irregular stone masonry building that belongs to vulnerability class B in compliance with EMS-98 [24]. The masonry wall texture consists of irregularly crafted natural stone (predominant) or Roman brick units (seldom), alternately laid out in lime mortar (fully grouted). In addition to the available materials, ruins of the 1667 earthquake were also used in the reconstruction process. The non-homogeneous material composition is attributed to the different construction periods as well as the strengthening measures carried out in localized regions over the years. An intensive experimental program was carried out on the quality of walls in Dalmatia, particularly in the Old City of Dubrovnik, as described in the research project report [25]. The compressive strength of lime mortar ( $f_m \leq 2.5$  MPa), the unit's compressive strength ( $5.0 \leq f_b \leq 35$  MPa;  $f_{b,min} = 5.0$  MPa), the masonry's compressive strength ( $2.0 \leq f_c \leq 4.0$  MPa), and elastic modulus ( $1715 \leq E \leq 3210$  MPa) are determined based on the gathered information [26].

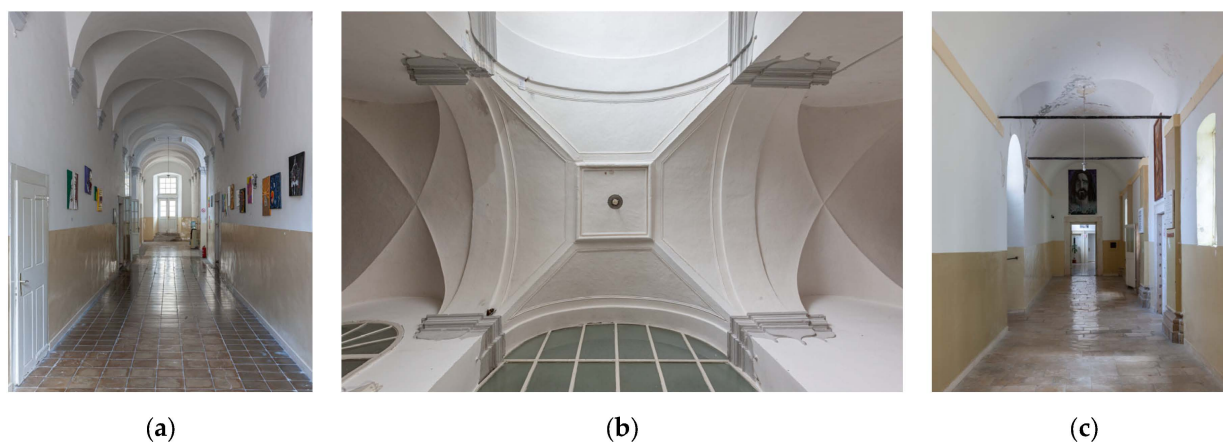
**Figure 4.** Different types of floor vaults: (a) Cross ribbed; (b) Intersection of different types of vaults; (c) Vaults reinforced with iron tie-rods (Photographic Collection of the Institute of Art History, Zagreb, photo by: Paolo Mofardin).

The building has a footprint of 57 m × 32 m with a total area of approximately 1690 m<sup>2</sup>. The ground, first, second, and third stories have an approximate inter-story height of 2.92 m, 5.30 m, 4.0 m, and 3.35 m, respectively. The wall height reaches up to a maximum of 22 m with the thickness varying within a range from approximately 70 cm to 105 cm. The roof structure is predominantly made of wood with no precise information available regarding the material properties. The wooden floors are covered with a light concrete cover of approximately 7 cm and are braced by wooden beams (depth range of 12 cm to 26 cm) either supported over the corbels or embedded into the adjacent walls. The cross-ribbed, cloister, and barrel vaults made of stone masonry support the floor system and represent one of the most important structural and architectural features of the building (see Figure 4). The complex geometry of the vaults is formed by multiple arch assemblies enchainned together into a continuous surface. The iron tie-rods provide auxiliary support to the vaulted structure and walls against out-of-plane deformations. The presence, location, and position of tie rods indicate intervention activities (i.e., retrofitting, strengthening, etc.) throughout the building's history [27].

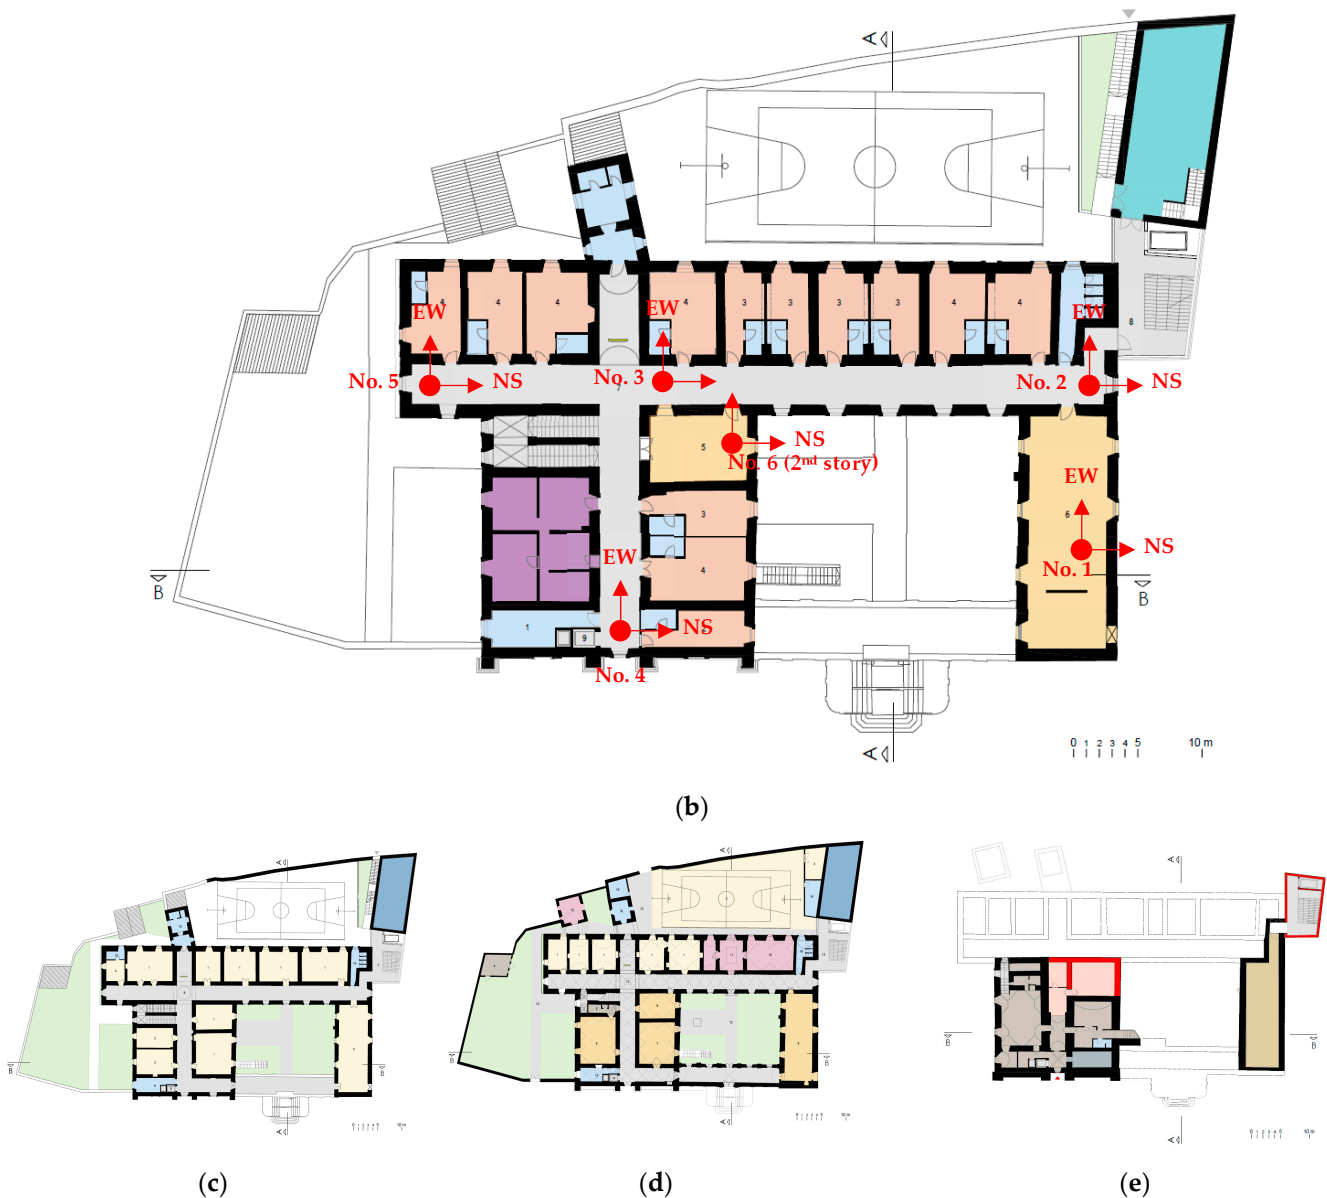
**Figure 5.** Building plan with an overview of the sensor layout and direction (red): (a) 3rd story (attic); (b) 2nd story; (c) 1st story; (d) ground story; (e) basement.

In assessing the seismic performance of the cultural heritage building, the determination of the stiffness of the structure (or individual structural elements) is an important task, often made difficult due to various influencing parameters, such as non-uniform quality of masonry workmanship (see Section 2.1), unknowns within or above the structural elements (thick walls, vaults, etc.), interconnectivity, and damage. The optimal solution in such cases is the calibration of a structural model utilizing vibrational characteristics of the building (natural frequencies), where the geometrical properties are known, and the material characteristics are determined by a trial-and-error process. To identify the natural frequencies, ambient vibration (noise) measurements were collected within the Jesuit College building in two ways: (1) Up to 20 min long (interim) at the 2nd and 3rd story (attic) using HVSr instruments (at five different locations per story); (2) Continuous over 3 days in the 2nd story using a SARA instrument (at one location). The north-south (NS), i.e., the longer direction of the building's south wing (see Figure 5a,b), and east-west (EW) response components were simultaneously measured at a sampling rate of 128 Hz. The fundamental frequencies in NS and EW directions were determined from the Fourier amplitude spectrum of the two recorded horizontal components (see Table 1 and Figure 6). Since no experimental modes were identified, it is not possible to correlate the frequencies with structural mode shapes. Therefore, the measured frequencies are referred to as  $f_{NS}$  and  $f_{EW}$  for the measurements recorded in the NS and EW directions, respectively. The mean frequency is used as a reference for the calibration of the finite element structural model. The standard deviation (St. dev.), variance (Var.), and variation coefficient (Var. coeff.) indicate the range of variability in the measured response.

In addition to an overview of the sensor layout, Figure 5c–e provides an insight into the structural (stone) masonry wall disposition and irregularity of the building construction. The positions for the measurements were selected across the building to possibly verify the interconnectivity between different wings of the building (structural wholeness). The calculated coefficient of variation is approximately 34% for the 2nd story and 12.5% for the 3rd story (EW and NS) (see Table 1). The overall variation coefficient is approximately 30% for the EW direction and approximately 20% for the NS direction, which indicates irregular behavior of different parts of the building, variation in material properties, structural weaknesses, and material degradation. The natural periods of the building, based on the overall average frequencies, are 0.16 s in EW, and 0.13 s in NS, i.e., longer direction, respectively.

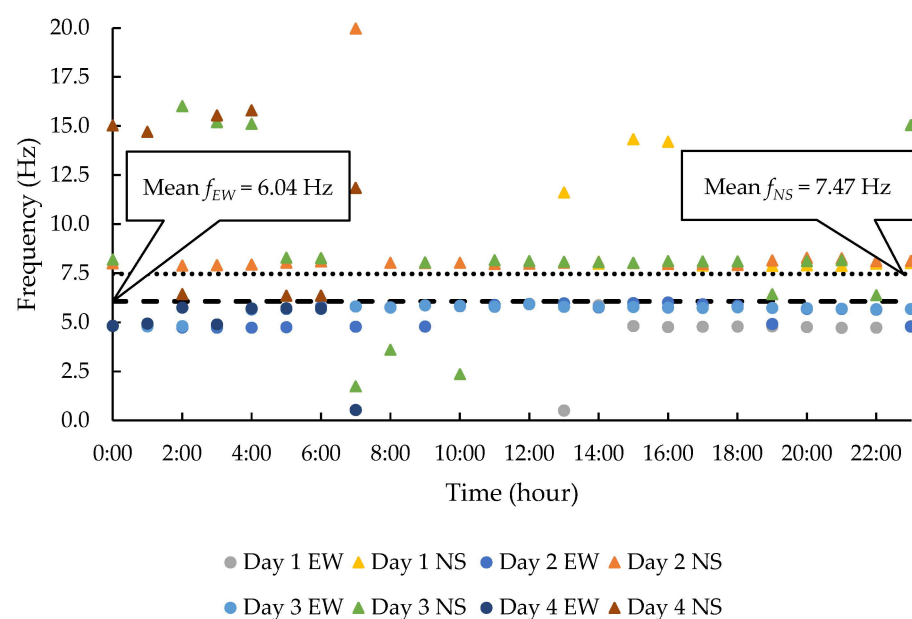
**Figure 6.** Natural frequencies of the Jesuit College obtained from the continuous measurements at the 2nd story, position no. 6 (see Figure 5b) [22,28].

Figure 6 shows the variation in the natural frequencies of the building based on continuous measurements with overall mean frequencies as reference values. The occasional discrepancies occurred due to external factors and were not considered in the analysis of vibrational characteristics ( $4 \text{ Hz} < f < 10 \text{ Hz}$ ).

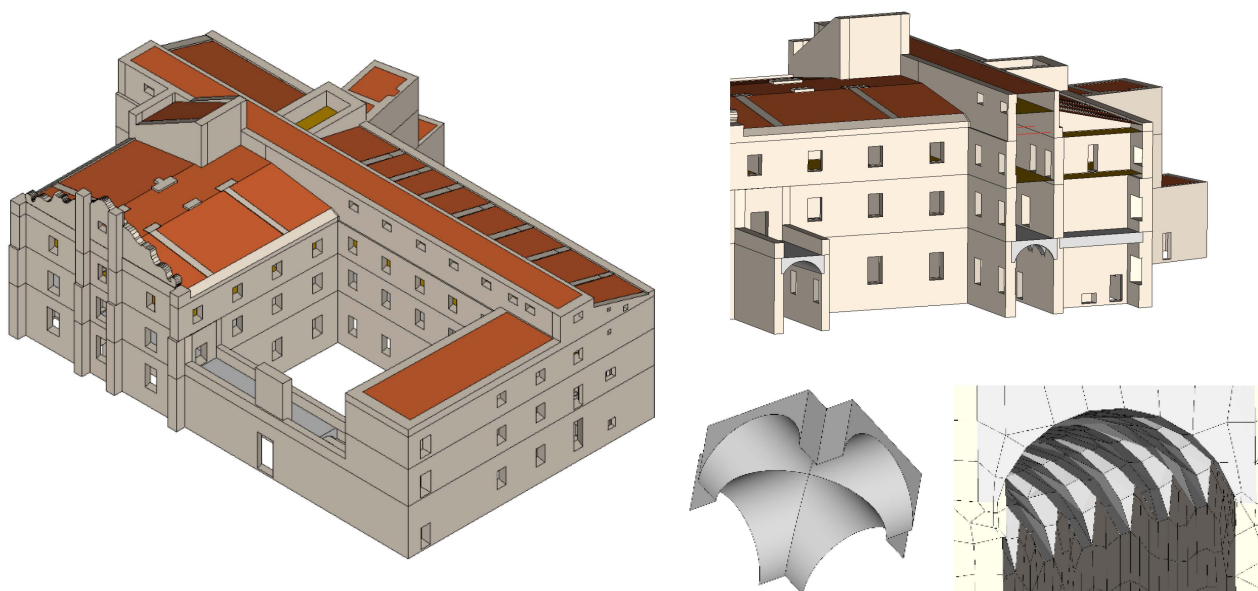
**Figure 7.** Finite element model of the case study building.

The building is modeled and analyzed using the finite element software DIANA v10.7 (see Figure 7) [29]. The influence of adjacent structures and the interaction among building sections built in different years is neglected based on a careful examination indicating separate entities rather than structural wholeness (representing constraint). The structural model is simplified further by excluding the basement since its contribution to the fundamental period is negligible. The walls and vaults are modeled using solid elements and elastic isotropic material properties. The initial material properties used for the finite element model are based on field investigations as well as an extensive literature review of similar masonry types (see Table 2) [30–34]. The timber floors and roof structure are modeled as isotropic shell elements allowing the transfer of bending effects due to the gravitational loads and in-plane stresses simulating the level of rigidity associated with a flexible diaphragm. The in-plane stiffness of the wooden structure and its components are represented by material properties taken from the literature with similar structural configurations [35,36]. The stiffness contribution of the spiral staircase is neglected in modeling since the surrounding walls are considerably rigid. The iron tie-rods are included as regular truss elements carrying a pre-stressing tensile force and allowing deformations only along the element axis.

The finite element model mesh consists of 4-node hexahedral and quadrilateral volumetric elements for the solids and flat shell elements, respectively. The basic mesh element size is 0.5 m with a 65% transition smoothness for the edges and corners shaped by connecting members, i.e., vaults, wooden floors, etc. The mesh density is determined through a parametric calibration in conjunction with the convergence analysis of the dynamic response. The goal is to find the mesh density that provides a satisfactory level of accuracy in the model's prediction of the dynamic response, without unnecessarily high computational cost. This optimal point is typically where the model's results have "converged", meaning that additional increases in mesh density lead to only minor improvements in accuracy. This approach is necessary because the dynamic response of historical masonry structures can be sensitive to the level of detail represented in the model. For instance, local behavior like stress concentrations requires a finer mesh to be accurately captured. Therefore, the mesh density needs to be calibrated to ensure it is sufficient for the specific analysis objective while maintaining reasonable computational efficiency. The final mesh has a total of 119,306 nodes from which 2659 are restricted at the base; 184,821 elements are distributed as 173,628 solid; 11,176 shell; and 17 truss elements.

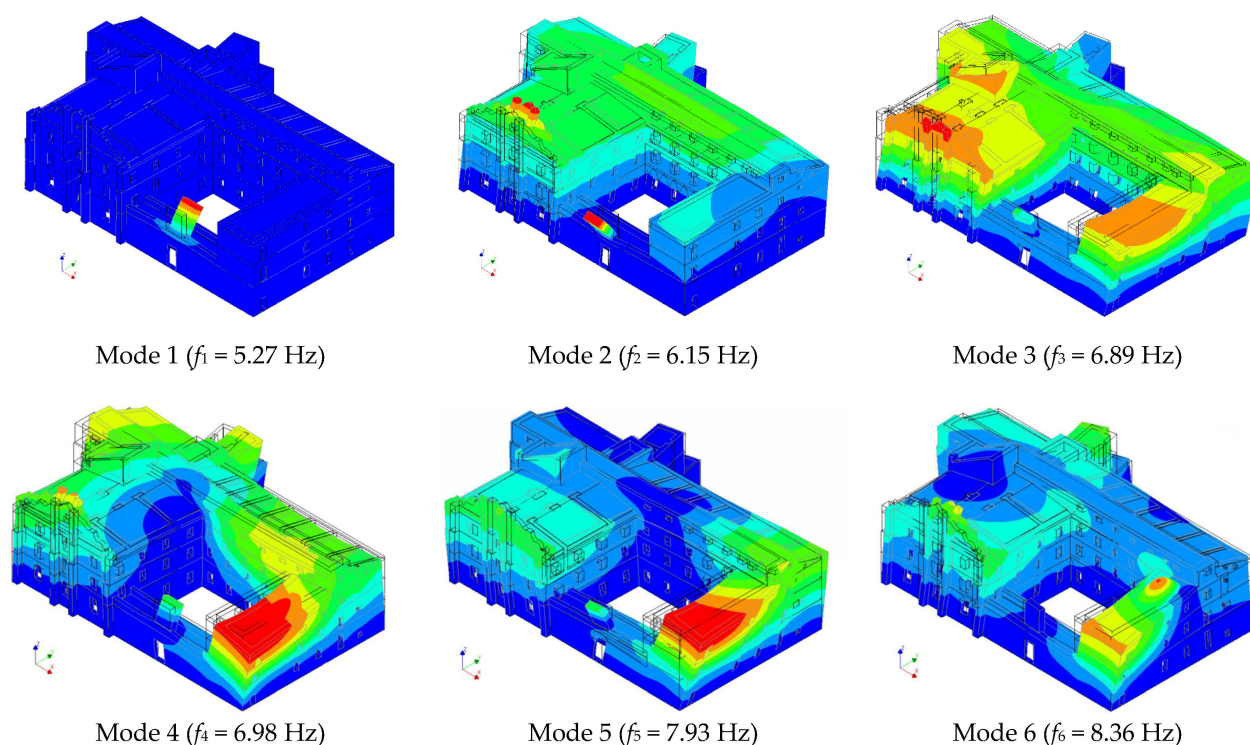
**Figure 8.** Mode shapes obtained from the free vibration eigenvalue analysis.

The cumulative effective mass for the first six free vibration modes corresponds to approximately 70% in the NS and 72% in the EW directions. The accumulation of higher mass participation requires the calculation of a large number of modes, i.e., approximately 250 modes are required to accumulate 90% mass participation in both horizontal directions. The mode shape 1 ( $f_1 = 5.17$  Hz) represents a local vibration mode of the clock tower, indicating high expected deformations at a relatively low frequency. Mode shape 2 ( $f_2 = 6.05$  Hz) shows the global mode shape in the EW direction with 61% cumulative mass participation.

Mode shape 3 ( $f_3 = 6.78$  Hz) represents the global mode shape in the NS direction with an effective mass participation of 56%. It is important to note that neither of the global mode shapes represents pure translation in either horizontal direction, accompanied by a significant translational motion in the orthogonal direction (see Figure 8). In the case of mode shapes 4–6, the concentrated deformations in various parts of the structure show potentially vulnerable zones even though these modes do not contribute significantly to the global dynamic response due to their relatively low mass participation.

The identified global modes which activate the major percentage of mass participation in EW and NS directions are selected for the model's calibration. The global modes are primarily characterized by a translational motion activating significant mass participation in the horizontal directions (see Table 4). Despite the complex dynamic responses caused by irregular distribution of mass and stiffness (eccentricity  $e_x = 3.8\%$  and  $e_y = 5.4\%$ ), the potential for torsional motion remains comparatively limited (indicated by the low effective rotational mass given in Table 4). In addition to the global mode shapes, the low-frequency local modes reveal the out-of-plane vibration of individual façade segments. These local modes help in the identification of the unwanted cantilever motion associated with the clock tower and gable wall which is used for the local verification in Section 4.2.

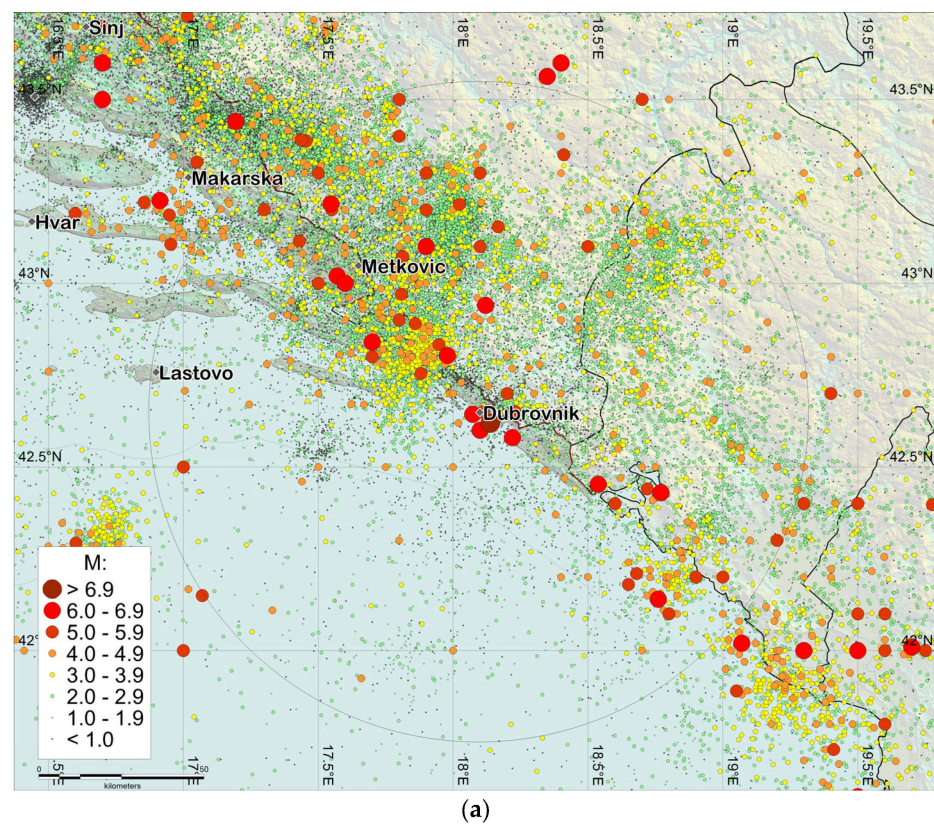
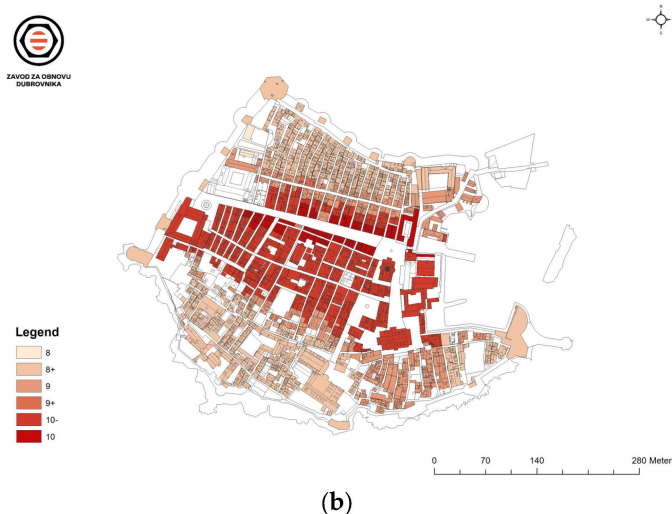
**Figure 9.** (a) Spatial distribution of earthquake locations around the Dubrovnik area based on data from the Croatian Earthquake Catalogue (updated and continuously supplemented version first described in [43] for the period BC–2021. Circle marks the area inside 100 km from Dubrovnik); (b) seismic micro-zoning in compliance with MCS scale available at [46].

The City of Dubrovnik is located on the coast of the Adriatic Sea in the southern part of Croatia and on the boundary between the African and Eurasian tectonic plates which move towards each other causing high seismic/tectonic activity in the region. This region is the most threatened area in Croatia with the highest expected earthquake magnitude of M7.5. According to geological classifications, the area is located at the contact between the Adriatic and Dinaric regional structural units, defined by karstic terrain and porous limestone bedrock. The immediate border of these units is the Ploče–Dubrovnik fault. Between Mljet and the Dubrovnik submarine, the Adriatic unit borders the Adriatic microplate [41]. Earthquakes are a major concern of the region due to the high concentration of cultural heritage buildings of outstanding historical significance. Since the 1979 M7.0 Montenegro Earthquake, the Old City of Dubrovnik is enlisted in the UNESCO World Heritage List [42]. Historic data for the period BC–2021 (see Figure 9), according to the Croatian Earthquake Catalogue—CEC [43], note about ten earthquakes in the region with intensity VIII or more ( $^{\circ}$ MCS) out of which the most significant is the 1667 earthquake of intensity X ( $^{\circ}$ MCS) [44,45]. Before the Great Dubrovnik Earthquake of 1667, strong earthquakes from 373 BC, 376, 1471, 1482, 1504, 1516, and 1520 are mentioned, which caused damage to the area. Of the very strong or severe earthquakes from the recent past, there are those from 1850 and 1869 with an intensity of VII on the  $^{\circ}$ MCS scale; however, the M7 earthquake in Montenegro from 1979 is particularly highlighted. In Dubrovnik, it manifested itself as an earthquake of intensity VII ( $^{\circ}$ MCS) with structural damage to numerous buildings in the Old City, including the Jesuit College (see Figure 10a).

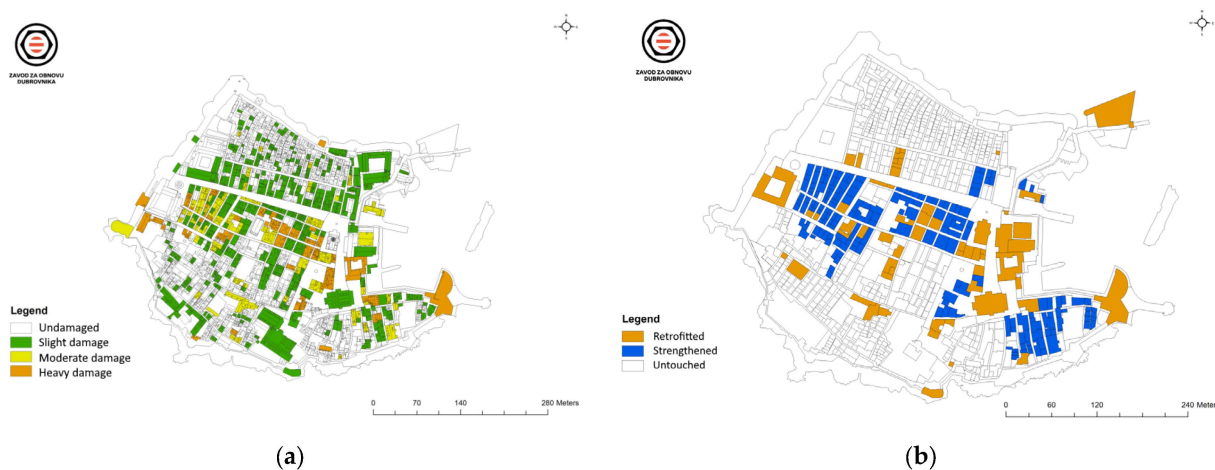
**Figure 10.** The Old City of Dubrovnik following the 1979 M7 Montenegro earthquake: (a) state of damage to buildings; (b) seismic intervention to buildings available at [46].

To mitigate the effect of earthquakes, retrofitting programs were initiated in the 1980s to repair and strengthen the heritage buildings in Dubrovnik (see Figure 10b). The last significant earthquake in the region occurred in 1996 near Ston VIII–IX (°MCS), and in Dubrovnik it manifested itself with an intensity of V–VI (°MCS) [47], causing minor damage to buildings in the Old City. The region remains an area of high earthquake risk (see Figure 11), emphasizing the importance of a continuous effort toward strengthening cultural heritage assets.

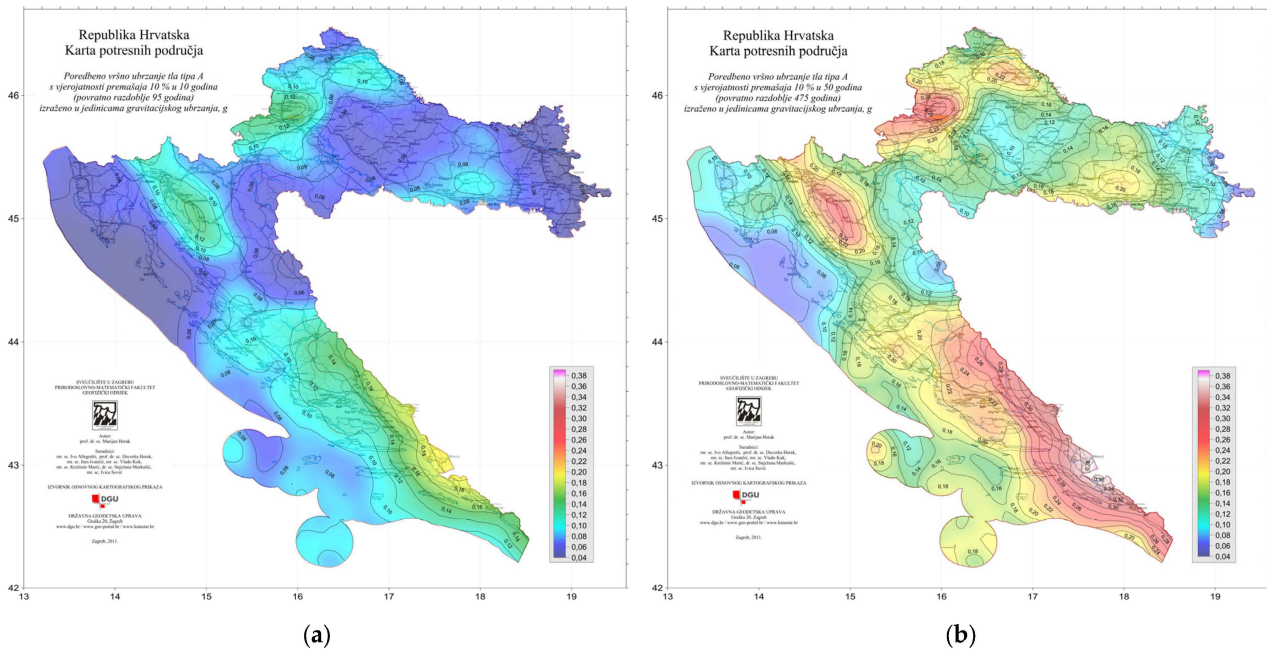
**Figure 11.** Seismic hazard map of the Republic of Croatia showing comparative peak ground acceleration of type A with a probability of exceeding (a) 10% in 10 years (95 years return period); (b) 10% in 50 years (475 years return period), expressed in the units of gravitational acceleration  $g$  [48].

The seismic action is defined according to the Eurocode 8 guidelines for the assessment and retrofitting of buildings using the nationally defined reference peak ground acceleration ( $a_{gR}$ ) established for a return period of 475 years [50,51]. Recent studies describe the site conditions of the Old City of Dubrovnik as cretaceous dolomitic limestone and quaternary clay, with sand sediments of up to 5 m thickness, classifying the site as soil type A with an

$a_{gR}$  of  $2.94 \text{ m/s}^2$  at the northern and southern bedrock ridge [52,53] and superficial deposits of approximately 20–25 m depth central-filled and flattened part (former sea embayment), i.e., soil class B [41,49]. The case study building is classified with an importance class of III and has an importance factor equal to 1.2. The load combination ( $LC_3$ ) refers to the seismic load applied mainly in the NS direction and considering a factored EW component (and vice versa in the case of  $LC_4$  acting mainly in the EW direction). Both load combinations consider accidental torsional effects according to the code requirements. The choice of analysis method (i.e., response spectrum analysis) is mainly influenced by the complex geometry and irregularity, leading to a multitude of local and global vibrational modes (see Figure 8). Nonetheless, the uncertainties introduced due to the simplified assumptions of linearity and damping, integral to response spectrum analysis, cannot accurately represent the complex features and nonlinear behavior of historical structures. Consequently, this research presents an initial assessment based on the available and accessible information/data given the absence of detailed nonlinear characteristics typically associated with historical masonry construction.

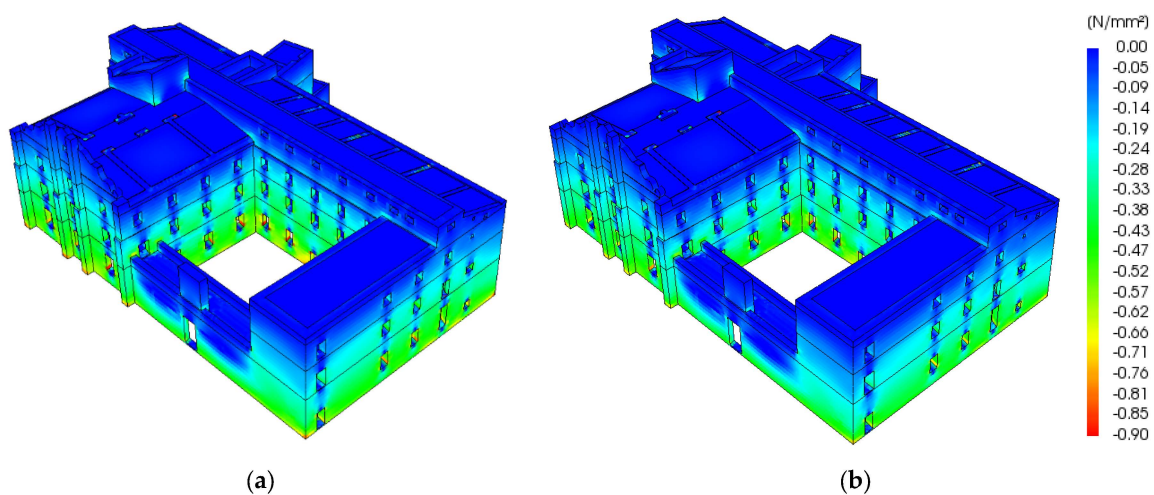
**Figure 12.** Vertical stresses due to the gravity load combinations applied following the code requirements: (a) Load combination LC<sub>1</sub>; (b) Load combination LC<sub>2</sub>.

The compressive stress limit is evaluated following the Eurocode guidelines using two design gravity load combinations [49]. To identify vulnerable zones, structural components prone to compressive stress concentration are investigated in detail. Load combination (LC<sub>1</sub>) evaluates the structure under unfavorable permanent loads while the load combination (LC<sub>2</sub>) considers unfavorable variable actions arising from the superimposed floor loads. The tensile ( $f_{t,CF} = 0.30$  MPa) and compressive ( $f_{c,CF} = 5.1$  MPa) elastic stress limits of the masonry material are calculated for a confidence factor (CF) equal to 1.35 and

corresponding to the limited knowledge level (KL<sub>1</sub>). The assignment of limited knowledge class is based on the non-availability of in situ material characteristics. Except for a few internal walls, the stress concentration at the base of the building is well under the compressive elastic stress limit indicating adequate compressive strength against crushing failure (indicated in Figure 12).

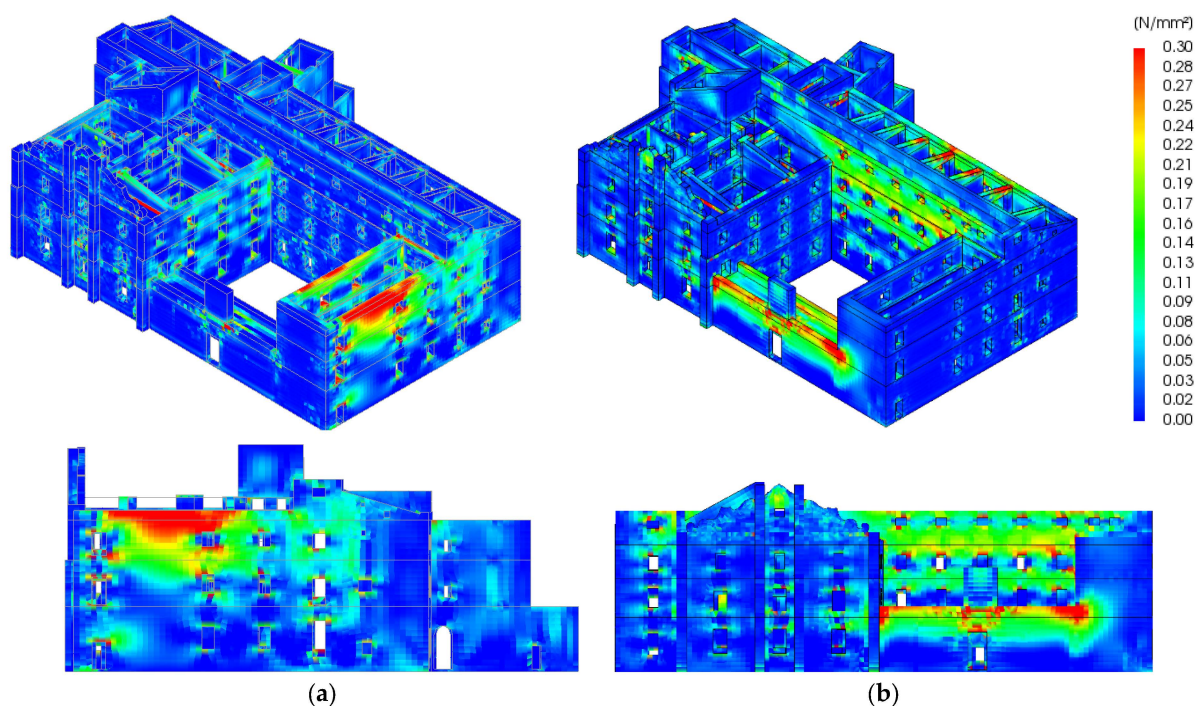
**Figure 13.** Tensile stresses in the walls resulting from the seismic load combinations: (a) Load combination  $LC_3$ ; (b) Load combination  $LC_4$ .

The tensile stresses are shown in Figure 13 where the legend is bounded such that the red color represents the regions where maximum tensile stress exceeds the elastic stress limit and cracking is expected to occur. In the case of  $LC_3$ , high tensile stresses are observed around the corners of the opening and near the wall–floor connections in the west wing. In the case of  $LC_4$ , parts of the front façade show considerable tensile stresses due to out-of-plane deformations, especially in the upper portions of the wall where the cantilever motion is not restricted (gable wall). Wall segments in the west façade show relatively smaller stresses in comparison to the east façade because of the fewer openings and torsional motion caused by the irregularity of the building in-plan. The sway motion of the west- and east-wing façade causes stress concentration at the reentrant corners. An evaluation corresponding to the seismic action level corresponding to the different seismic zones in Croatia shows that the tensile stresses stay below the elastic tensile limit until the peak ground acceleration ( $a_{gR}$ ) is 0.10 g. However, the capacity is exceeded for  $a_{gR}$  equal to 0.20 g in localized regions, such as openings and critical corners identified from the modal analysis.

The numerical results indicate numerous wall segments in the building that experience stresses higher than the elastic tensile limit of 0.30 MPa. Critical zones with high tensile stresses due to the out-of-plane bending of the walls are identified to provide recommendations for strengthening and retrofitting. These include the facade walls of the west wing, the north façade of the south wing where there is an intersection with the east and west wings, the base of the clock tower, the piers between adjacent wall openings, the walls of the hallway in the south wing, the south-wing facade, and the west-wing façade. Out-of-plane bending is observed at the west- and south-wing walls. The out-of-plane bending is primarily attributed to the absence of moment stabilizing elements, flexible diaphragms, and the minimal torsional effects caused by inherent eccentricity. The wall sections between adjacent openings are prone to shear stress concentration due to the relatively small slenderness ratios (see Figure 15, indicated by red colors).

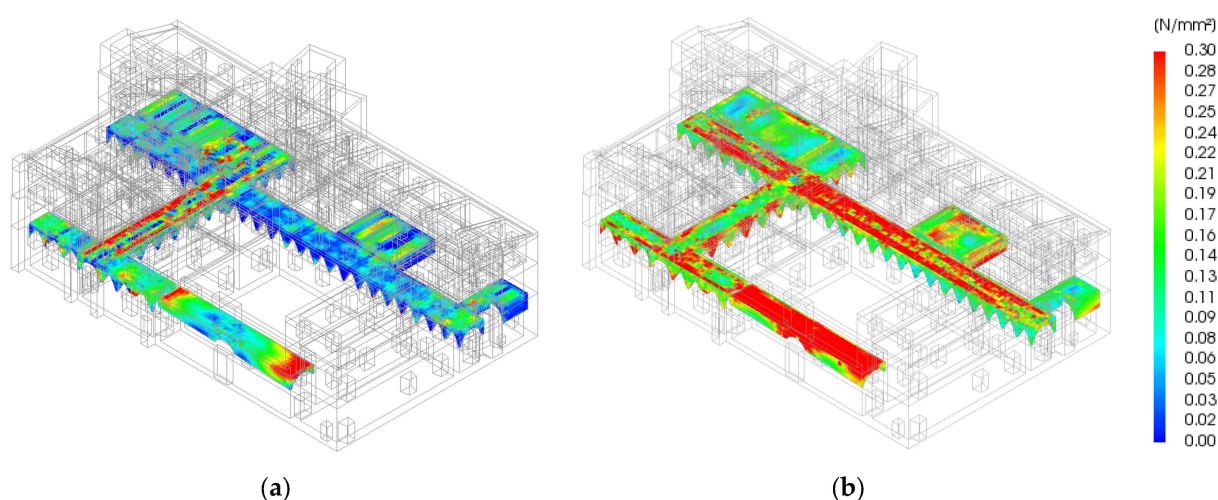
**Figure 14.** Tensile stresses in the vaults resulting from the seismic load combinations: (a) Load combination LC<sub>3</sub>; (b) Load combination LC<sub>4</sub>.

High tensile stresses are also observed in the masonry vaults near the wall connections and along the longitudinal direction of the vault in the east-wing hallway (see Figure 14). The development of stress follows along the length of the cross vault in the hallway of the south wing. The same response is observed at the entrance of the north wing and additionally in localized regions along the entire length of the vault, preventing the lateral walls to bend separately out-of-plane. Higher stresses are generated when the vault is oriented perpendicular to the direction of the seismic forces. Tensile stresses also develop in the vaults of the north wing near the connection with the east- and west-wing façade due to the tensile force generated by the east- and west-wing façades when the earthquake occurs in the EW direction. In general, the orientation of the barrel vault with respect to the seismic action plays a crucial role in the overall resistance where low-stress concentration is observed except for the sides which are relatively weaker due to the relatively smaller thickness.

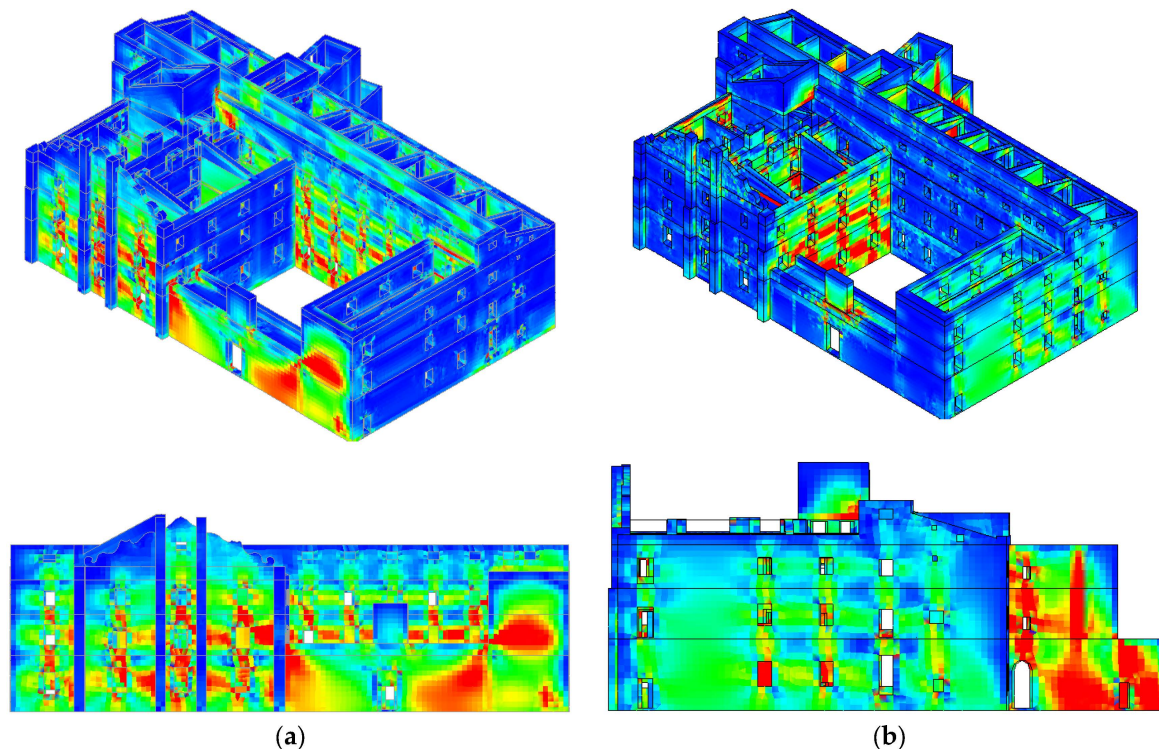
**Figure 15.** In-plane shear stresses resulting from the seismic load combinations: (a) Load combination LC<sub>3</sub>; (b) Load combination LC<sub>4</sub>.

In-plane shear stresses for the seismic load combinations are shown in Figure 15. In the case of LC<sub>3</sub>, concentrated diagonal shear stresses are observed between adjacent openings of the front façade and at the corners of the north-wing walls. The front and back façade of the south wing also indicate shear stresses with diagonal trajectories concentrated in the wall sections between adjacent openings. Similar results are obtained for the stresses originating from LC<sub>4</sub>, with the particularity that the stresses are higher at the walls of the east wing because of comparatively higher mass leading to the concentration of seismic forces.

The floor system is supported by stone masonry vaults representing one of the most important structural and architectural features of the building, distributing lateral loads and the minimal torsional effects to the adjacent walls as shear forces. The complex geometry of the vaults is formed by multiple arch assemblies enchainned together into a continuous surface. The analysis indicates the principal tensile stresses, which are higher than the material tensile stress limit in some parts of the structure in the case of a peak ground acceleration higher than  $2.94 \text{ m/s}^2$  (i.e., in the hallway cross vaults oriented perpendicularly to the main direction of the seismic action between the vault and the lateral walls, see Figure 14; at the long walls that lack the transverse-resistant elements to prevent the out-of-plane movement, see Figure 15).

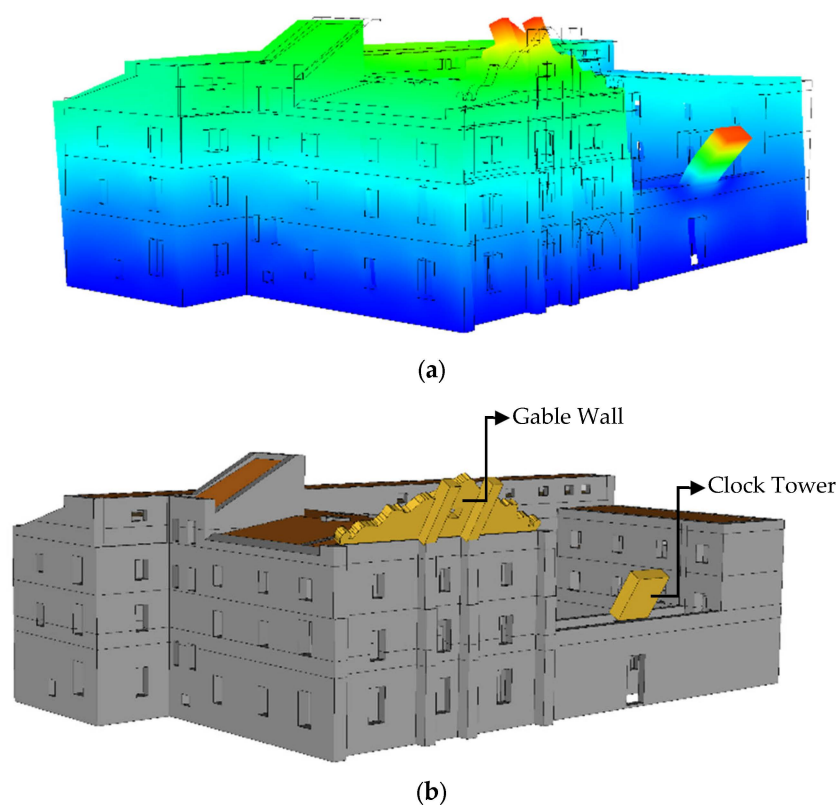
**Figure 16.** Out-of-plane failure mechanism: (a) Identification of vulnerable areas using modal analysis; (b) Kinematic block of the gable wall and clock tower.

The clock tower situated at the entrance of the building as well as the free-standing gable wall located at the top of the front façade, exhibit considerable deformations even when subjected to low frequencies, making them particularly vulnerable to out-of-plane bending (see Figure 16a). Geometrical characteristics of the macro-element involved in the overturning are defined using the unsupported height and by assuming no connection to the orthogonal walls (see Figure 16b). The Croatian National Annex to Eurocode 8 requires the verification of damage limitation and ultimate limit states with a peak ground acceleration equal to 0.301 g and 0.156 g, respectively [50].

In the case of the clock tower with a height of 4.95 m, the relatively low value of the horizontal load multiplier indicates that a peak ground acceleration of 0.05 g is sufficient to activate the local mechanism, rendering the wall vulnerable to excessive deformations/bending. The local mechanism is activated at a slightly higher peak ground acceleration of 0.09 g in the case of the gable wall with a height of 6.18 m. The non-compliance corresponding to both limit states indicates high vulnerability even at low peak ground acceleration levels (see Table 5).
