Seismic Performance Assessment of the 18th Century Jesuit College in Dubrovnik's Old City

Uzair, Aanis; Abrahamczyk, Lars; Vrban, Ante; Penava, Davorin

Source / Izvornik: **Buildings, 2023, 13**

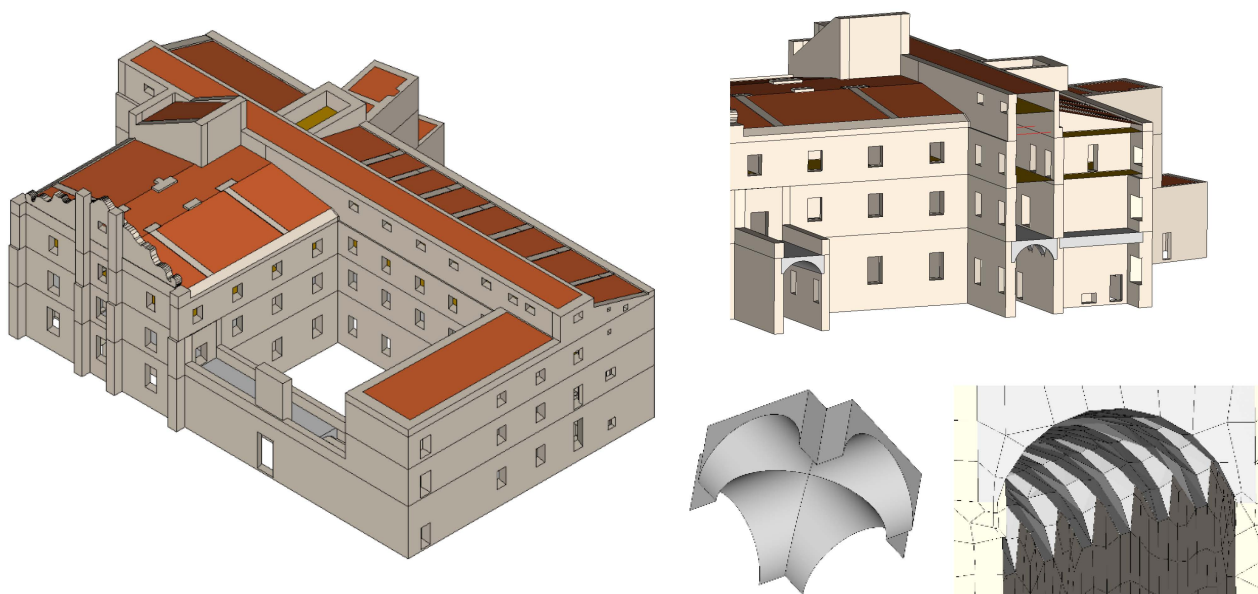
Figure 7. Finite element model of the case study building.

The building is modeled and analyzed using the finite element software DIANA v10.7 (see Figure 7) [29]. The influence of adjacent structures and the interaction among building sections built in different years is neglected based on a careful examination indicating separate entities rather than structural wholeness (representing constraint). The structural model is simplified further by excluding the basement since its contribution to the fundamental period is negligible. The walls and vaults are modeled using solid elements and elastic isotropic material properties. The initial material properties used for the finite element model are based on field investigations as well as an extensive literature review of similar masonry types (see Table 2) [30–34]. The timber floors and roof structure are modeled as isotropic shell elements allowing the transfer of bending effects due to the gravitational loads and in-plane stresses simulating the level of rigidity associated with a flexible diaphragm. The in-plane stiffness of the wooden structure and its components are represented by material properties taken from the literature with similar structural configurations [35,36]. The stiffness contribution of the spiral staircase is neglected in modeling since the surrounding walls are considerably rigid. The iron tie-rods are included as regular truss elements carrying a pre-stressing tensile force and allowing deformations only along the element axis.

The finite element model mesh consists of 4-node hexahedral and quadrilateral volumetric elements for the solids and flat shell elements, respectively. The basic mesh element size is 0.5 m with a 65% transition smoothness for the edges and corners shaped by connecting members, i.e., vaults, wooden floors, etc. The mesh density is determined through a parametric calibration in conjunction with the convergence analysis of the dynamic response. The goal is to find the mesh density that provides a satisfactory level of accuracy in the model's prediction of the dynamic response, without unnecessarily high computational cost. This optimal point is typically where the model's results have "converged", meaning that additional increases in mesh density lead to only minor improvements in accuracy. This approach is necessary because the dynamic response of historical masonry structures can be sensitive to the level of detail represented in the model. For instance, local behavior like stress concentrations requires a finer mesh to be accurately captured. Therefore, the mesh density needs to be calibrated to ensure it is sufficient for the specific analysis objective while maintaining reasonable computational efficiency. The final mesh has a total of 119,306 nodes from which 2659 are restricted at the base; 184,821 elements are distributed as 173,628 solid; 11,176 shell; and 17 truss elements.

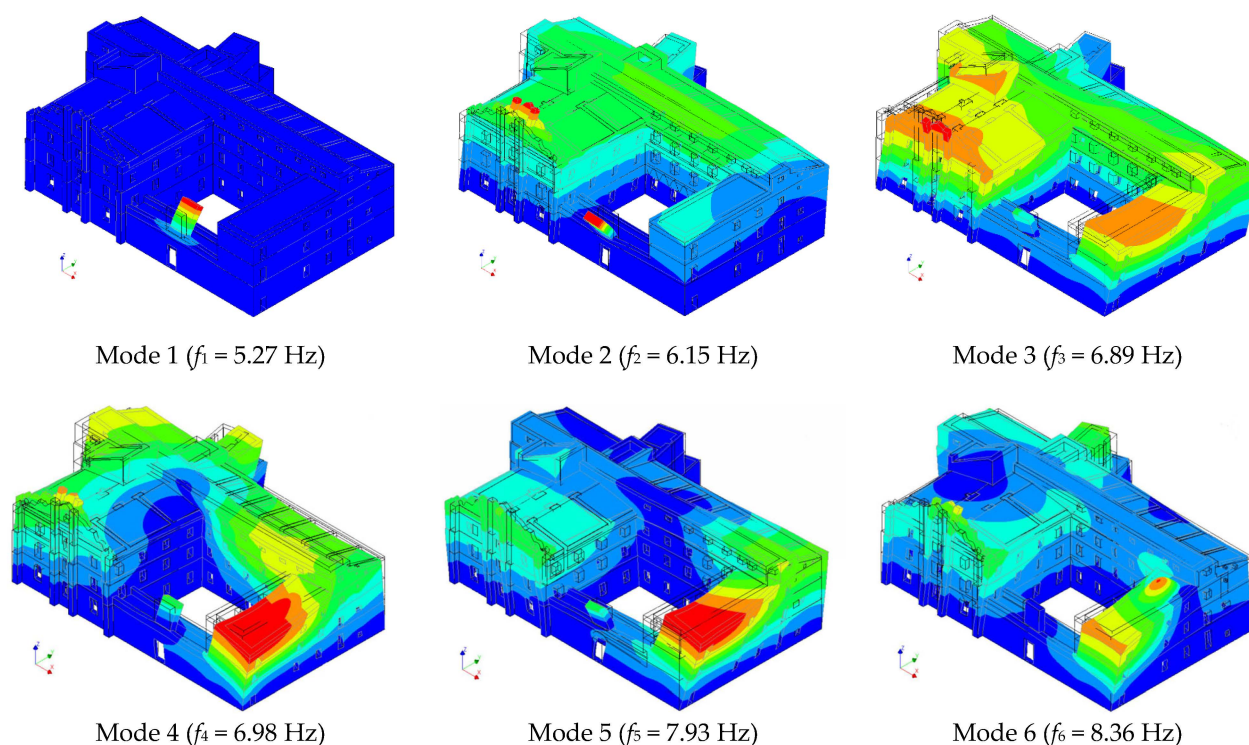
Figure 8. Mode shapes obtained from the free vibration eigenvalue analysis.

The cumulative effective mass for the first six free vibration modes corresponds to approximately 70% in the NS and 72% in the EW directions. The accumulation of higher mass participation requires the calculation of a large number of modes, i.e., approximately 250 modes are required to accumulate 90% mass participation in both horizontal directions. The mode shape 1 ($f_1 = 5.17$ Hz) represents a local vibration mode of the clock tower, indicating high expected deformations at a relatively low frequency. Mode shape 2 ($f_2 = 6.05$ Hz) shows the global mode shape in the EW direction with 61% cumulative mass participation.

Mode shape 3 ($f_3 = 6.78$ Hz) represents the global mode shape in the NS direction with an effective mass participation of 56%. It is important to note that neither of the global mode shapes represents pure translation in either horizontal direction, accompanied by a significant translational motion in the orthogonal direction (see Figure 8). In the case of mode shapes 4–6, the concentrated deformations in various parts of the structure show potentially vulnerable zones even though these modes do not contribute significantly to the global dynamic response due to their relatively low mass participation.

The identified global modes which activate the major percentage of mass participation in EW and NS directions are selected for the model's calibration. The global modes are primarily characterized by a translational motion activating significant mass participation in the horizontal directions (see Table 4). Despite the complex dynamic responses caused by irregular distribution of mass and stiffness (eccentricity $e_x = 3.8\%$ and $e_y = 5.4\%$), the potential for torsional motion remains comparatively limited (indicated by the low effective rotational mass given in Table 4). In addition to the global mode shapes, the low-frequency local modes reveal the out-of-plane vibration of individual façade segments. These local modes help in the identification of the unwanted cantilever motion associated with the clock tower and gable wall which is used for the local verification in Section 4.2.
