Seismic Performance Assessment of the 18th Century Jesuit College in Dubrovnik's Old City

Uzair, Aanis; Abrahamczyk, Lars; Vrban, Ante; Penava, Davorin

Journal article, Published version

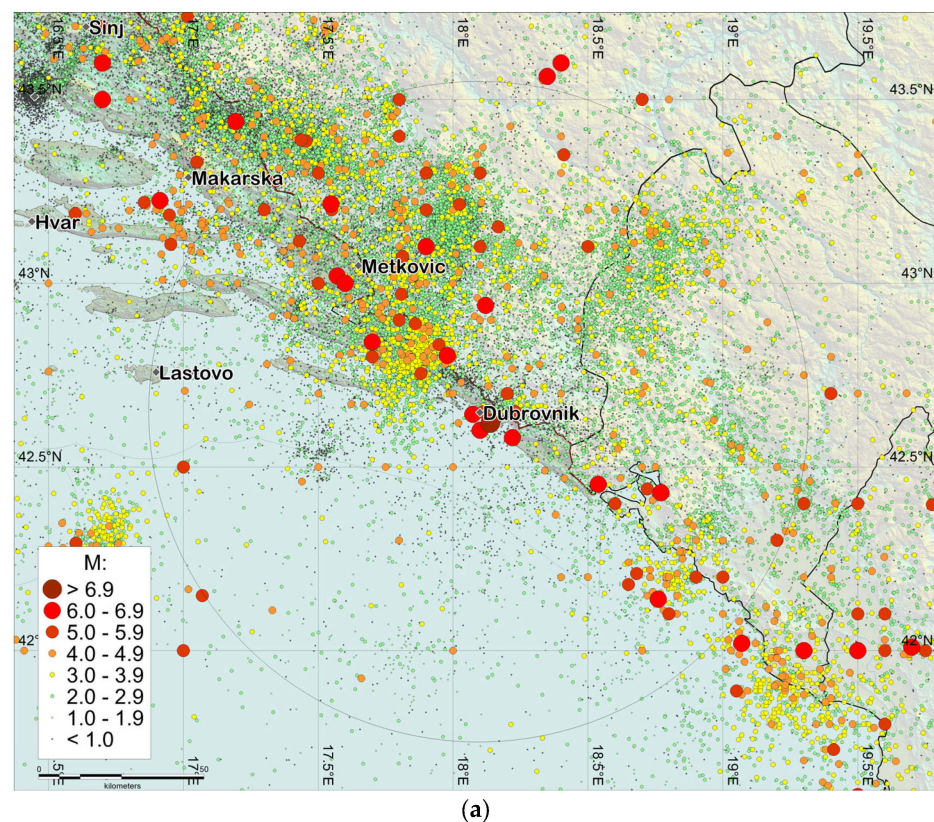
Figure 9. (a) Spatial distribution of earthquake locations around the Dubrovnik area based on data from the Croatian Earthquake Catalogue (updated and continuously supplemented version first described in [43] for the period BC–2021. Circle marks the area inside 100 km from Dubrovnik); (b) seismic micro-zoning in compliance with MCS scale available at [46].

The City of Dubrovnik is located on the coast of the Adriatic Sea in the southern part of Croatia and on the boundary between the African and Eurasian tectonic plates which move towards each other causing high seismic/tectonic activity in the region. This region is the most threatened area in Croatia with the highest expected earthquake magnitude of M7.5. According to geological classifications, the area is located at the contact between the Adriatic and Dinaric regional structural units, defined by karstic terrain and porous limestone bedrock. The immediate border of these units is the Ploče–Dubrovnik fault. Between Mljet and the Dubrovnik submarine, the Adriatic unit borders the Adriatic microplate [41]. Earthquakes are a major concern of the region due to the high concentration of cultural heritage buildings of outstanding historical significance. Since the 1979 M7.0 Montenegro Earthquake, the Old City of Dubrovnik is enlisted in the UNESCO World Heritage List [42]. Historic data for the period BC–2021 (see Figure 9), according to the Croatian Earthquake Catalogue—CEC [43], note about ten earthquakes in the region with intensity VIII or more ($^{\circ}$ MCS) out of which the most significant is the 1667 earthquake of intensity X ($^{\circ}$ MCS) [44,45]. Before the Great Dubrovnik Earthquake of 1667, strong earthquakes from 373 BC, 376, 1471, 1482, 1504, 1516, and 1520 are mentioned, which caused damage to the area. Of the very strong or severe earthquakes from the recent past, there are those from 1850 and 1869 with an intensity of VII on the $^{\circ}$ MCS scale; however, the M7 earthquake in Montenegro from 1979 is particularly highlighted. In Dubrovnik, it manifested itself as an earthquake of intensity VII ($^{\circ}$ MCS) with structural damage to numerous buildings in the Old City, including the Jesuit College (see Figure 10a).
