Seismic Assessment of a Modernist Building in Sarajevo, Bosnia and Herzegovina

Article

Abstract: This paper presents an in-depth analysis of the Kopčić House, a significant example of modernist architecture in Sarajevo, Bosnia and Herzegovina, focusing on its structural-specific features and seismic performance. The Kopčić House embodies a confined masonry structure with innovative construction features, combining load-bearing masonry walls with reinforced concrete elements. This architectural approach was pioneering for its time, combining traditional construction methods with innovative materials and techniques. Detailed analysis using numerical modeling techniques, specifically 3D modeling with the 3Muri software (Vers.14.2.0.4), was conducted to assess the seismic resilience of the structure. The analysis considered different load distributions and eccentricities to comprehensively evaluate the building's response to lateral forces. The findings of this research reveal the structural capacity and potential vulnerabilities of the Kopčić House when subjected to seismic events. While the building demonstrates inherent strength due to its confined masonry design, areas requiring

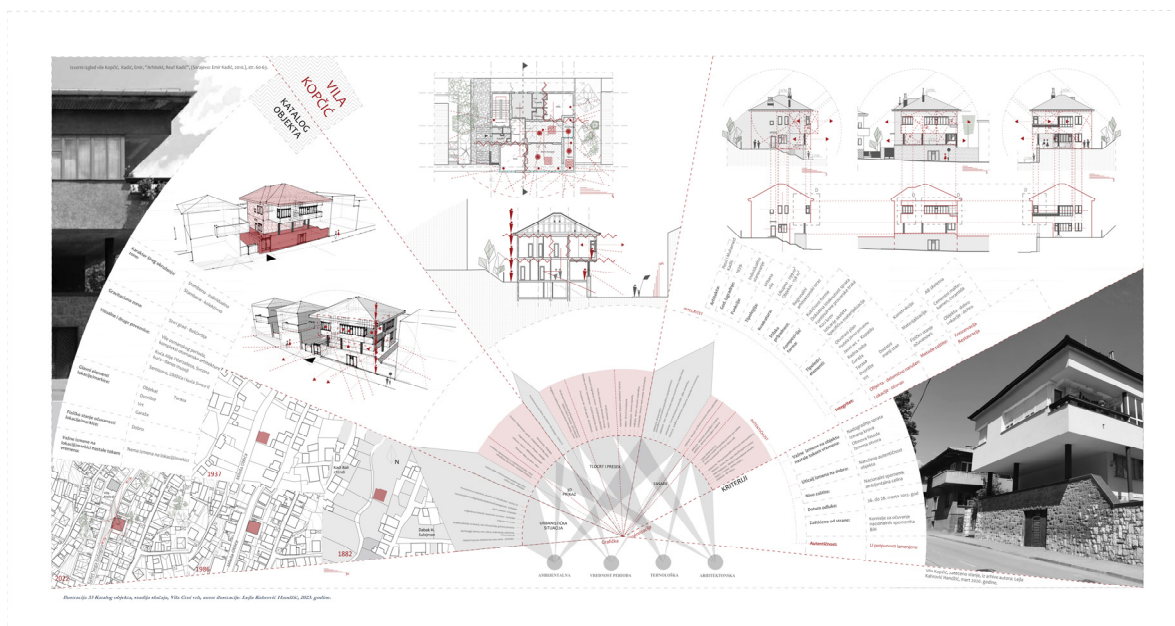
Figure 4. Catalog of Kopčić House [2].

Figure 4 illustrates the updated integral methodology developed to systematically and contextually identify and assess the values of 20th-century architectural heritage in Bosnia and Herzegovina. It emphasizes the classification of criteria into four primary categories: architectural, technological, period value, and environmental value. From this figure, one can derive the structured approach used in analyzing and evaluating architectural heritage, emphasizing authenticity, integrity, and various dimensions of value. More details can be found in [2].

In the graphic representation of Kopčić House (Figure 4), criteria related to authenticity (highlighted in red fill) and integrity (highlighted in gray fill) are emphasized in the service of graphical presentation according to graphic appendices (floor plans, cross-sections, elevations, three-dimensional views, and urban context) across categories of values (architectural, technological, period significance, and ambiance) [2].

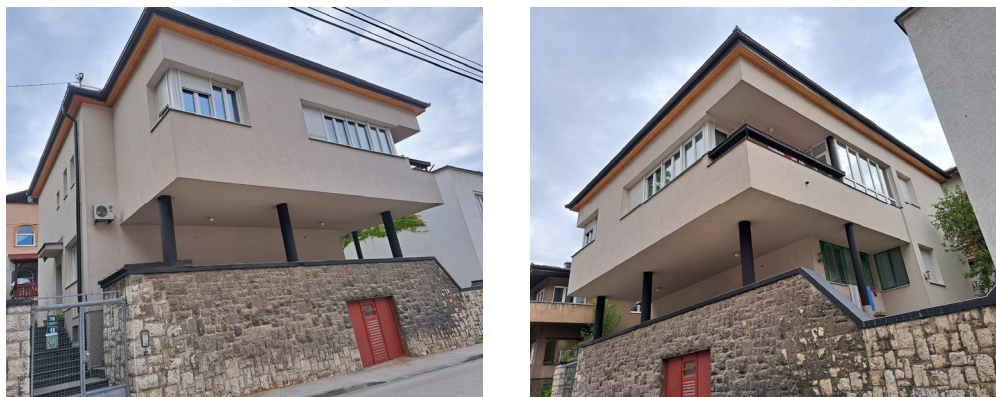
Figure 5. Kopčić House today (author's source).

Noteworthy are the specific measurements defining the building’s spatial characteristics. The basement’s clear height is determined to be 2.60 m, while the subsequent floors

have a height of 3.40 m, with the roof reaching a height of 3.83 m. The cumulative height of the structure is 13.20 m.

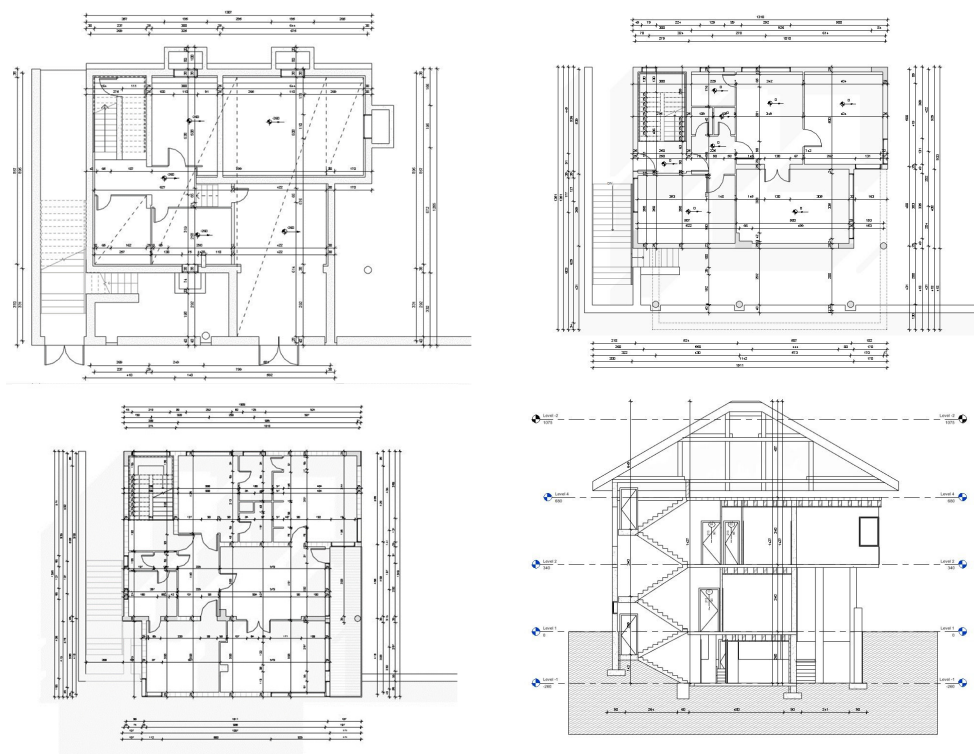
Figure 6. The original blueprint of the buildings was obtained from the Kopčić family. Reproduced with permission from the Kopčić family.

In the plan view, the building exhibits a near-regular square shape, delineated by axis spans of $13.10\text{ m} \times 13.50\text{ m}$ (see Figure 6), illustrating a deliberate architectural symmetry. All external walls fulfill load-bearing functions, providing essential structural support throughout the building. Moreover, the structure features longitudinal load-bearing walls positioned nearly at its midpoint, extending throughout all the floors. Adjacent to the staircase, a transversal load-bearing wall spans the entirety of the structure, guaranteeing structural stability and integrity. Nonetheless, a distinct internal transverse wall in the basement fails to extend to the upper floors. The locations of the non-load-bearing walls are not the same on all the floors but are arbitrarily positioned. The position of the load-bearing walls, along with the four columns, renders the structure structurally asymmetrical.

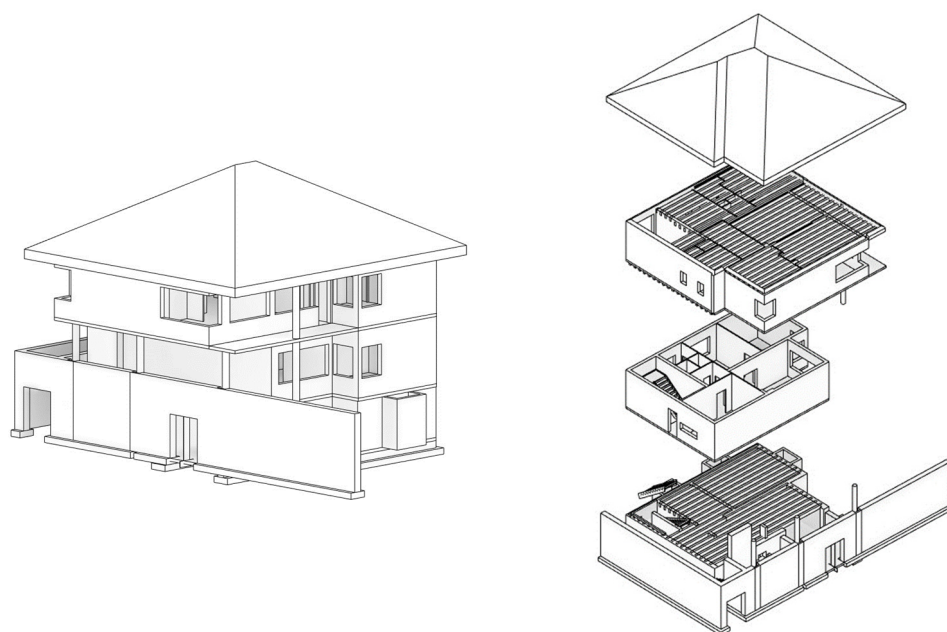
Figure 7. BIM model.

From the detailed measurements extracted from the architectural drawings, a comprehensive 3D Building Information Modeling (BIM) model was meticulously constructed, as illustrated in Figure 7. This BIM model serves as a digital representation of the physical building, incorporating precise geometric and spatial data to accurately depict its structural elements, architectural features, and overall layout in a virtual environment.

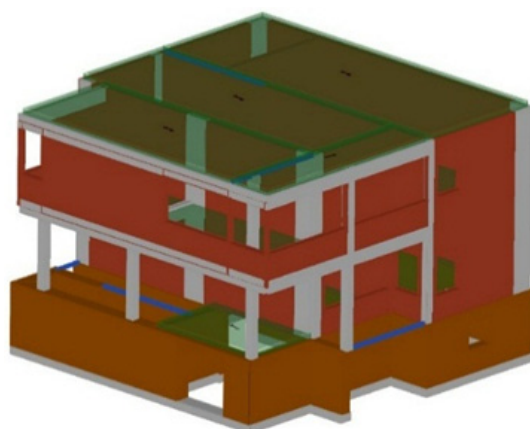
Figure 8. Three-dimensional model of the analyzed building [16].

The 3D model is presented in Figure 8.

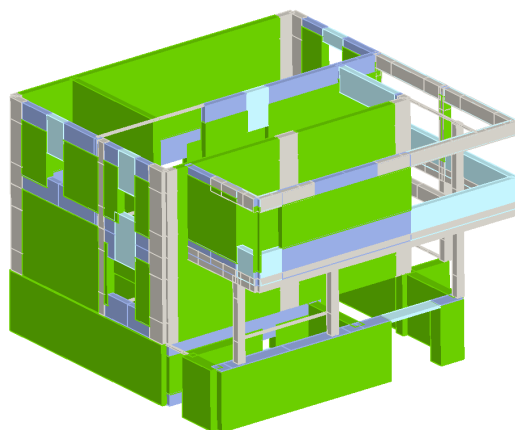
Based on the analysis, all walls have successfully passed both checks. The overall result for the entire structure is presented in Figure 9, where all elements are indicated in green, signifying the fulfillment of both conditions outlined in Eurocode 6: the slenderness check $h_{ef}/t_{ef} \leq \lambda_{lim} = 27$ and the condition for vertical loading $N_{Ed} \leq N_{Rd}$. Notably, there is a significant difference observed between the values of N_{Ed} and N_{Rd} , with the maximum value obtained for wall 2 being $N_{Ed}/N_{Rd} = 0.43$ compared to the unity threshold, indicating underutilization of elemental capacity. Additionally, it is worth noting that the slenderness criteria are satisfied as the maximum calculated value $h_{ef}/t_{ef} = 13.60$ is well below the threshold of 27.

Figure 9. Three-dimensional view of the static analysis results of the structure.

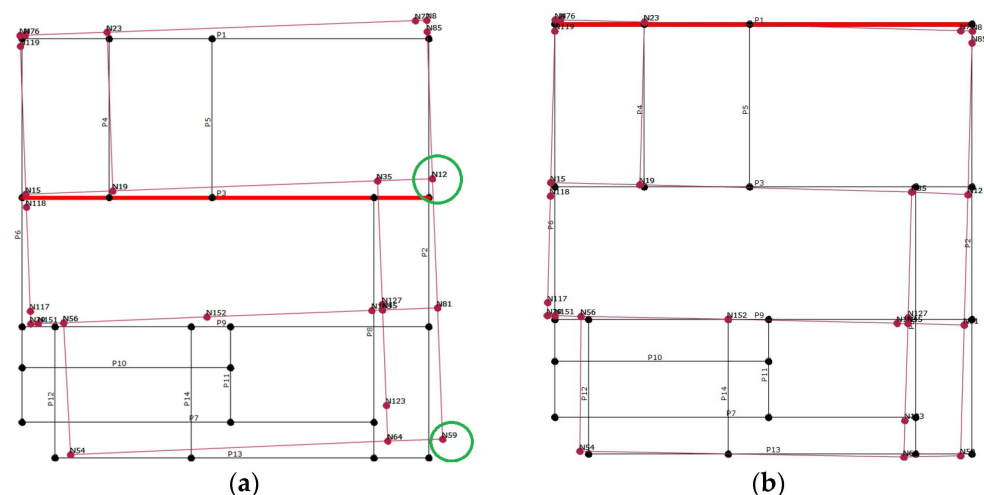
It is interesting to note that both modes are not purely translational; there is also some rotational motion, as evident in Figure 10. Torsional modes can occur in masonry structures, especially when there are asymmetries or irregularities in the distribution of mass and stiffness. The torsion is primarily attributed to the asymmetric positioning of the load-bearing walls, which results in uneven distribution of forces throughout the structure. Additionally, the presence of the four columns introduces structural irregularities, further exacerbating torsional effects. Moreover, the inclusion of confining elements, such as tie-columns and “reinforcement walls,” contributes to the complex interplay of forces within the structure, ultimately leading to a discrepancy between the center of mass and the center of stiffness. These discrepancies amplified torsional forces, making it a significant factor in the structural behavior of the system.

Figure 10. Eigen modes. (a) First eigen mode, Y-direction; (b) second eigen mode, X-direction.

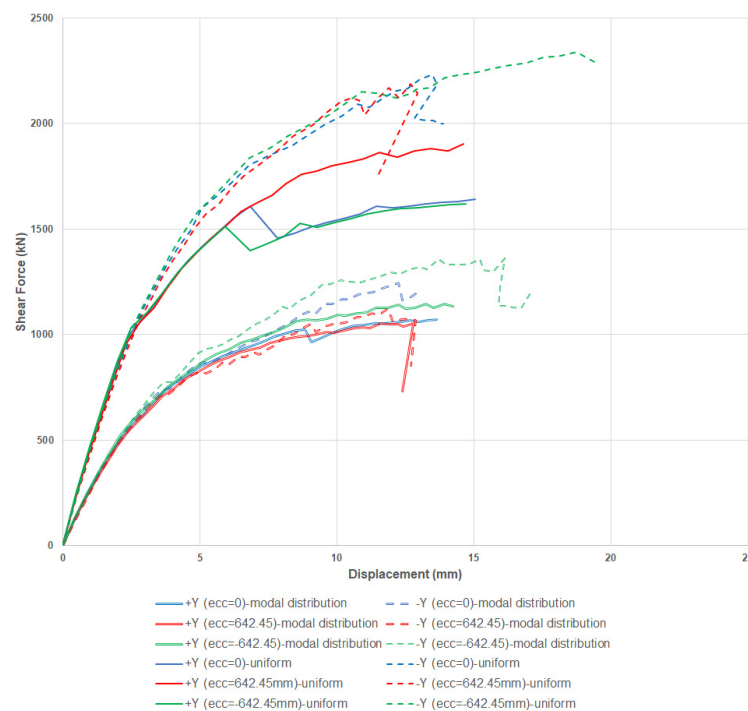
Additionally, to provide a comprehensive view of the structure's performance, capacity curves for both the Y- and X-directions were generated. These curves, depicted in Figures 11 and 12, offer valuable insights into the structure's ability to withstand lateral loads from different orientations.

Figure 11. Pushover in the Y-direction.

Under uniform force distribution, the structure reaches a maximum force of 1030.1 kN, with a corresponding displacement of 2.52 mm before transitioning into nonlinear behavior. This force signifies the formation of initial cracks in the wall, indicating the structural capacity. Interestingly, there is a decrease in capacity for the +Y-direction when no eccentricity and positive eccentricities are considered, which is not observed when the eccentricity is negative. Upon examining the damage to the wall elements, it was observed that this decrease is attributed to the shear and flexure failure of one of the “reinforcement walls” and one of the masonry walls in the Y-direction, which is in line with the findings [38–40]. The highest capacity is achieved in the +Y-direction with a +5% accidental eccentricity, reaching a maximum shear force of 1919.8 kN and a maximum displacement of 18.6 mm (Figure 11).

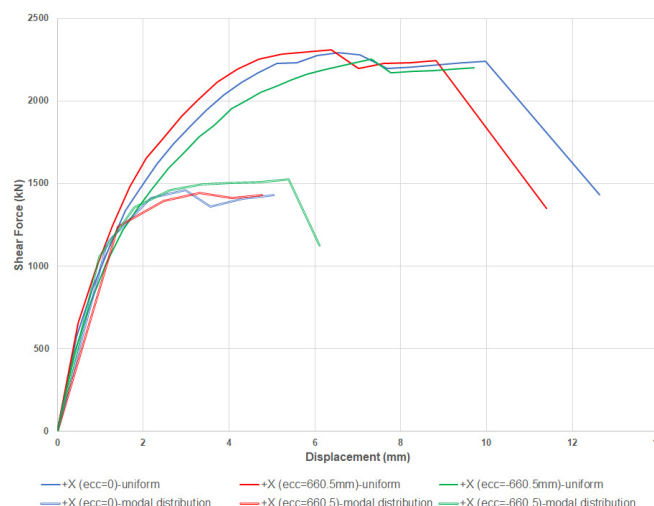
Figure 12. Pushover in the X-direction.

In the X -direction, particular attention is directed towards the positive direction. Upon comparing the structural response between the uniform distribution and the modal distribution, a notable discrepancy in structural capacity and ductility becomes apparent. The uniform distribution consistently demonstrates a higher structural capacity and greater ductility compared to the modal distribution. Interestingly, when examining the capacity curves for uniform distribution across various eccentricity values, a remarkable similarity is observed, indicating a consistent structural response regardless of eccentricity. This uniformity in response is also reflected in the set of modal distributions for different eccentricities.

However, the modal distribution with a $+5\%$ eccentricity presents a distinct behavior characterized by its lower capacity and ductility. In this configuration, the shear force measures 1442 kN, accompanied by a maximum displacement of 5.63 mm. Despite experiencing a minor increase of 5.4% in shear force compared to other configurations, this particular modal distribution exhibits the structure's reduced resilience under positive eccentricity conditions (Figure 12). Conversely, the uniform distribution demonstrates a significantly higher capacity compared to the modal distribution. The maximum obtained shear force in this scenario reaches an impressive 2307.8 kN (refer to Figure 12), underscoring the structural robustness achievable with uniform load distribution across the structure.

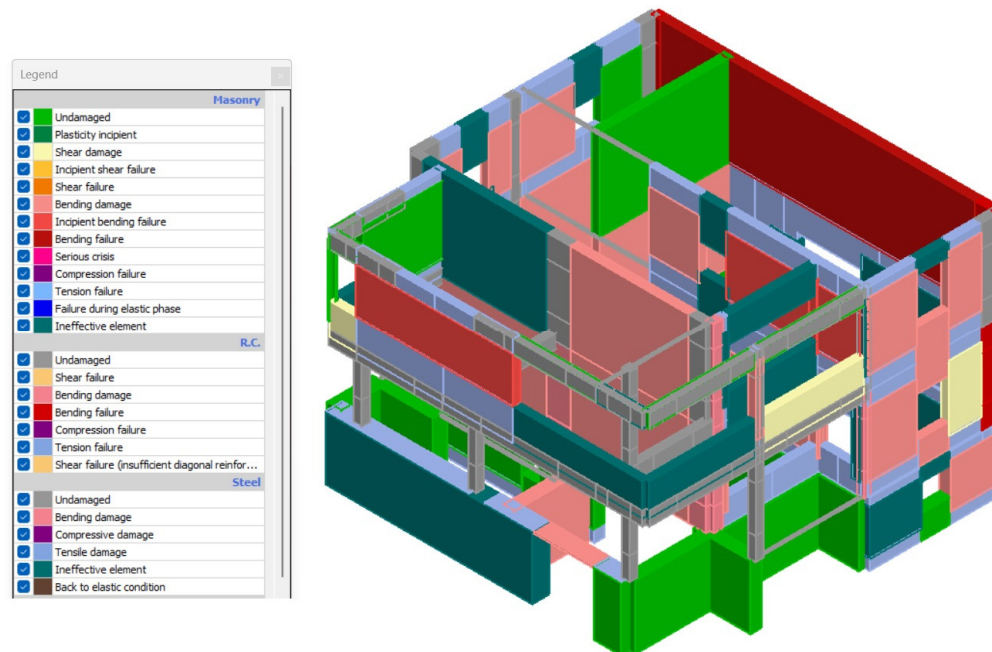
In Figure 13, the damage incurred by the structural elements under loading case 23 (+Y-direction) is depicted, revealing a vulnerability index of 0.632. This index indicates a capacity of only 63.2%, highlighting significant structural vulnerability. Upon closer examination in the final step of the analysis, predominant damages are observed around the structural openings, primarily manifested as bending failures. Furthermore, evidence of shear damage and bending failure is observed within the “reinforced walls”, further emphasizing the structural challenges encountered. In the masonry walls, signs of incipient bending failure gradually progress to full bending failure, particularly pronounced along the outer longitudinal wall parallel to the street façade. Additionally, on the first floor, shear damage is evident, particularly notable around the balcony area.

Figure 13. Damage of the structure during analysis No. 23.

This comprehensive evaluation of Figure 13 underscores the complex array of structural vulnerabilities presented across various elements under loading case 23. The observed damages provide valuable insights into the structural performance under applied loads, emphasizing the importance of mitigation strategies in enhancing structural resilience.

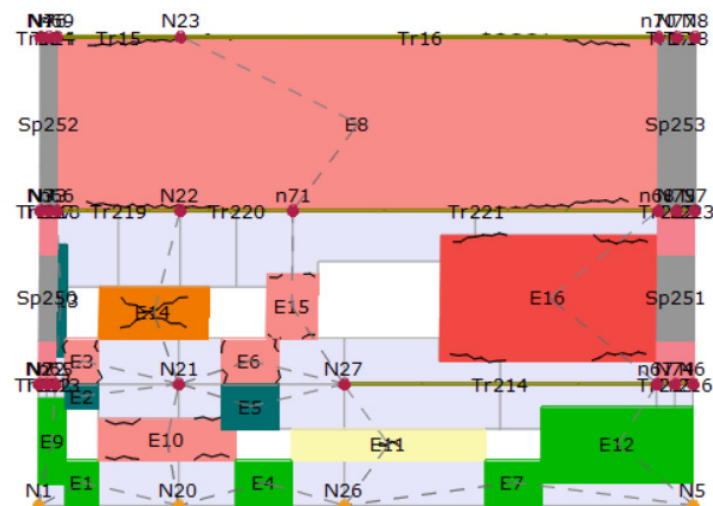
The structural vulnerabilities are demonstrated in the form of apparent damage to various structural elements, as delineated by Figure 14. Notably, the “reinforcement walls” and tie-columns exhibit discernible signs of bending damage, indicative of structural

distress and compromised load-bearing capacity. Furthermore, the masonry walls display evident indications of bending damage, particularly around openings, progressing to incipient bending damage in localized regions. Additionally, instances of shear damage and even shear failure are observed in select locations, further emphasizing the structural vulnerabilities and susceptibility to loading-induced damage.

Figure 14. Damage of the wall during analysis no. 11.
