Architectural Features and Soil Properties of Traditional Rammed Earth Houses: Eastern Croatia Case Study

Article

Keywords: earthen houses; rammed earth; earth building; geometric survey; soil properties

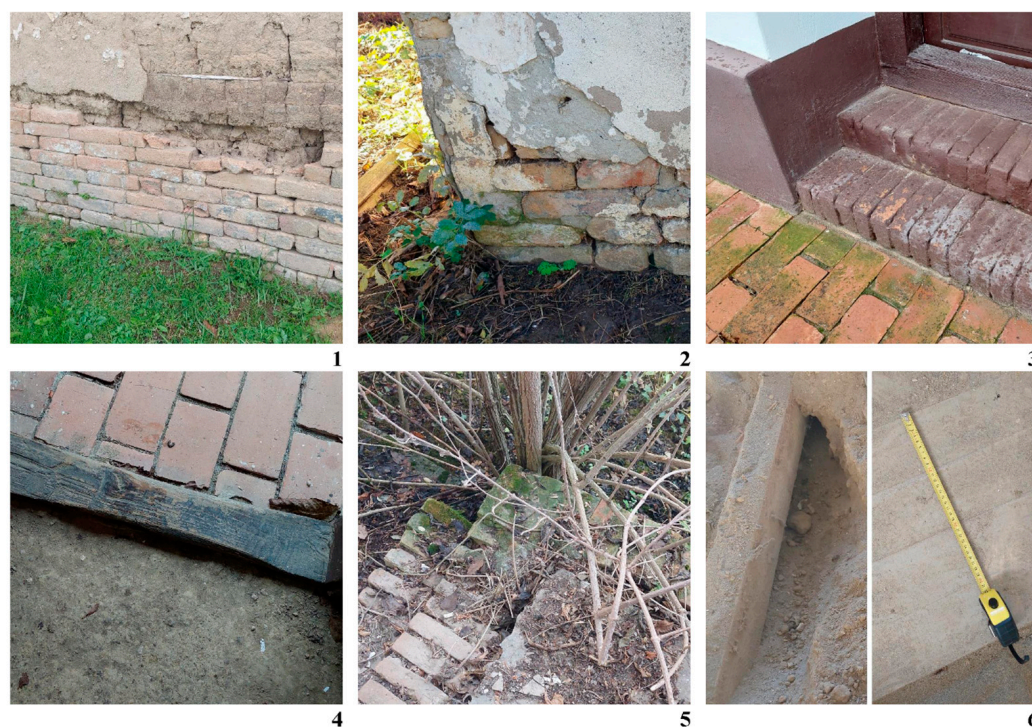
Figure 5. Various options for solving the houses plinths: (1)—RE with bricks cladding; (2)—brick plinth; (3)—dark brown colored brick plinth; (4)—RE floor; (5): brick stairs; (6)—wooden floors. Author's photos.

The brick cladding was made by removing a layer of earth from the rammed earth wall façade, and a brick cladding was inserted into the resulting groove, forming a plane of the wall together with the upper rammed earth part of the wall. The example in Figure 5-(1) shows a wall with cladding of new-size bricks stacked 10 rows high without a binder. This type of cladding was observed at the back of the houses. Some houses have brick plinths (*cro. sokl*) on street façades. The plinth was painted in a darker color, usually brown

(Figure 5-(3), house BB-2), and protruded beyond the wall surface by half the width of the brick. In the examined houses, the plinth consists of five to seven rows of bricks and is usually approximately 60 cm high. The plinth was plastered with a mixture of earth, cement, and lime and coated with lime or cement mortar.

- covering the wall with a layer of brick cladding (Figure 5-(1)),
- building the plinth (Figure 5-(2), house ALJ-3),
- building the lower part of the wall from the bricks (described in more detail in the Section 3.2.2).
