# Study on Effectiveness of Regional Risk Prioritisation in Reinforced Concrete Structures after Earthquakes

Source / Izvornik: **Applied sciences (Basel), 2024, 14**

**Journal article, Published version**

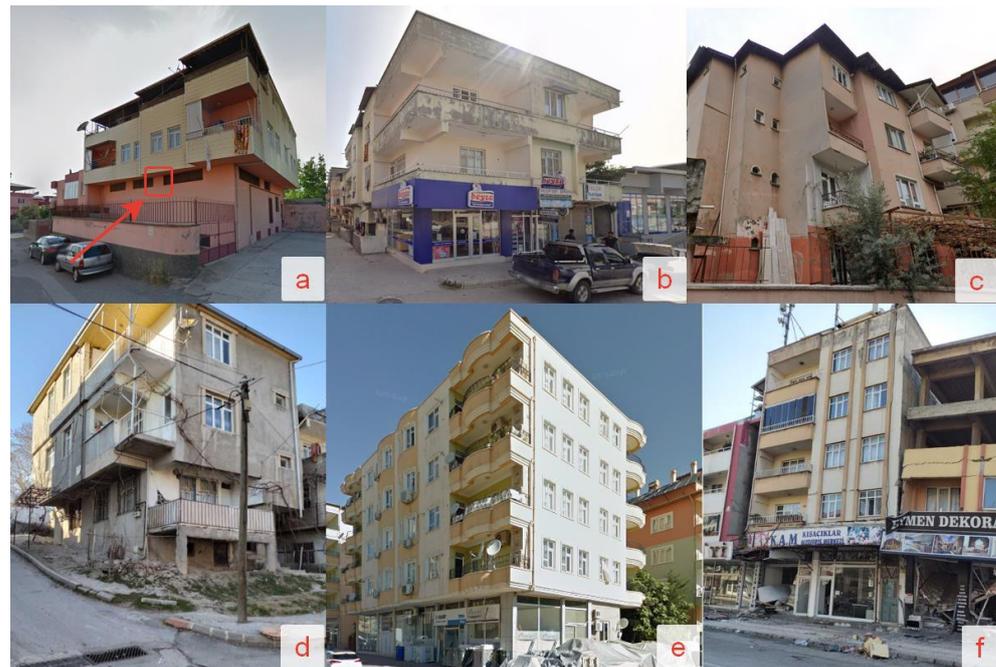
Application examples of the parameters considered in this study on the existing building stock in the earthquake region are shown in Figure 11. Google Street [72] was used to obtain images.

**Figure 11.** (a) Short column, (b) soft/weak storey, (c) plan irregularity, (d) hill/slope effect, (e) heavy overhang, (f) adjacent buildings.

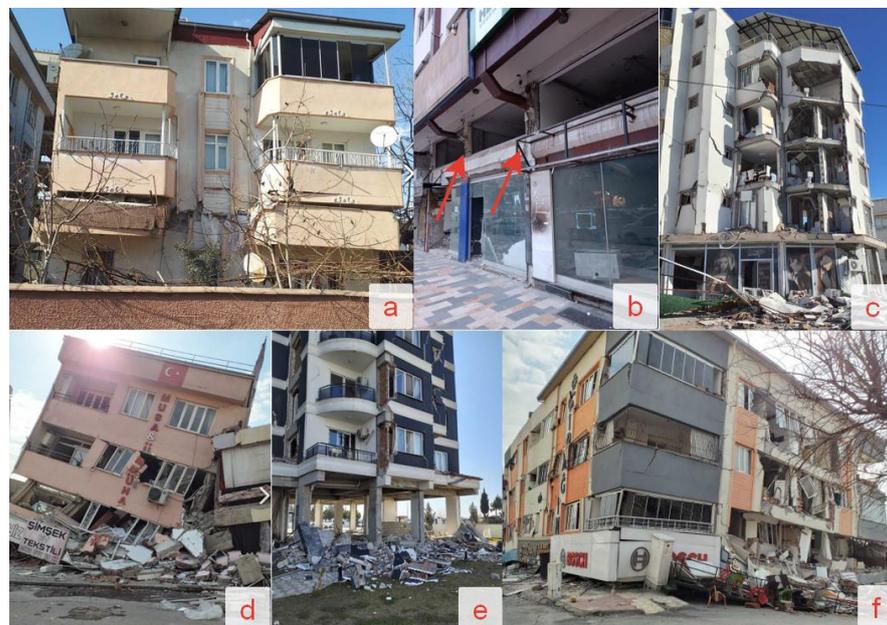
Examples of structural damage that occurred in RC structures as a result of the presence of one or more of these parameters as a result of field observations are shown in Figure 13.

Figure 13. (a) Soft/weak-storey damage caused by mezzanine, (b) structural damage caused by short column, (c) example of damage caused by irregularity in plan, (d) example of damage caused by collision, (e) example of damage caused by heavy overhangs, (f) soft/weak-storey damage example caused by ground story.
