# Locating Hidden Elements in Walls of Cultural Heritage Buildings by Using Infrared Thermography

*Source / Izvornik:* **Buildings, 2019, 9**

**Journal article, Published version**

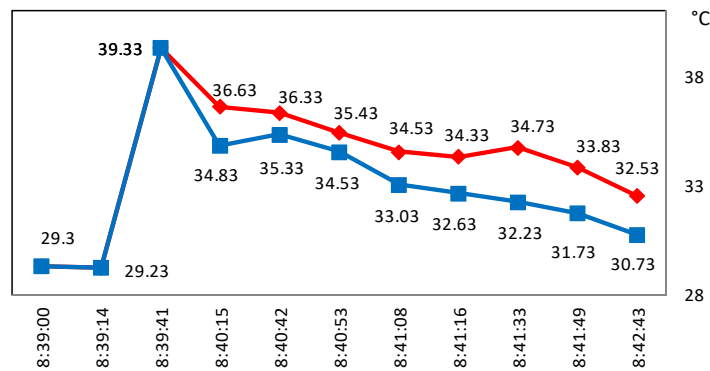
Figure 10. The temperature values in the junction box and its immediate area.

The time duration and the temperature values are shown in Figure 10. The measured values, marked with squares, represent the point which is located between the box and the switch, while the line, marked with diamonds, indicates the temperature in the area of the junction box.

Figure 10 shows the precise temperature values in the analyzed spot point, but not their spatial distribution. Due to camera accuracy and slight camera movement, individual temperature measurement readings over time tend to show variations, although the actual temperature values are continuously falling. This is one of the basic problems associated with classical thermography. The special temperature distribution is presented in Figure 11, where the hidden junction box is located, which clearly illustrates the location of the connection line by which the thermostat is connected to the junction box.

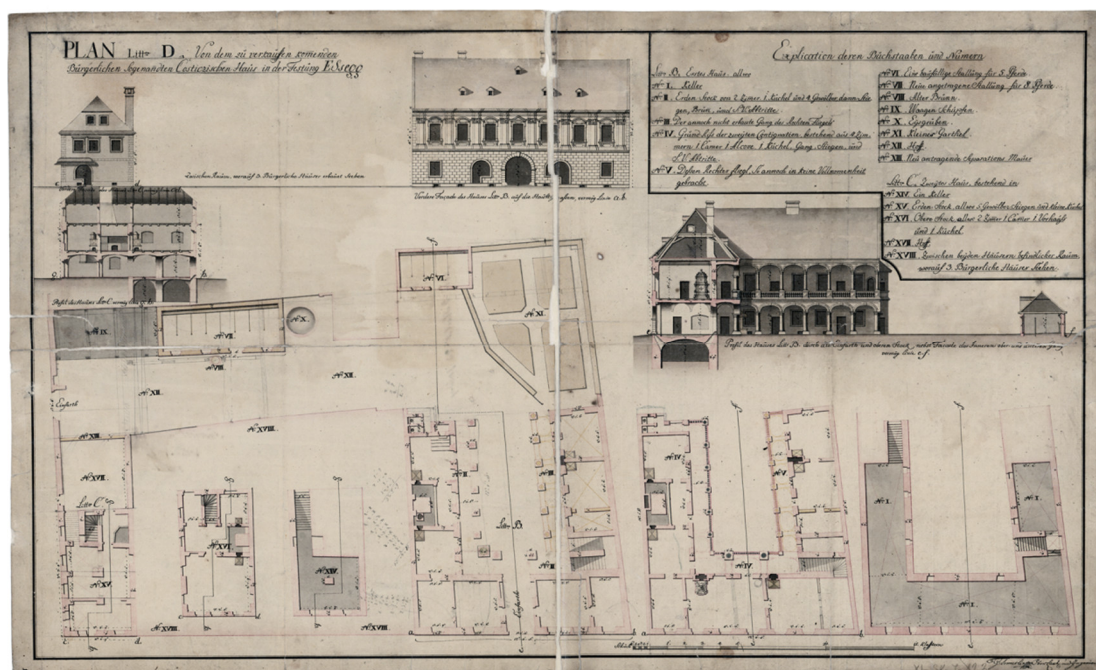
**Figure 15.** Architectural drawings of Kostić houses in 23 Kuhačeva Street from the 1774 [27].

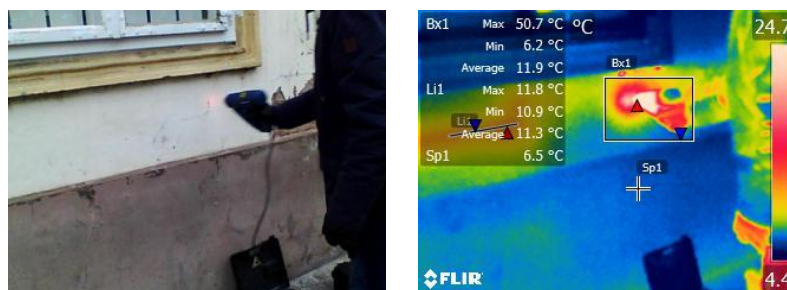
In order to determine the existence of discontinuity in the outer envelope, heating was applied, as is shown in Figure 19.

Figure 19. Initial application moment of thermal excitation.
