# Locating Hidden Elements in Walls of Cultural Heritage Buildings by Using Infrared Thermography

**Abstract:** The structure of Tvrđa and its buildings date back to the Middle Ages. Tvrđa represents the Old Town of the city of Osijek and the best-preserved and largest ensemble of Baroque buildings in Croatia. After the withdrawal of the Ottomans in 1687, during the 18th century, the Austro-Hungarian administration systematically formed a new fortification system, regulated streets and squares and built a large number of military objects. Tvrđa took its present form in the 19th century and has kept it since then. Investigating the historical development of individual buildings, in addition to archival sources and existing architectural documentation, the obvious source of information are the buildings themselves. The aim of this paper is to explore the possibilities of using infrared thermography to find structural elements and hidden openings in historic buildings in Osijek's Tvrđa. This paper describes the exploration of the 18th century openings on the facades of the former Kostić houses. The facades were bricked into the walls in the 19th century because houses were reused and

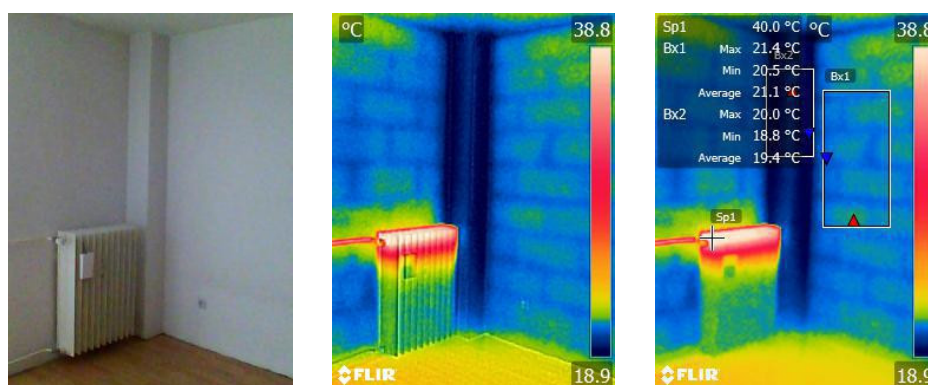
If the outer envelope is made of various materials, the heat flow will be different with different structural elements. Figure 6 shows the outer wall of a reinforced concrete multi-storey building whose walls are made of aerated concrete units. The average temperature on the aerated concrete units is 21.1 °C, while the difference between the unit and the binder is 0.9 °C. The temperature on the reinforced concrete bearing wall is 19.4 °C, with a temperature difference of 1.2 °C.

Figure 6. Thermal pattern of the outer wall.

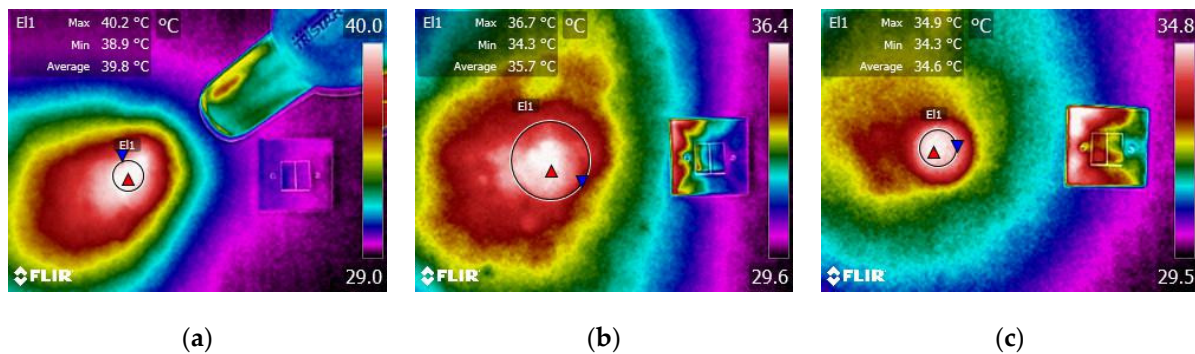
Based on the previous experience of the application of step heating results, we were encouraged to replicate the procedure on historical buildings. For example, the case of a hidden box, in which a thermostat connection is performed, is presented on the thermogram in Figure 9. The box position is not known, but it is assumed that it is near the switch. In order to determine its exact position, a hair dryer can be used to heat the wall. The thermographic camera is used to monitor the response to the heat excitation. The surface behind which the box is hidden has increased its thermal resistance and heat retention, which is longer in duration due to the difference in thermal resistance. The initial

location of the hair dryer is presented in Figure 9a while the indication of the box position, as well as the structure of the bearing switch elements, can be seen in Figure 9b. Over time, the outline of the box contour can be clearly seen in Figure 9c.

Figure 9. Finding a hidden distribution box by means of thermal incentive.

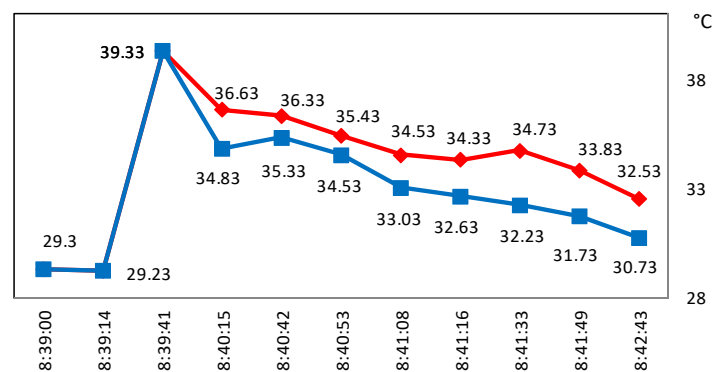
The time duration and the temperature values are shown in Figure 10. The measured values, marked with squares, represent the point which is located between the box and the switch, while the line, marked with diamonds, indicates the temperature in the area of the junction box.

Figure 10. The temperature values in the junction box and its immediate area.

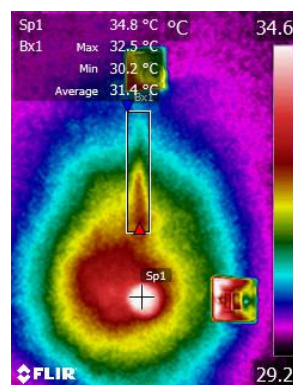
Figure 11. Thermogram of the hidden junction box.

In Figure 11, the position of the conductor under plaster is visible due to the material variation. It should be taken into account that, during the recording, the observed image is monochromatic and that, in most cases, it represents the sum of radiation in the IR spectrum. The advantages of using an IR thermal camera in finding a power supply cable can be seen in Figure 12, where materials of similar characteristics were used, namely plaster and gypsum.

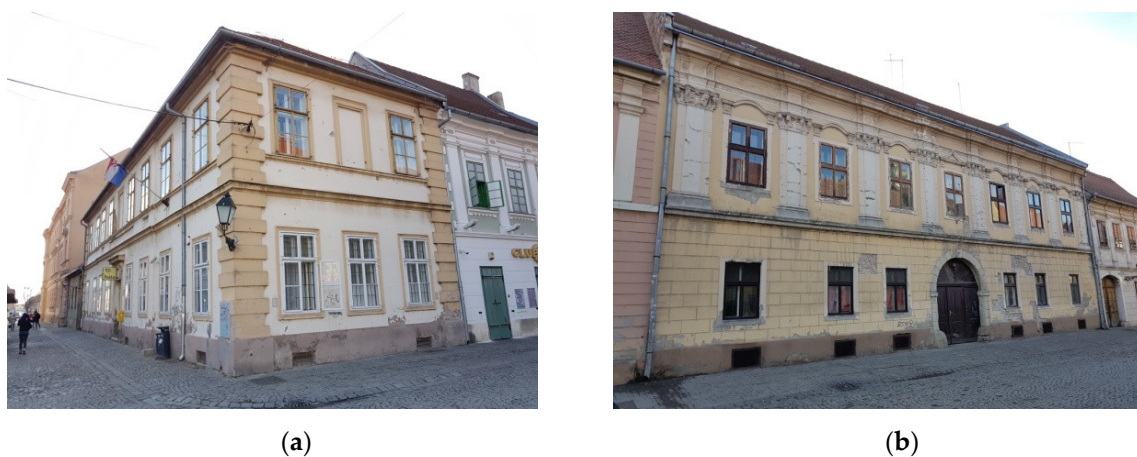
On the basis of the purchase contract with the Stekić family, between 1733 and 1747, trader Mihovil Kostić became the owner of the house in 23 Kuhačeva Street and the house on the corner of Kuhačeva and Marković Street (2 Markovićeve Street) (Figure 14a) [26]. Both buildings are two-storey houses with gabled roofs, masonry brick and stucco. In the architectural layout from 1774, when the military government of Tvrđa bought the Kostić houses, spatial organization and facade partition are evident. On the ground floor, there were shopping spaces with shop windows/openings; the door and the window were joined by a unique segmental overhang. There were two shop openings according to the drawing, east and west of the centrally located entrance on the ground floor. The position of these openings in 23 Kuhačeva Street was confirmed by the restoration probes (Figure 14b).

**Figure 14.** Kostić house (a) at the corner of Kuhačeva and Marković street (2 Markovičeva Street) and (b) in 23 Kuhačeva Street.

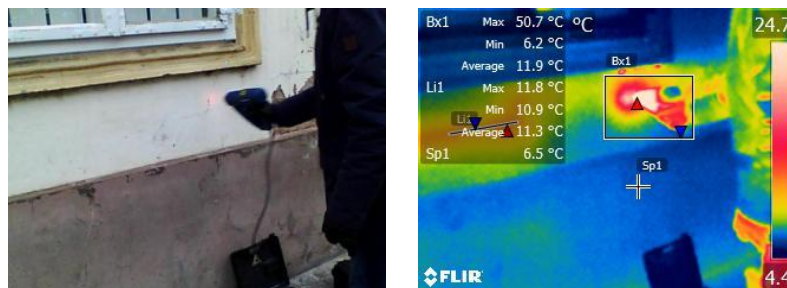
In order to determine the existence of discontinuity in the outer envelope, heating was applied, as is shown in Figure 19.

Figure 19. Initial application moment of thermal excitation.
