Locating Hidden Elements in Walls of Cultural Heritage Buildings by Using Infrared Thermography

Abstract: The structure of Tvrđa and its buildings date back to the Middle Ages. Tvrđa represents the Old Town of the city of Osijek and the best-preserved and largest ensemble of Baroque buildings in Croatia. After the withdrawal of the Ottomans in 1687, during the 18th century, the Austro-Hungarian administration systematically formed a new fortification system, regulated streets and squares and built a large number of military objects. Tvrđa took its present form in the 19th century and has kept it since then. Investigating the historical development of individual buildings, in addition to archival sources and existing architectural documentation, the obvious source of information are the buildings themselves. The aim of this paper is to explore the possibilities of using infrared thermography to find structural elements and hidden openings in historic buildings in Osijek's Tvrđa. This paper describes the exploration of the 18th century openings on the facades of the former Kostić houses. The facades were bricked into the walls in the 19th century because houses were reused and their

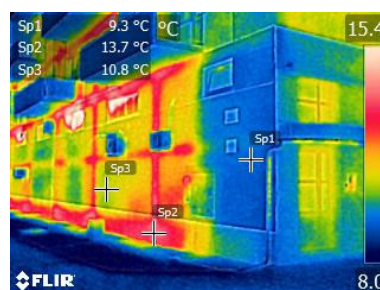
Qualitative thermography provides basic information about the temperature distribution on the surface of analyzed structures. The actual temperature values may differ significantly from those read on the camera. Figure 2 shows a residential building with the areas for commercial usage on the ground floor, where horizontal ties and structural elements are clearly visible, as well as a part of the staircase (bottom right corner of the building) which is not a heated space.

Figure 2. An example of highly-visible structural elements as well as a heated and an unheated space.
