The Effects of Strong Earthquakes on Built Heritage: A Preliminary Case Study of Rector's Palace in Dubrovnik's Old City

Source / Izvornik: **Sustainability, 2023, 15**

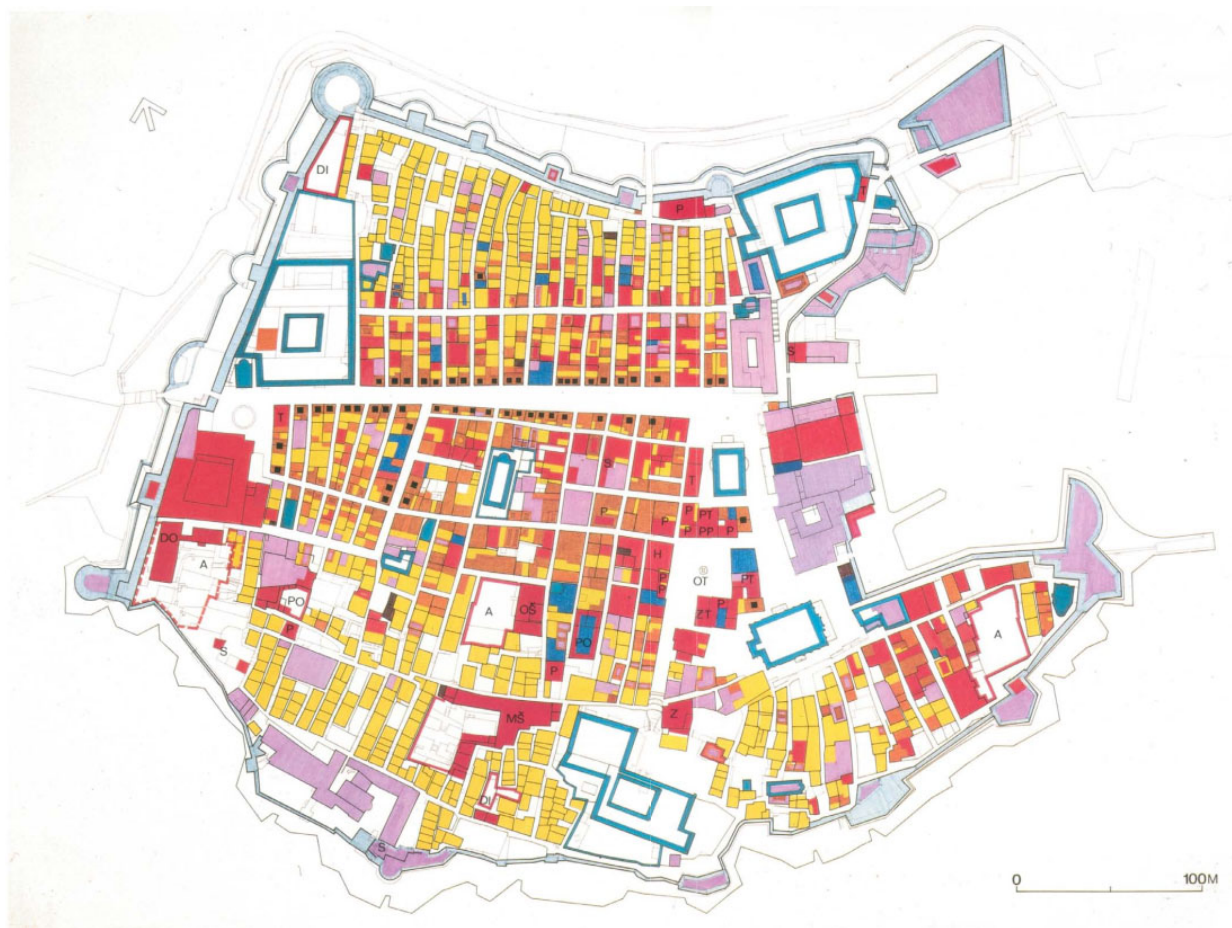
Figure 4. Urban plan of the Old City of Dubrovnik from 1982 (legend by color: yellow = residential buildings; pink = cultural; blue = management, administration, and economy; red and brown = tourism and stores) [47,48].

The Old City, confined with stone masonry fortification ramparts, is a unique urban entity that successfully preserved its historical form and meaning. In compliance with the contemporary urban plan (see Figure 4), the city comprises residential and public buildings. The buildings were adapted to the contemporary requirements according to their purpose.

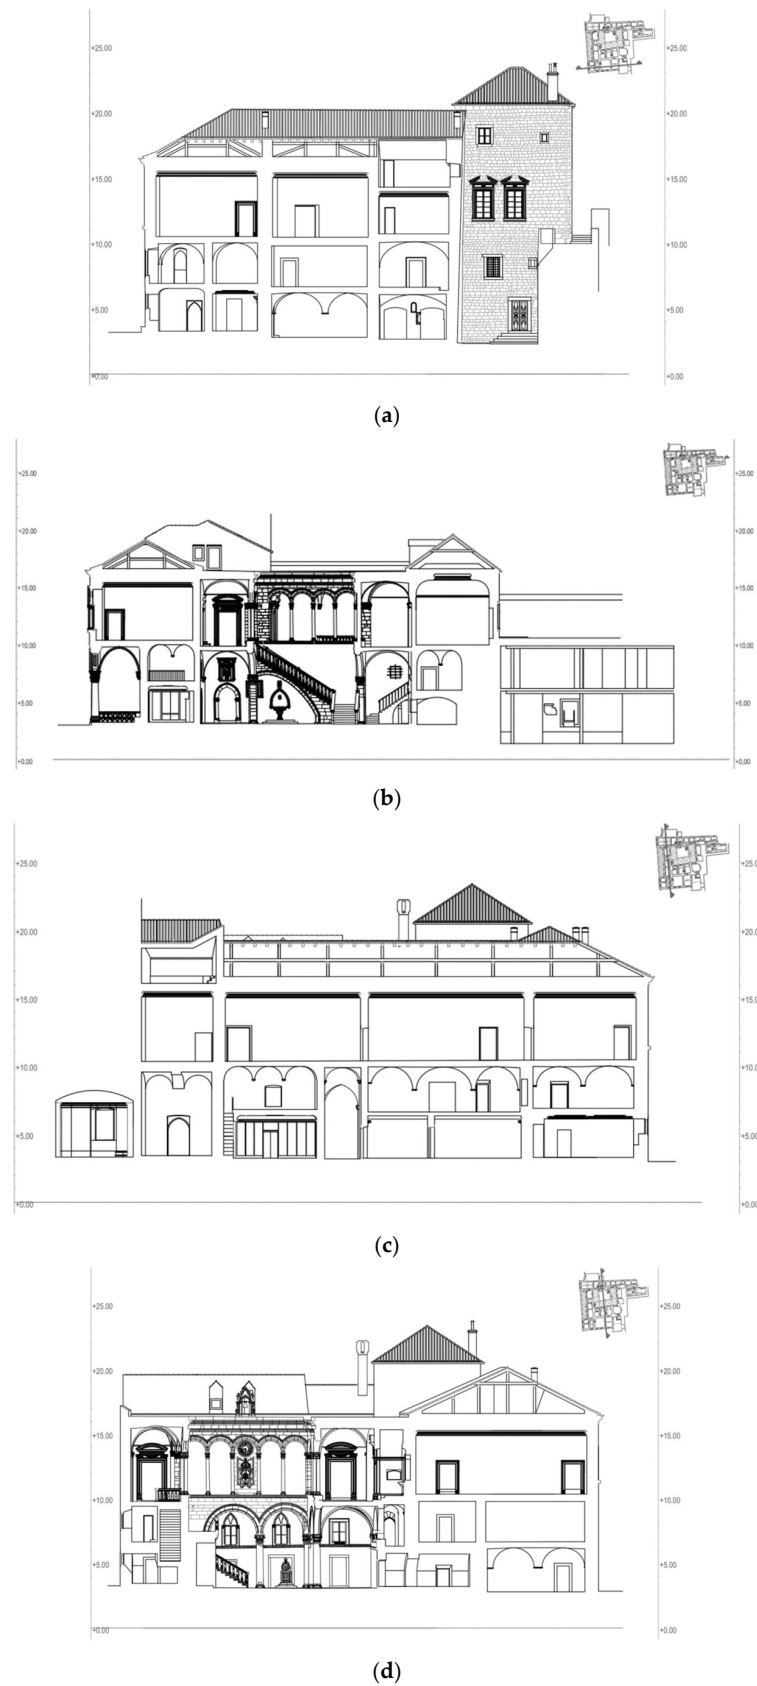
Figure 7. Selected cross-sections of the Rector's Palace: (a) "2-2"; (b) "3-3"; (c) "6-6"; (d) "9-9" as specified in original architectural drawings (courtesy of the Institute for the Restoration of Dubrovnik).
