# The Effects of Strong Earthquakes on Built Heritage: A Preliminary Case Study of Rector's Palace in Dubrovnik's Old City

*Source / Izvornik:* **Sustainability, 2023, 15**

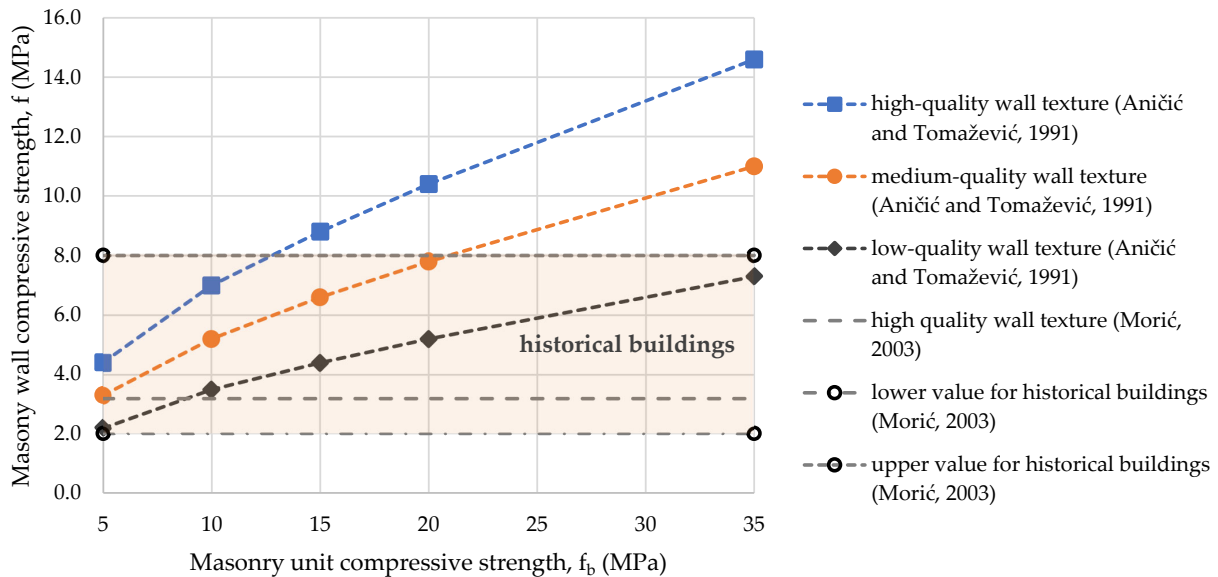
**Figure 9.** Compressive strength of natural stone masonry walls made with lime mortar,  $f$  (MPa), belonging to the eastern Adriatic coast with reference to the corresponding compressive strength of masonry units,  $f_b$  (MPa), in correlation with the quality of the wall texture (high, medium, and low) and reference values for historical buildings as given by [54,55,58,59].

Figure 9 shows the compressive strength of natural stone masonry walls made with lime mortar,  $f$  (MPa), belonging to the eastern Adriatic coast with reference to the corresponding compressive strength of masonry units,  $f_b$  (MPa), in correlation with the quality of the wall texture (high, medium, and low) and reference values for historical buildings as given by [54,55,58,59]. The walls are of high-quality texture, finely dressed stone masonry with an intermediate layer of fill. Based on the relations shown in Figure 9, the lower and upper limits of the compressive strength of stone masonry walls are 2.2 and 14.6 MPa [54,55]. The upper and lower values for historical buildings of 2.0 and 8.0 MPa, respectively, also stated in Figure 10, refer to (lime) mortar strength  $f_m < 2.5$  MPa.

where  $K$  is constant with a value of 0.45 for dimensioned natural stone;  $f_b$  is normalized compressive strength of a masonry unit; and  $f_m$  is the compressive strength of a mortar, ranging from 1.83 MPa (for  $f_b = 5$  MPa and  $f_m = 2.5$  MPa) to 8.8 MPa (for  $f_b = 35$  MPa and  $f_m = 5.0$  MPa), which corresponds to limits shown in Figure 9 as defined in [54,55].

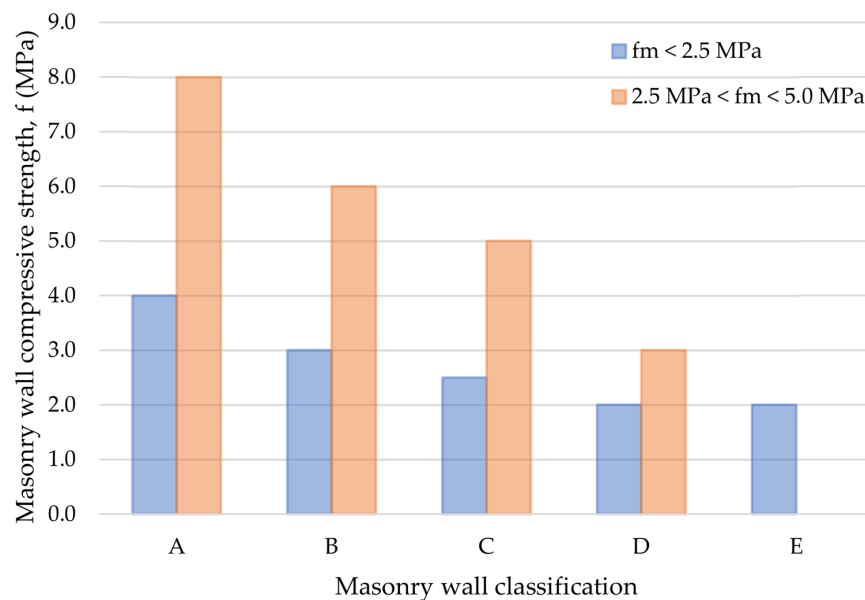
**Figure 10.** Compressive strength of natural stone masonry walls made with lime or cement–lime mortar,  $f$  (MPa), belonging to the eastern Adriatic coast with reference to wall classification (A–E) as proposed by [54,55] where letter symbols refer to (A) designated walls made of finely dressed and properly arranged stone blocks, without intermediate layers; (B) walls made of large regularly dressed stone blocks with a relatively narrow central layer filled with fill material and stone chippings; (C) walls made of large irregularly dressed stone blocks with a relatively narrow central layer filled with fill materials and stone chippings; (D) walls made of roughly dressed irregular stone blocks with a large number of stone chippings and fill material in the central layer, and with irregular joints; and (E) walls made of undressed stone with a large quantity of fill.

In addition, Figure 10 shows the compressive strength of natural stone masonry walls made with lime  $f_m < 2.5$  (MPa) or cement–lime mortar,  $2.5 < f_m < 5.0$  (MPa), belonging to the eastern Adriatic coast with reference to wall classification (A–E) as proposed by [54,55] where letter symbols refer to (A) designates walls made of finely dressed and properly arranged stone blocks, without intermediate layers; (B) walls made of large regularly dressed stone blocks with a relatively narrow central layer filled with fill material and stone chippings; (C) walls made of large irregularly dressed stone blocks with a relatively narrow central layer filled with fill materials and stone chippings; (D) walls made of roughly dressed irregular stone blocks with a large number of stone chippings and fill material in the central layer, and with irregular joints; and (E) walls made of undressed stone with a large quantity of fill. According to the EN 1996-1-1:2005 [24] building code, the wall compression strength estimate is based on the constituent contribution, i.e.,

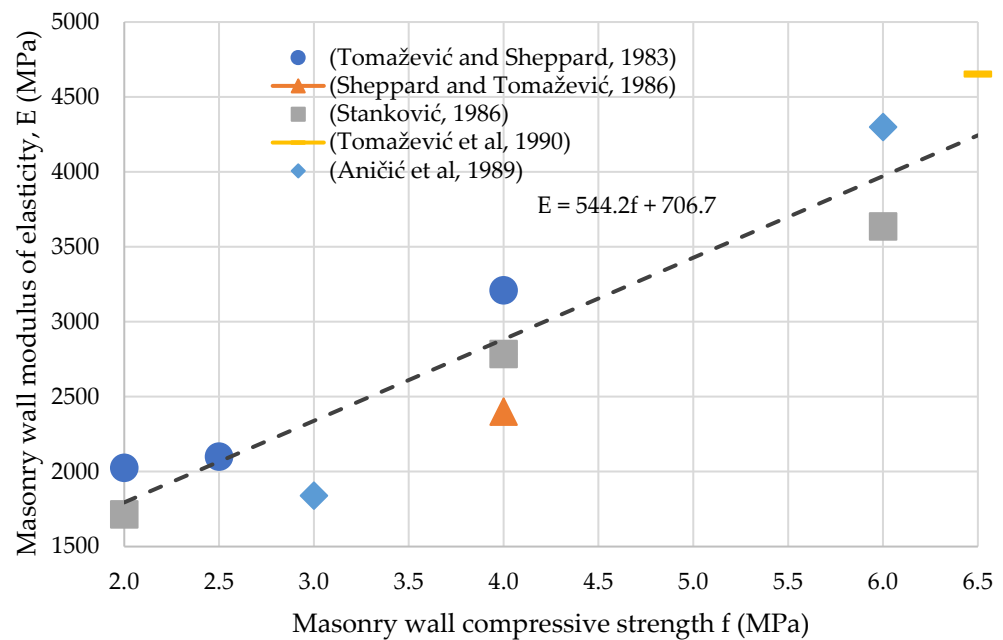
**Figure 11.** Modulus of elasticity of natural stone masonry walls made with lime mortar,  $E$  (MPa), belonging to the eastern Adriatic coast with reference to corresponding wall compressive strength,  $f$  (MPa), from test results, as given by [54,55,60–64].

(B class in the case of Rector’s Palace). The modulus of elasticity, besides the structure’s mass, is critical in the calculation of the natural frequency of the building and, therefore, the earthquake performance. The adequate modulus elasticity was determined by structural model calibration with reference to measured natural frequencies. The initial, i.e., orientation values of the modulus of elasticity of natural stone masonry walls made with lime mortar,  $E$  (MPa), belonging to the eastern Adriatic coast with reference to corresponding wall compressive strength,  $f$  (MPa), from test results, as given by [54,55,60–64], are shown in Figure 11 and Table 1. As proposed by [54,55], and based on Figure 11 and Table 1 information, the lower limit (referring to walls of low-quality texture) of the modulus of elasticity can be expressed as  $E = 650 \times f$  (MPa), while the upper limit (referring to walls of high-quality texture) as  $E = 900 \times f$  (MPa), which is lower than the prediction  $E = 1000 \times f$  (MPa) given in the EN 1996-1-1:2005 [24] building code. The corresponding value of stone masonry wall shear modulus  $G$  ranges from  $E/6$  to  $E/4$ . In addition, the recommended values of stone masonry wall tensile strength  $f_t$  range from 0.09 to 0.3 MPa in relation to corresponding compressive strength ranging from 2.0 to 8.0 MPa, respectively.

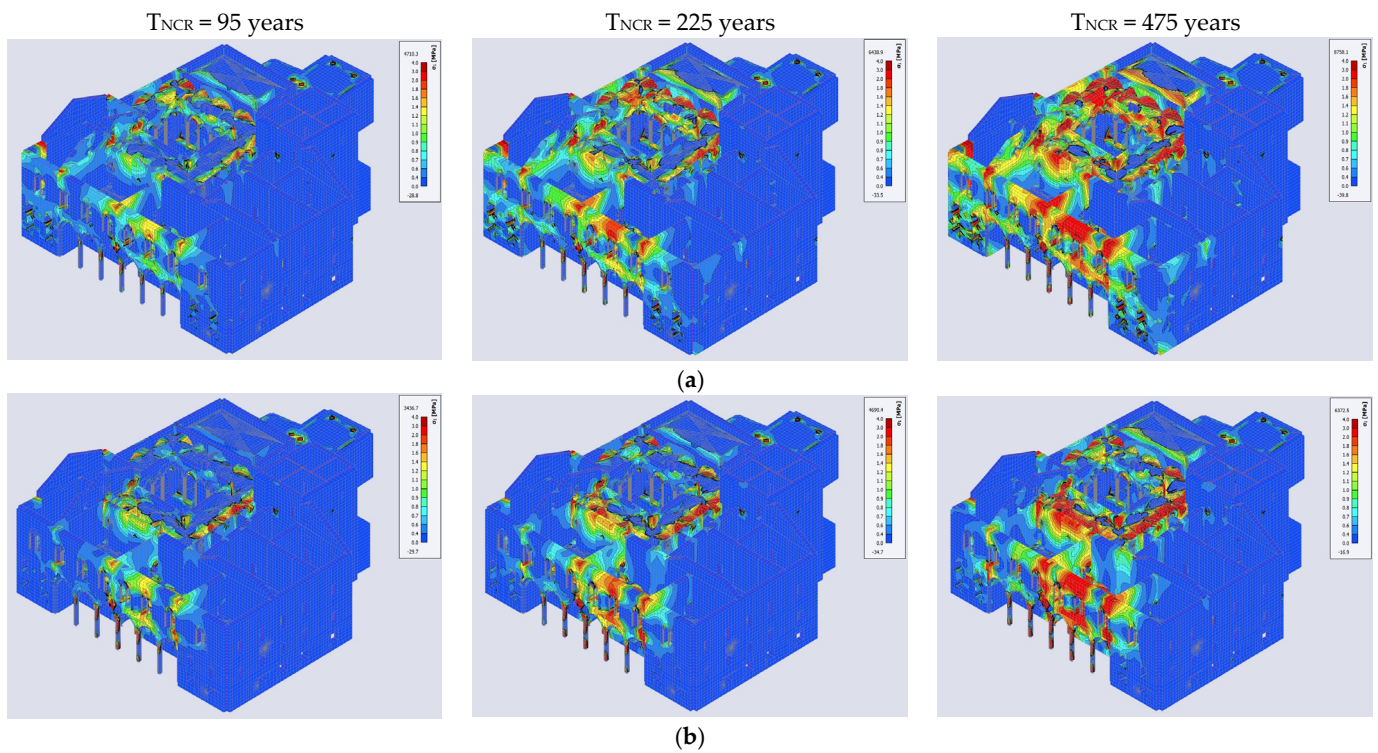
**Figure 17.** Principal tensile stresses,  $\sigma_1$  (MPa), on the Rector’s Palace, at reference return periods,  $T_{NCR}$ , of 95, 225, and 475 years: (a) load combination—LC1; (b) load combination—LC2.

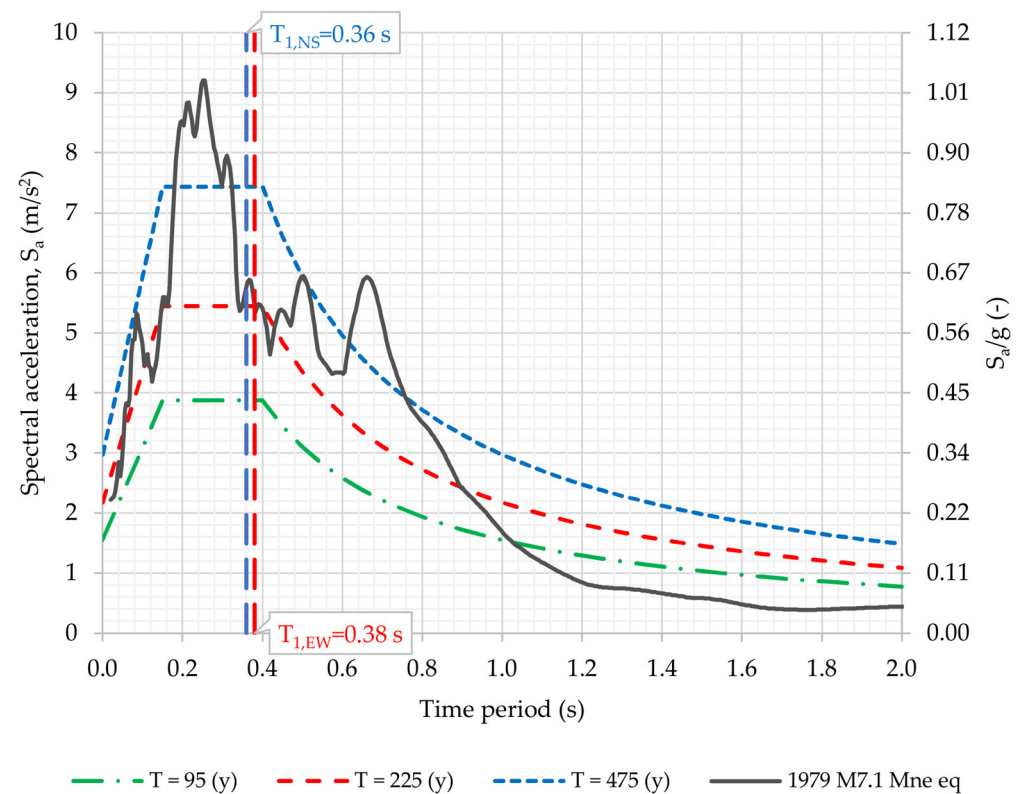
**Figure 19.** Response spectrum of Type 1 for reference return periods,  $T_{NCR}$ , of 95, 225, and 475 years [25], respectively, and of the  $M_w = 7.1$  1979 Montenegro earthquake [74,75] recorded at Herzeg Novi station in the N-S direction for behavior factor  $q = 1.0$  (at a 50 km distance from Dubrovnik's Old City) with the corresponding building's measured pre-retrofitting fundamental periods in the N-S and E-W directions, i.e.,  $T_{1,NS}$  and  $T_{1,EW}$ , respectively.

In comparison with the corresponding building code response spectrums, Figure 19 shows the response spectrum of the 1979  $M_w = 7.1$  Montenegro earthquake [74,75] recorded at Herzeg Novi station in the N-S direction (at a 50 km distance from Dubrovnik's Old City) for behavior factor  $q = 1.0$ , the building's fundamental periods in the N-S and E-W directions, i.e.,  $T_{1,NS}$  and  $T_{1,EW}$ , respectively. The geology and soil conditions of the Montenegrin and Croatian coasts in the observed area have matching characteristics. As seen in Figure 19, the measured fundamental frequencies (periods) of the building in the

NS and EW direction, namely,  $T_{1,NS} = 0.36$  s and  $T_{1,EW} = 0.38$  s, comply with the highest demand represented by the building code and the 1979  $M_w = 7.1$  Montenegro earthquake response spectrum.

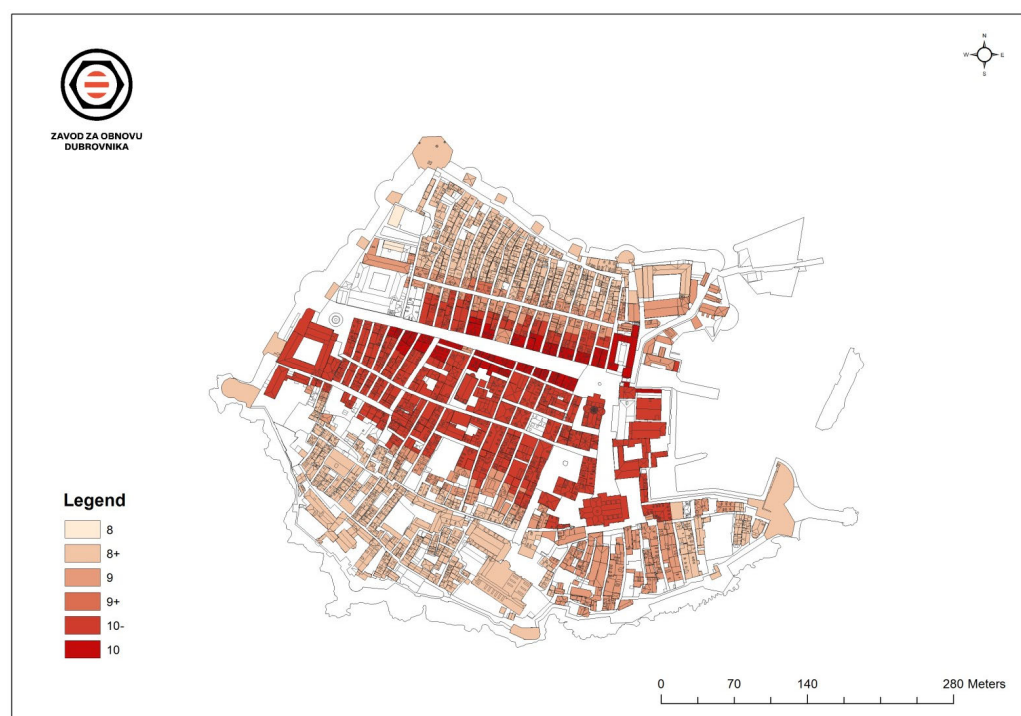
**Figure 20.** Seismic microzoning earthquake intensity map of the Old City of Dubrovnik in compliance with the Mercalli–Cancani–Sieberg (MCS) scale (publicly available at URL: <https://zod.hr/obnova-dubrovnika/potres-1979-i-aseizemicka-sanacija/>; accessed on 22 September 2023).

Consequently, the earthquake-related risk to the whole built heritage of Dubrovnik's Old City is relatively high, as evident from seismic microzoning earthquake intensity map (in compliance with the Mercalli–Cancani–Sieberg (MCS) scale) shown in Figure 20 and damage map in Figure 2.

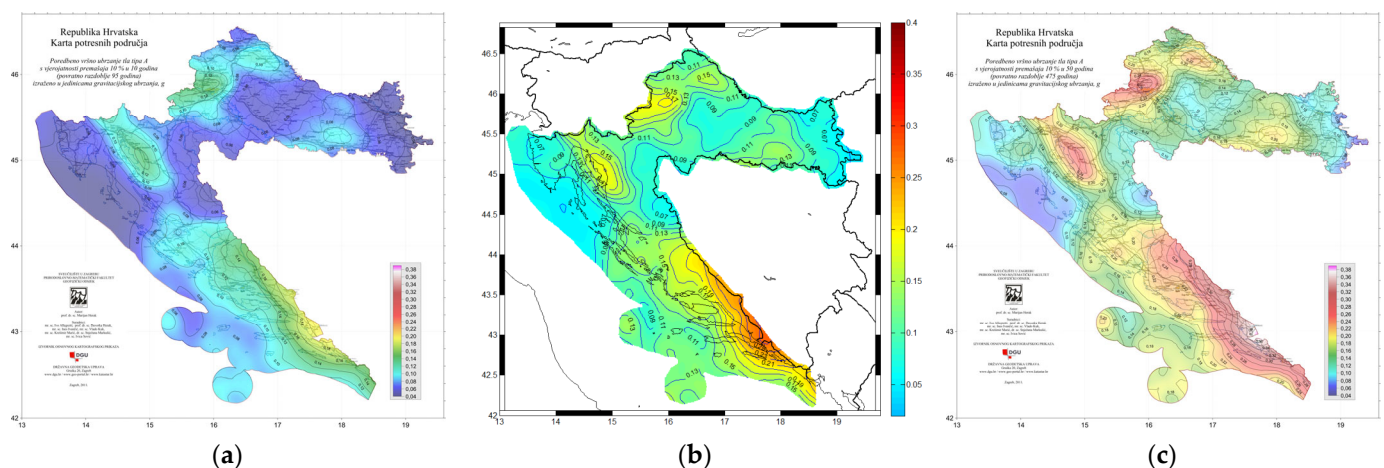
**Figure 21.** The Earthquake Hazard Maps of the Republic of Croatia for the return period of (a) 95, (b) 225, and (c) 475 years (publicly available at URL: <http://seizkarta.gfz.hr/hazmap/karta.php>; accessed on 22 September 2023).

The damage evolution based on principal tensile stress,  $\sigma_1$  (MPa), observation in Figure 17a,b at return periods  $T_{NCR} = 95$  ( $a_g/g = 0.16$ ), 225 ( $a_g/g = 0.21$ ), and 475 ( $a_g/g = 0.30$ ) years (see Figure 21), reveals that in spite of the interventions applied to atrium’s vertical structural elements (namely, stone columns and masonry walls) the adjacent stone vaults still remain the most vulnerable building part to earthquakes, even for the damage limitation (DL) limit state design requirements, i.e.,  $T_{NCR} = 95$  ( $a_g/g = 0.16$ ). Considering the corresponding increased return period principal tensile stress values, i.e., at  $T_{NCR} = 225$  and 475 years, besides the building’s atrium, the vulnerability of arcades (western façade) becomes evident and highly sensitive to out-of-plane failure (see also Figures 16b and 22b).
