Infrared Thermography in Maintenance of Building Applied Photovoltaics

SUMMARY

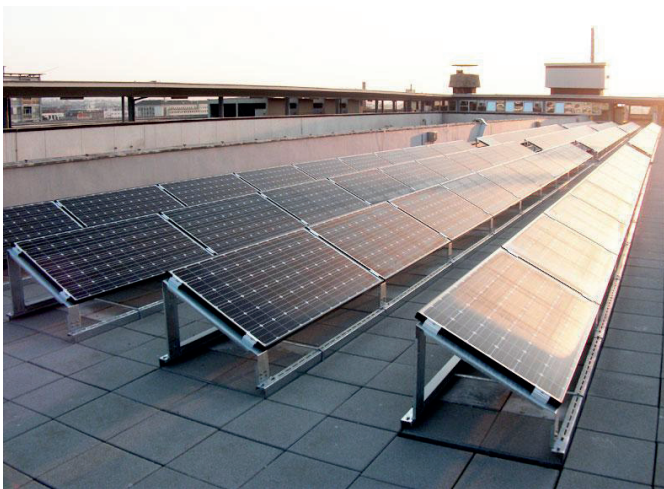
Figure 1. PV panels on the flat roof, picture source Končar d.d.

Photovoltaic systems on existing buildings are usually laid using an aluminum pre-fabricated structure that, in the case of a sloping roof, is fixed to the roof-mounted supports underneath the roof cover to ensure unobstructed precipitation of rainwater. In the case of flat roofs, the construction is fixed to the concrete slabs (Figure 1) or plastic trays filled with stone aggregates in the case of a flat roof where the fixture with the screws is not possible (the first example in the Republic of Croatia, Konzum maxi Sopot 2011). When constructing new buildings, it is increasingly common to integrate panels to a wooden roof structure, (Figure 2), or to use a cover with integrated photovoltaic cells (Figure 3).

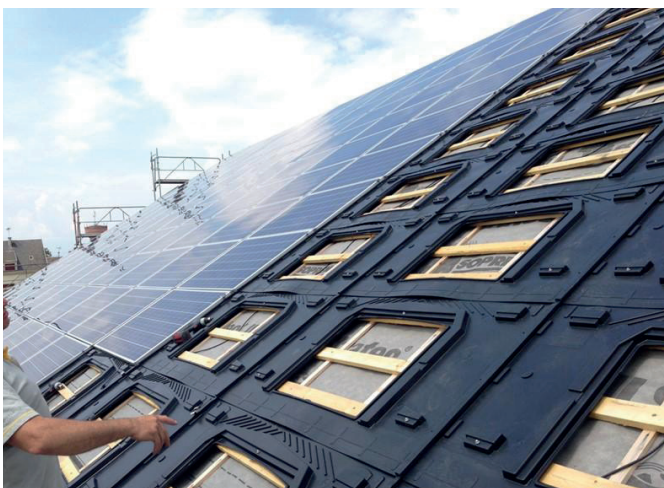
Figure 2. Photovoltaic panels on the roof of a new building, [3]
