# Infrared Thermography in Maintenance of Building Applied Photovoltaics

*Source / Izvornik:* **Energija : časopis Hrvatske elektroprivrede, 2018, 67, 7 - 11**

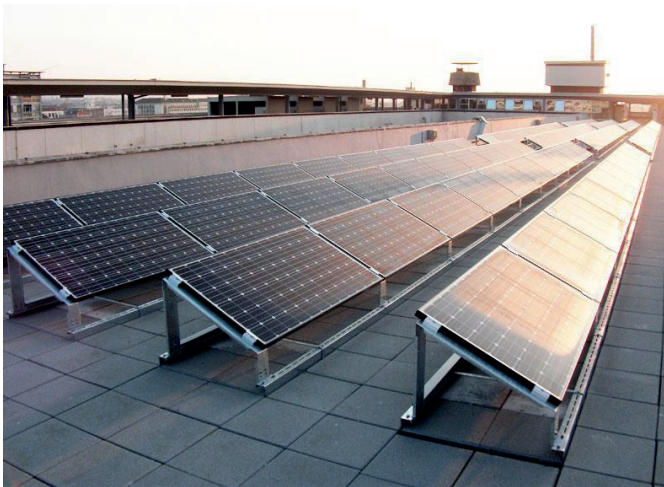
Figure 1. PV panels on the flat roof, picture source Končar d.d.

Photovoltaic systems on existing buildings are usually laid using an aluminum pre-fabricated structure that, in the case of a sloping roof, is fixed to the roof-mounted supports underneath the roof cover to ensure unobstructed precipitation of rainwater. In the case of flat roofs, the construction is fixed to the concrete slabs (Figure 1) or plastic trays filled with stone aggregates in the case of a flat roof where the fixture with the screws is not possible (the first example in the Republic of Croatia, Konzum maxi Sopot 2011). When constructing new buildings, it is increasingly common to integrate panels to a wooden roof structure, (Figure 2), or to use a cover with integrated photovoltaic cells (Figure 3).

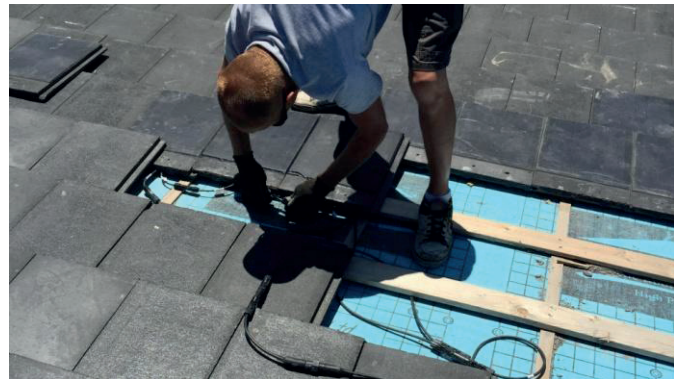
Figure 3. An integrated solar cell in roofing, [4]

The main problem of the integrated cover is reduced efficiency due to an increased panel working temperature (0.3-0.5 % and more per 1 °C increase of the temperature) due to reduced ventilation and inability to access the connection points. Reduction of the power due to the increase in working temperature is not so pronounced with panels integrated into façades of buildings, Figure 4.
