The Effects of Strong Earthquakes on Built Heritage: A Preliminary Case Study of Rector's Palace in Dubrovnik's Old City

Source / Izvornik: **Sustainability, 2023, 15**

Journal article, Published version

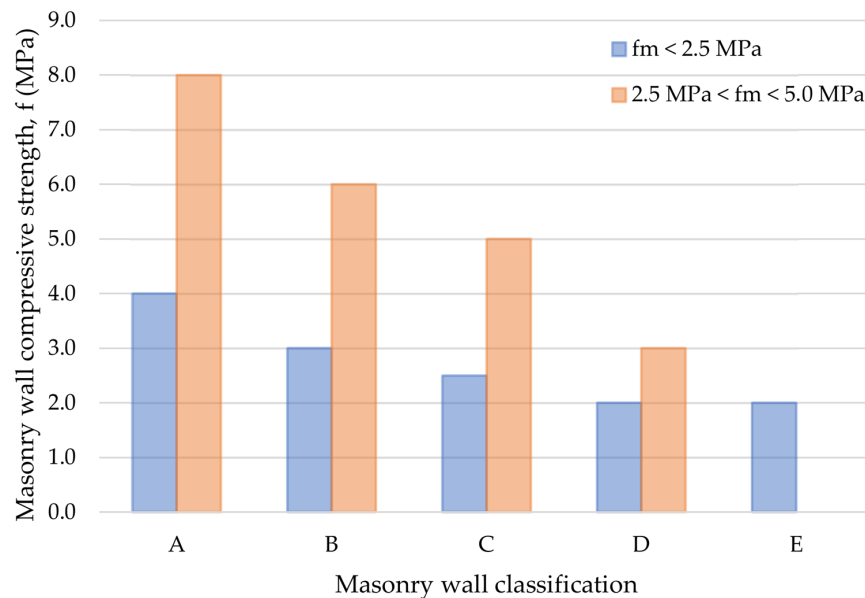
Figure 10. Compressive strength of natural stone masonry walls made with lime or cement–lime mortar, f (MPa), belonging to the eastern Adriatic coast with reference to wall classification (A–E) as proposed by [54,55] where letter symbols refer to (A) designated walls made of finely dressed and properly arranged stone blocks, without intermediate layers; (B) walls made of large regularly dressed stone blocks with a relatively narrow central layer filled with fill material and stone chippings; (C) walls made of large irregularly dressed stone blocks with a relatively narrow central layer filled with fill materials and stone chippings; (D) walls made of roughly dressed irregular stone blocks with a large number of stone chippings and fill material in the central layer, and with irregular joints; and (E) walls made of undressed stone with a large quantity of fill.

In addition, Figure 10 shows the compressive strength of natural stone masonry walls made with lime $f_m < 2.5$ (MPa) or cement–lime mortar, $2.5 < f_m < 5.0$ (MPa), belonging to the eastern Adriatic coast with reference to wall classification (A–E) as proposed by [54,55] where letter symbols refer to (A) designates walls made of finely dressed and properly arranged stone blocks, without intermediate layers; (B) walls made of large regularly dressed stone blocks with a relatively narrow central layer filled with fill material and stone chippings; (C) walls made of large irregularly dressed stone blocks with a relatively narrow central layer filled with fill materials and stone chippings; (D) walls made of roughly dressed irregular stone blocks with a large number of stone chippings and fill material in the central layer, and with irregular joints; and (E) walls made of undressed stone with a large quantity of fill. According to the EN 1996-1-1:2005 [24] building code, the wall compression strength estimate is based on the constituent contribution, i.e.,
