The Effects of Strong Earthquakes on Built Heritage: A Preliminary Case Study of Rector's Palace in Dubrovnik's Old City

Journal article, Published version

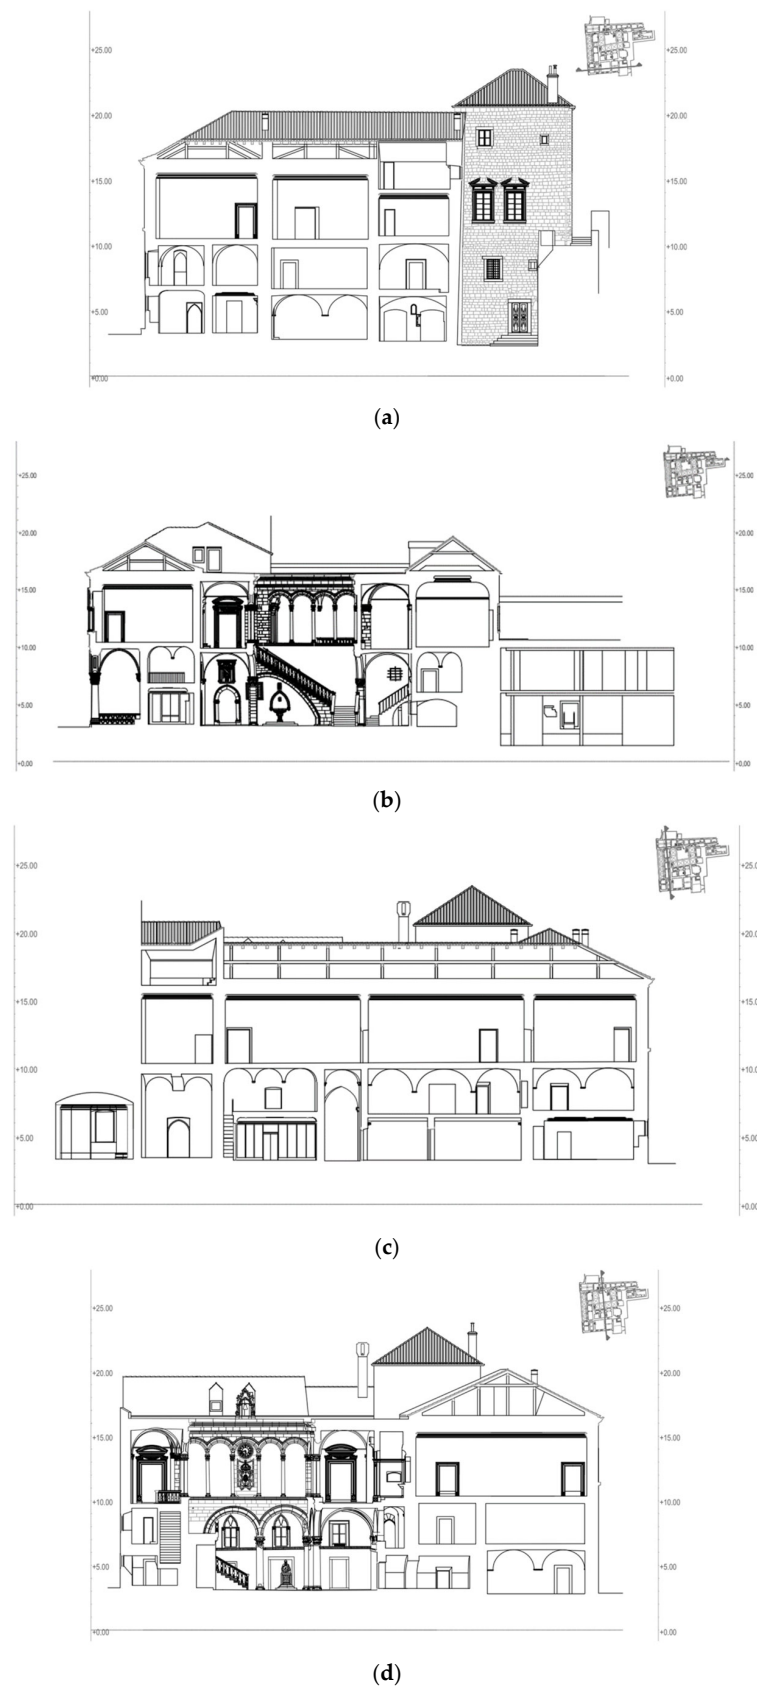
Figure 7. Selected cross-sections of the Rector's Palace: (a) "2-2"; (b) "3-3"; (c) "6-6"; (d) "9-9" as specified in original architectural drawings (courtesy of the Institute for the Restoration of Dubrovnik).
