Infrared Thermography in Maintenance of Building Applied Photovoltaics

Source / Izvornik: **Energija : časopis Hrvatske elektroprivrede, 2018, 67, 7 - 11**

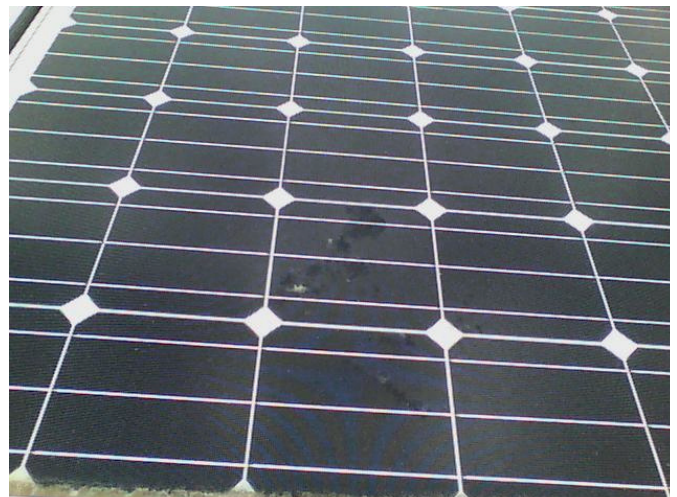
Figure 8. The surface of the panel covered with bird droppings

Shading of the PV panel does not have to be obvious in the visible part of the spectrum to be noticeable with an infrared thermal camera in the infrared part. Figure 8 shows the surface area covered with bird droppings. On the corresponding thermogram, a 1.6 °C apparent temperature increase

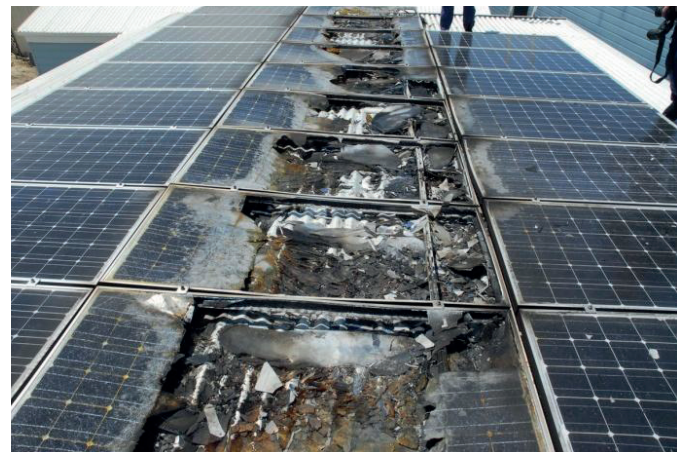
Figure 13. The consequence of fire on photovoltaic system, example [9]

Monitoring the condition of the equipment is indispensable because defective equipment can lead to significant negative consequences. Figures 13 and 14 show the consequences of the defective PV system.
