The Effects of Strong Earthquakes on Built Heritage: A Preliminary Case Study of Rector's Palace in Dubrovnik's Old City

Article

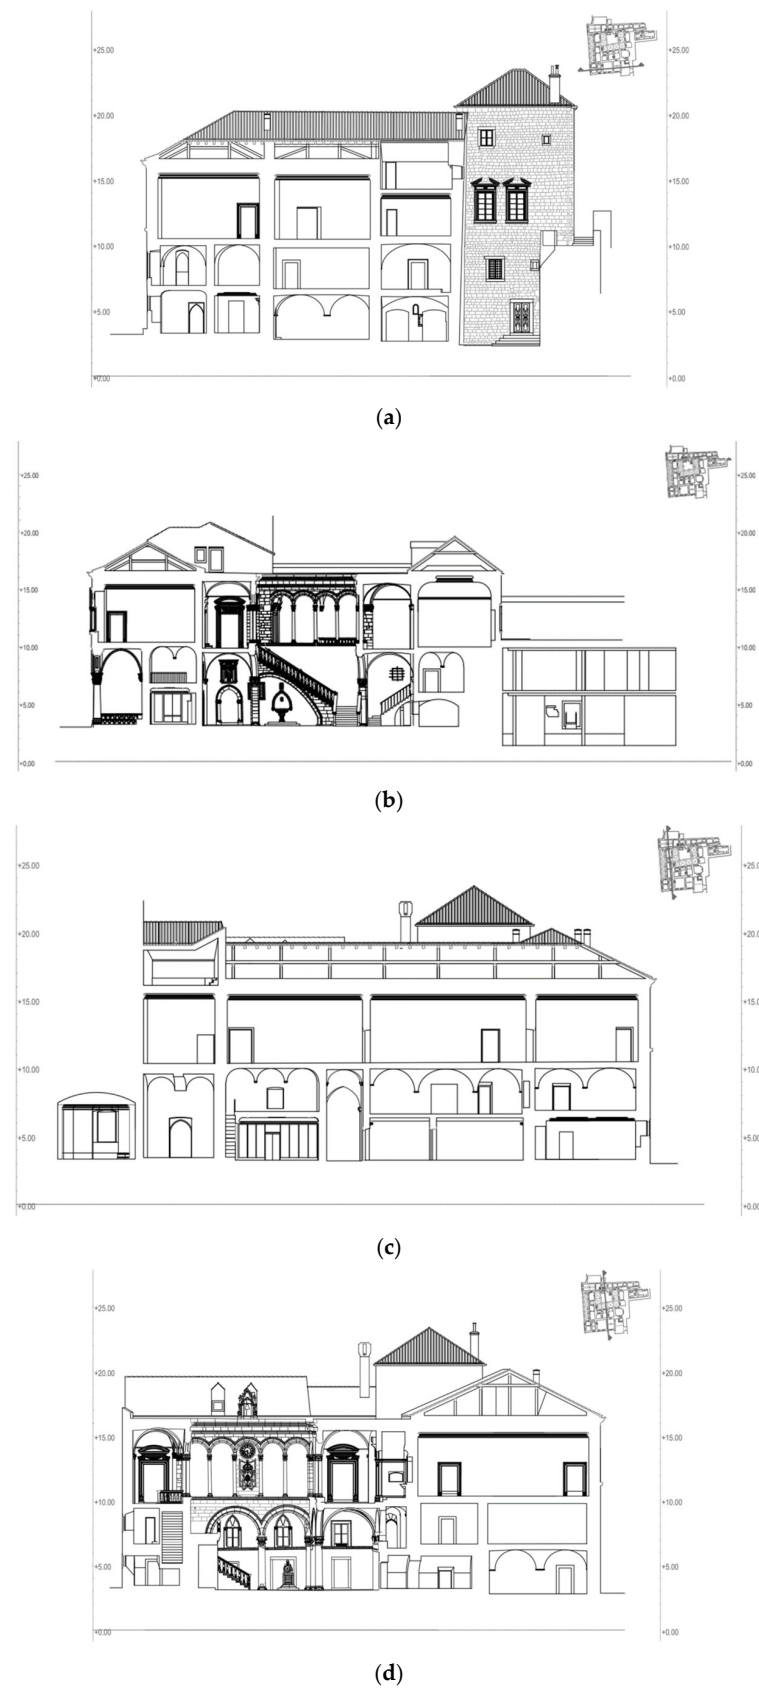
Figure 7. Selected cross-sections of the Rector's Palace: (a) "2-2"; (b) "3-3"; (c) "6-6"; (d) "9-9" as specified in original architectural drawings (courtesy of the Institute for the Restoration of Dubrovnik).
