Influence of openings, with and without confinement, on cyclic response of infilled R-C frames: an experimental study

Sigmund, Vladimir; Penava, Davorin

Source / Izvornik: **Journal of Earthquake Engineering, 2014, 18, 113 - 146**

This article presents the experimental results of a study on reinforced-concrete frames infilled with masonry with openings. The frames were designed according to current European codes. They were built in a scale 1:2.5 and infilled with masonry walls. Mid-size window and door openings were located centrally and eccentrically and were executed with and without tie-columns around them. Presence of masonry infill, although not accounted for in design, improved the system behavior (increase in stiffness, strength and energy dissipation capacity) at drift levels of up to 1%. During the test, openings did not influence the initial stiffness and strength at low drift levels. Their presence became noticeable at higher drift levels, when they lowered the energy dissipation capacity of the system. The infill wall had a multiple failure mechanism that depended on the opening height and position. Tie-columns controlled the failure type, independent of the opening

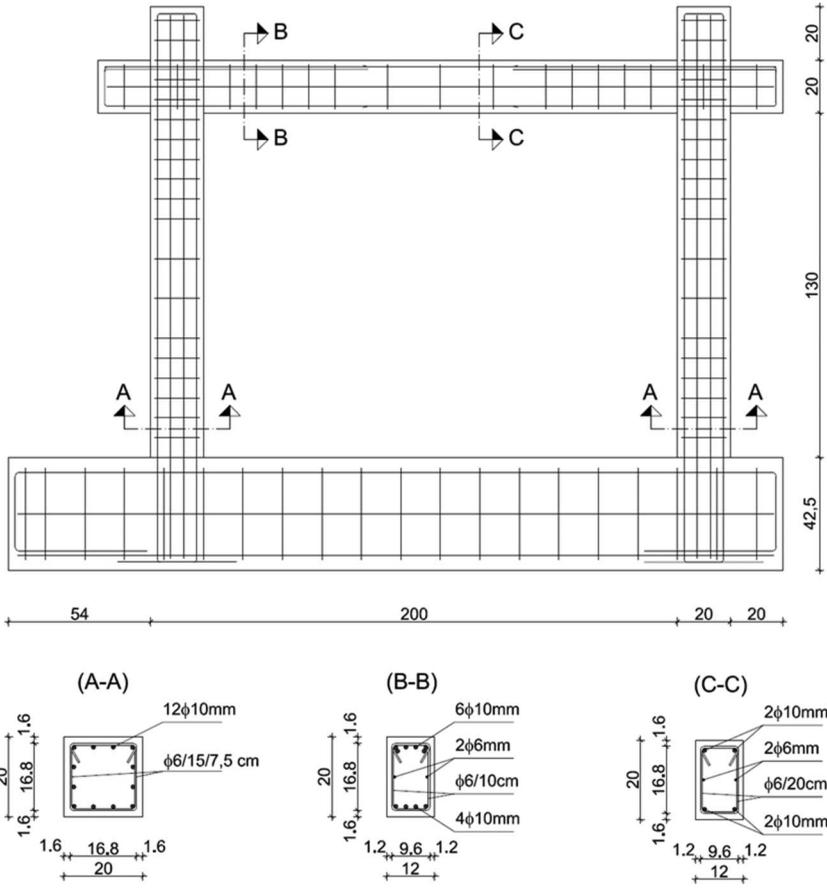
FIGURE 1 Reinforcement details and specimen's dimensions (cm).

The frame elements were reinforced with ribbed reinforcing bars (longitudinal reinforcement $\phi 10$ mm for columns and $\phi 10$ mm and $\phi 6$ mm for beams). Stirrups in columns with $\phi 6$ mm were placed at an interval of 7.5 and 15 cm and in beams $\phi 6$ mm placed at intervals of 10 and 20 cm. Reinforcement details are shown in Fig. 1.

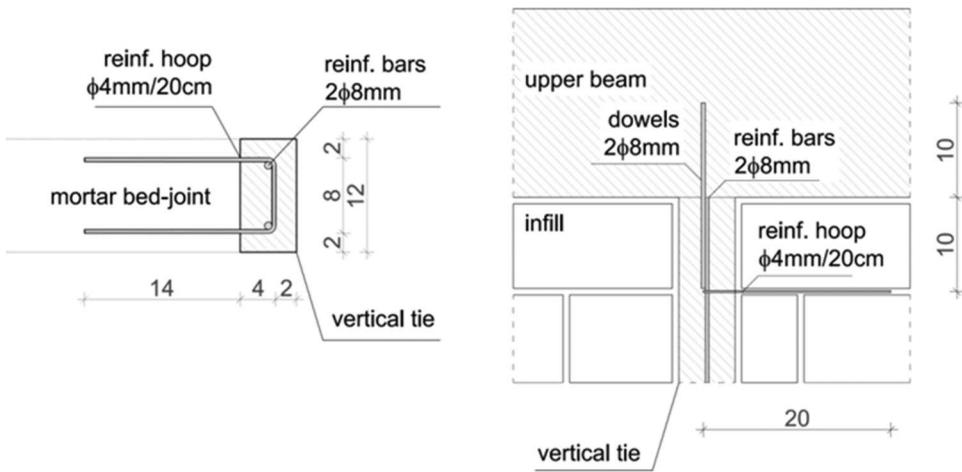
FIGURE 2 Tie-reinforcement details in the cross-section (left) and in elevation (right).

Vertical ties were reinforced with two longitudinal reinforcement bars, each of $\phi 8$ mm. These were anchored into the beams by dowels nailed 10 cm into previously drilled holes. Dowel stirrups, $\phi 4$ mm, were anchored into every second horizontal mortar joint. Reinforcing details are presented in Fig. 2. The lintel above the opening was reinforced by four longitudinal bars of $\phi 6$ mm with stirrups of $\phi 6$ mm placed at intervals of 9 cm.

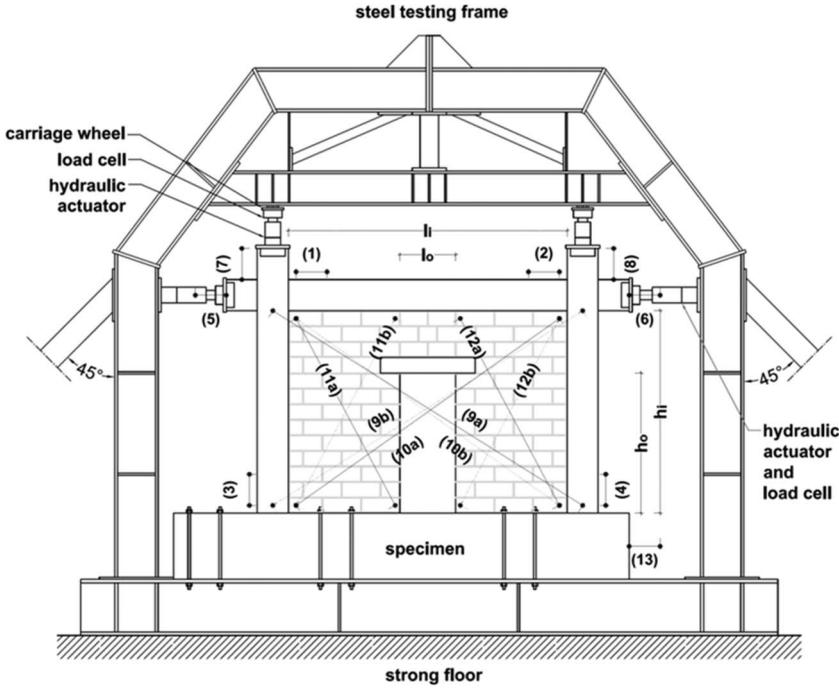
FIGURE 3 Test setup.

The test setup consisted of a closed steel testing frame connected to the strong floor. Lateral deformations of the resisting frame were prevented by braces, as shown in Fig. 3. The frame was stiff enough to prevent any interaction with the forced response of the specimen being tested.

Extensive instrumentation was utilized to monitor all aspects of the specimens' behavior. A schematic depiction of the instruments' location is shown in Fig. 3. The test measured applied forces by pressure transducers, lateral displacements on the left (5) and right end of the R-C beam (6) and vertical displacements (7 and 8) using LVDTs mounted on separate scaffolding. Diagonal deformations were measured by string transducers on the frame (9a and 9b) and on the masonry infill (10a and 10b) on the front (a) and back (b) side of the specimen. Specimens with openings were additionally provided with diagonal string transducers on one (11a and 11b) and/or other side of the opening (12a and 12b) depending on the opening's type and position. Measuring devices, 12a and 12b were not placed in the case of eccentric opening. Local strains were measured by strain gauges at the column's bottom and at the beam's hinge location (1–4). For signal conditioning, data acquisition

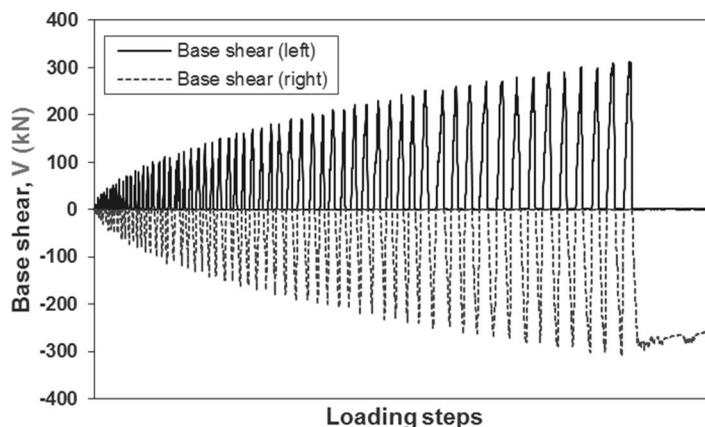
FIGURE 4 Recorded loading history.

The specimen's foundation beam was fixed to the steel frame and the floor. Four hydraulic actuators were fixed to the frame in order to simulate constant vertical and quasi-static lateral loadings. Vertical load, simulating loading from the upper floors, was applied to the specimen's columns' tops by means of two vertical hydraulic actuators of 500 kN capacity and ± 150 mm stroke. The load was kept constant at $N = 365$ kN by means of the pressure valves mounted on the actuators. Vertical hydraulic actuators were placed on carriage wheels that enabled the horizontal column's displacement and prevented its rotation. Two hydraulic actuators, of 350 kN capacity and stroke ± 150 mm, were fixed to the frame at beam level in order to simulate the cyclic in plane lateral load. It was applied quasi-statically and cyclically, first as force (at the initial stage up to yielding) and then as displacement controlled (after yielding), according to [FEMA 461, 2007]. The load was increased stepwise in a series of increments of 10 kN, repeating each step twice, until the structural system yielded. Then displacements were increased by increments of 1 mm until the drift of 1.0–1.2% was reached, or the masonry wall came out of plane. When the masonry infill wall was extensively damaged, lateral loading was applied from one side only, up to the infill's total failure. Recorded loading history is presented in Fig. 4.

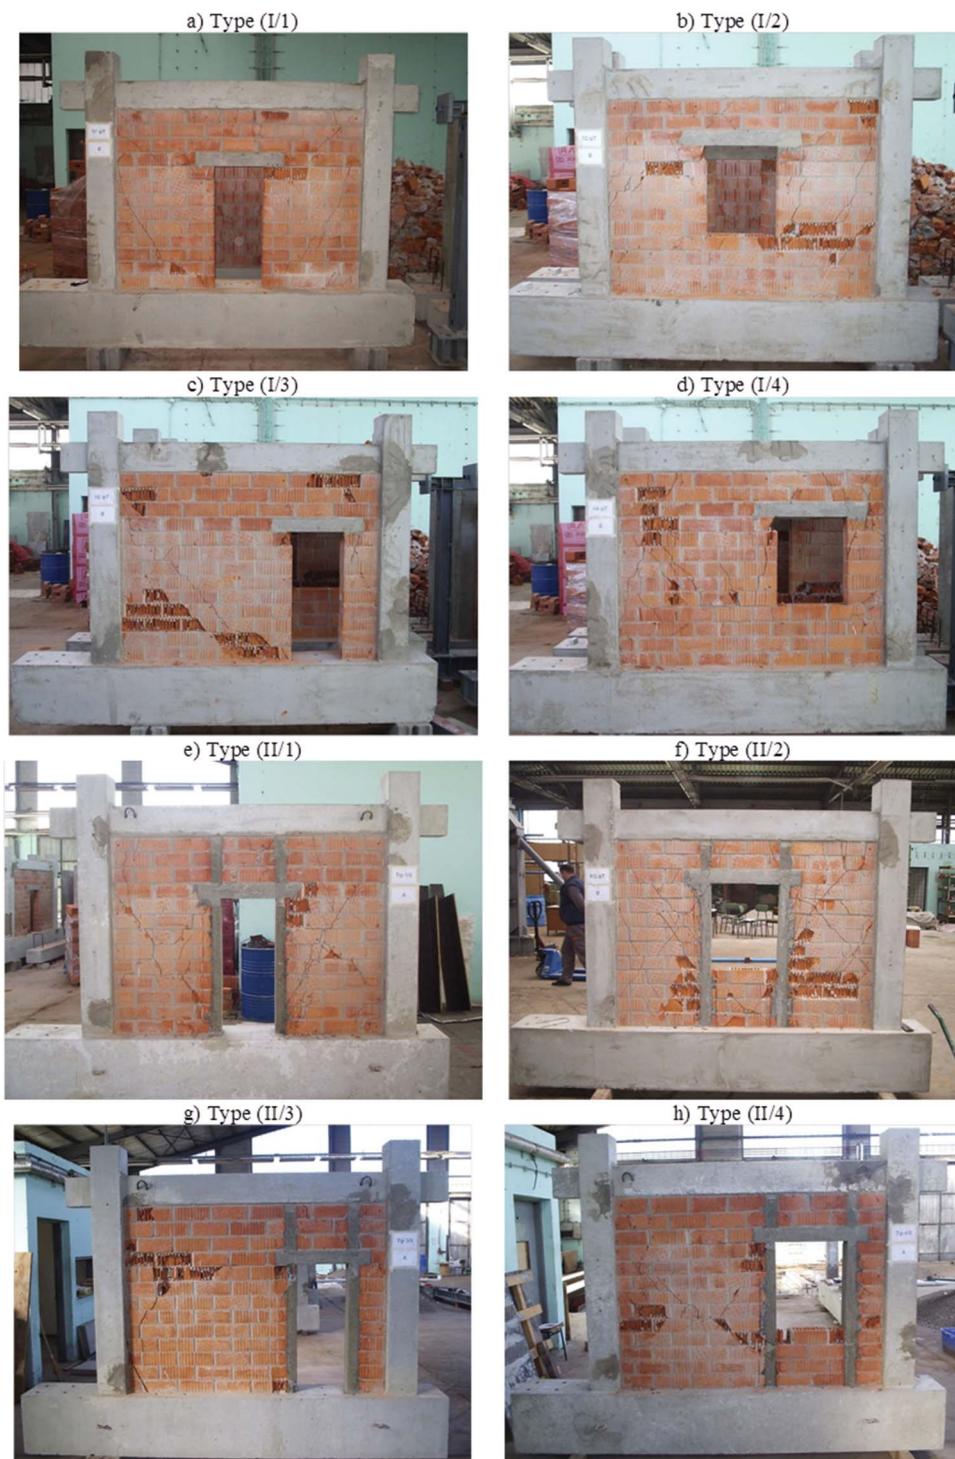
FIGURE 5 Specimens after the test (color figure available online).

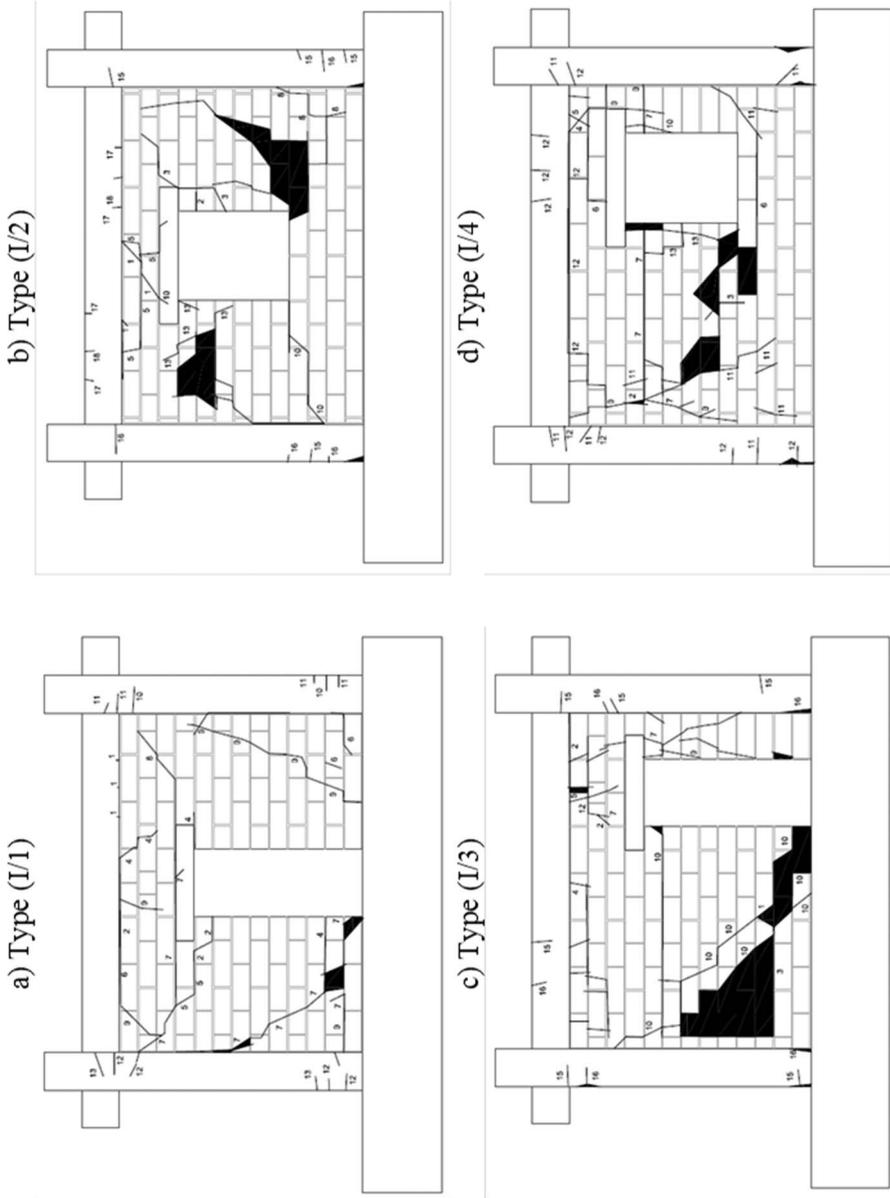
FIGURE 6 Group I specimens' crack patterns.

Diagonal tensile cracks occurred in the masonry piers at an angle of 45–65° (Figs. 6a–d). At higher drifts they became unstable and tended to fall out of the plane. Pier height was equal to that of the opening. Diagonal shear and/or horizontal bed-joint sliding shear failure of the pier were dominant.

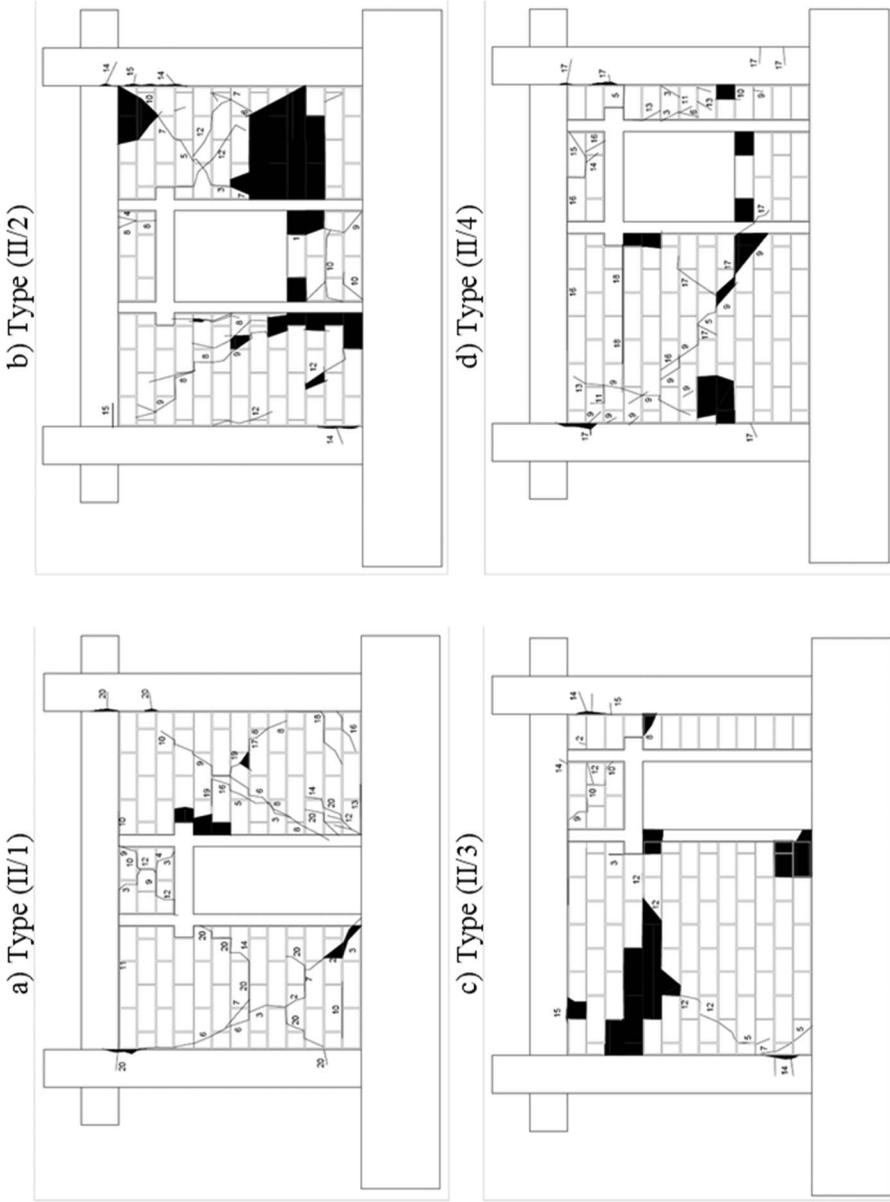
FIGURE 7 Group II specimens' crack patterns.

Introduction of the vertical tie-columns influenced the infill's behavior during the test. Diagonal tensile cracks occurred in masonry piers at an angle of 45–65° (Figs. 7a–d). The

height of the opening did not influence the pier's height and in the most cases it was equal to the infill's height (except in the case when the tie failed in shear). The cracks that crossed tie elements were observed on the specimens with eccentrically placed openings, on the side of the infill's bigger pier. They were close to the opening's edges. Dominant were diagonal shear and/or horizontal bed-joint sliding shear failures of the pier.

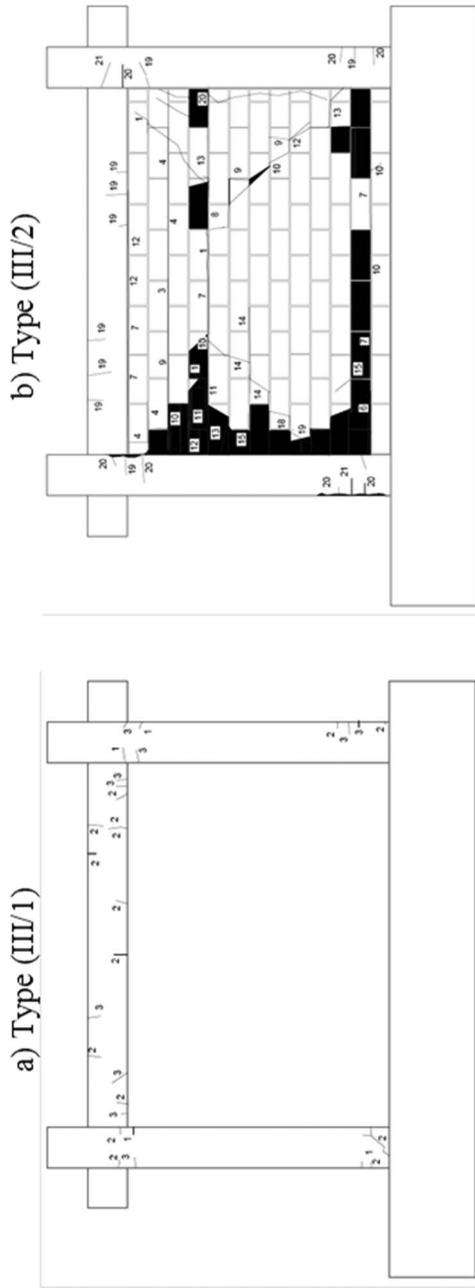
FIGURE 8 Group III specimens' crack patterns.

The reinforced-concrete frame yielded at a lateral displacement of ± 14.00 mm (drift $d_r = 1.00\%$) and horizontal load of 209 kN. Plastic hinges were formed at columns' bottoms and beam's ends. After-yield stiffness was about 5% of the initial value. The frame structure was able to carry the vertical load up to drifts of 2% without degradation. Strong column-weak beam flexural failure was dominant, and the observed crack pattern is shown in Fig. 8a.

The infill wall collapsed at lateral displacement ± 15.24 mm ($d_r = 1.09\%$) and horizontal load 254 kN. Diagonal tension cracks extended from the corners and bed-joint sliding occurred in the mid plane of the masonry infill. At the infill-column interface significant crushing of the masonry units occurred (Fig. 8b) and horizontal shear failure was dominant.

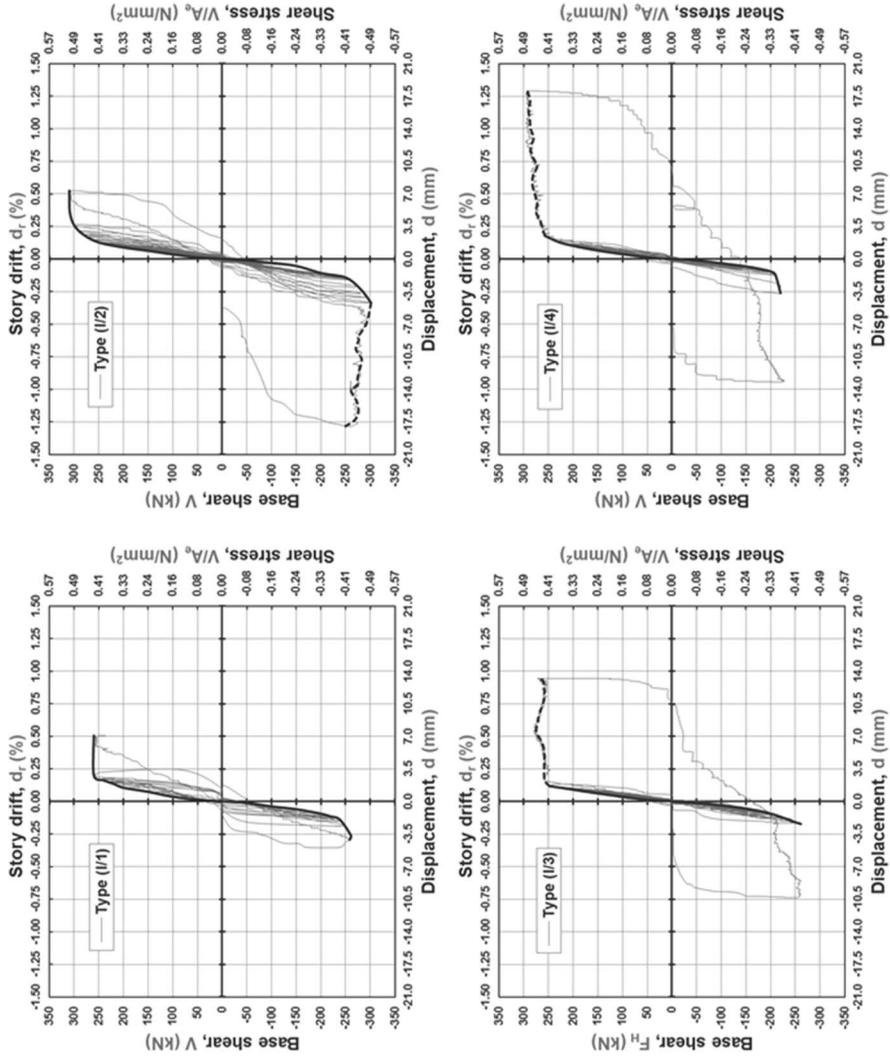
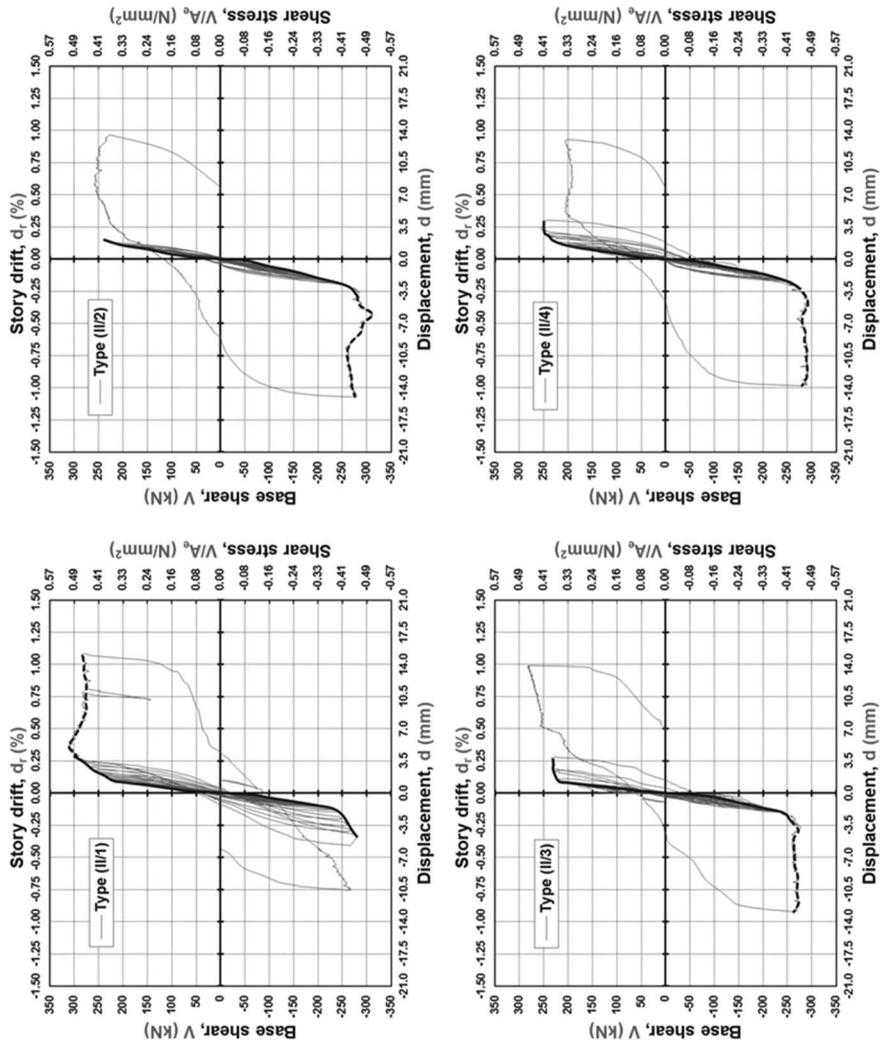
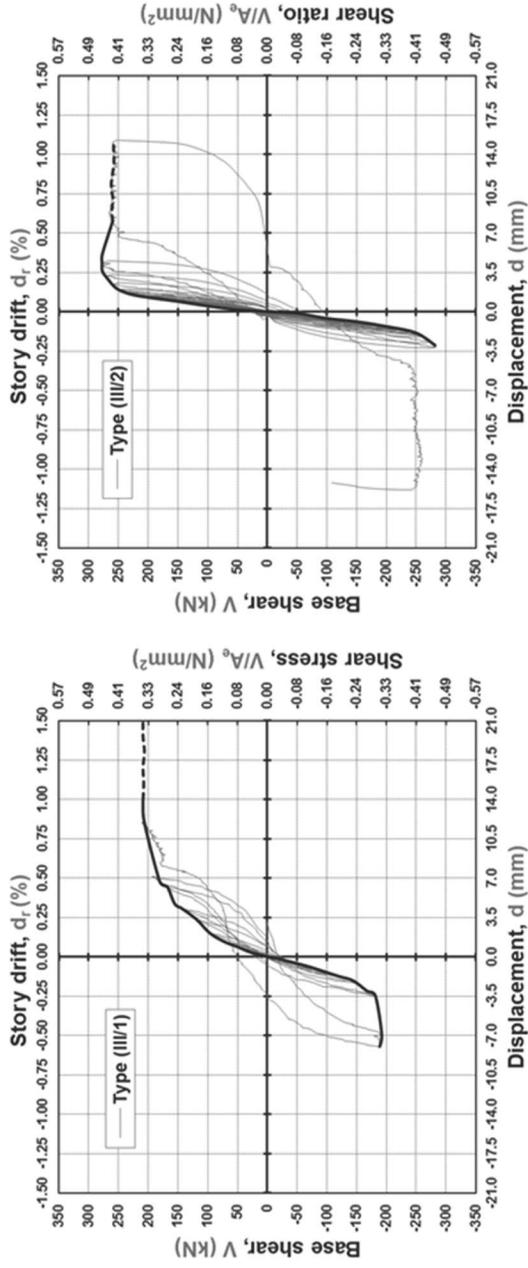
FIGURE 9 Group I specimens' hysteretic loops and resistance envelope curves.

FIGURE 10 Group II specimens' hysteretic loops and resistance envelope curves.

FIGURE 11 Group III specimens' hysteretic loops and resistance envelope curves.

Hysteretic loops (obtained from the second loading cycle) and the primary curves are presented in Figs. 9–11. The primary curves were obtained by connecting the peaks of these cycles (solid part) and extending further (dashed part) when the specimen was pushed from one (weak) side only (pushover). It should be noted that the difference between the

The behavior of masonry infilled specimens was linear-elastic up to the slight damage level (story drift range 0.05–0.10%). Then the stiffness decreased and lateral resistance increased. At the moderate damage level (story drift range 0.20–0.30%) the specimens reached lateral load capacity and maintained it, or showed a slight increase of lateral resistance up to drifts of 0.50%. Degradation started then and the lateral load capacity reached that of the bare frame at drifts of about 1.0%. Measured results, obtained from the primary curves, are presented in Tables 3 and 4.

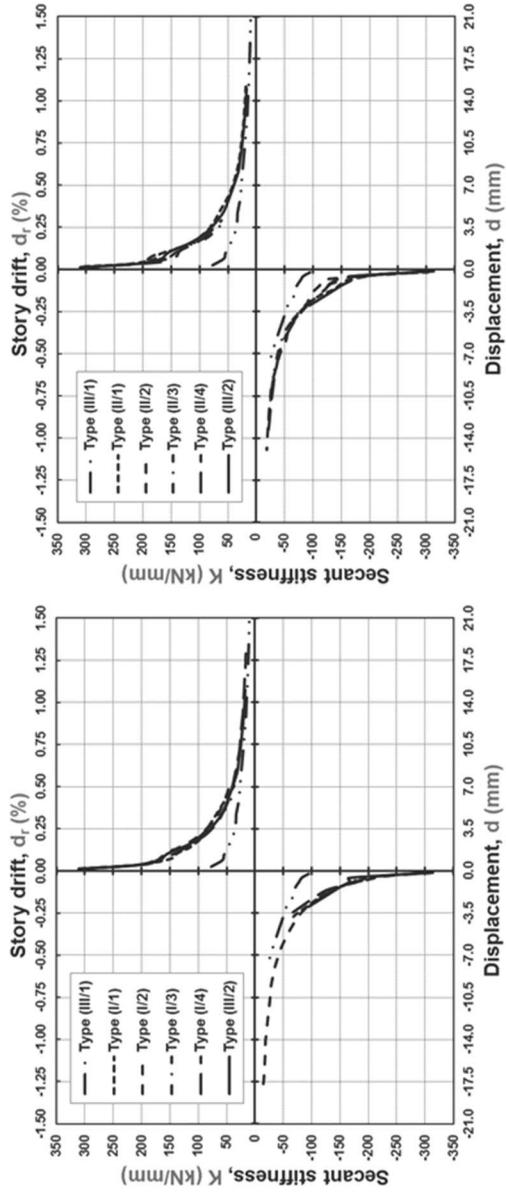
FIGURE 12 Specimen's secant stiffness degradation curves.

Measured values of the secant stiffnesses (K) for various drifts are given in Table 5. The ratios of K/K_0 , where K_0 represents the initial secant stiffness, are also presented. Degradation (changes) of the specimens' secant stiffness in respect to drift is shown in Fig. 12.

The contribution of the masonry infill to the overall “framed-wall” stiffness decreased with increasing drifts and was about 2.8 times at moderate, 1.5 times at heavy, and negligible at pre-collapse damage levels. Secant stiffnesses of the infilled specimens were similar within the observed drifts. They decreased exponentially and were approximately 50% of the initial value at slight, 30% at moderate, 15% at heavy, and 5% at close to collapse drift levels. Infills with the tie columns had higher stiffness at the same drifts and decreased more slowly. The contribution of tie columns became noticeable at increased drifts and was 14% at heavy and 56% at close to collapse drift levels.

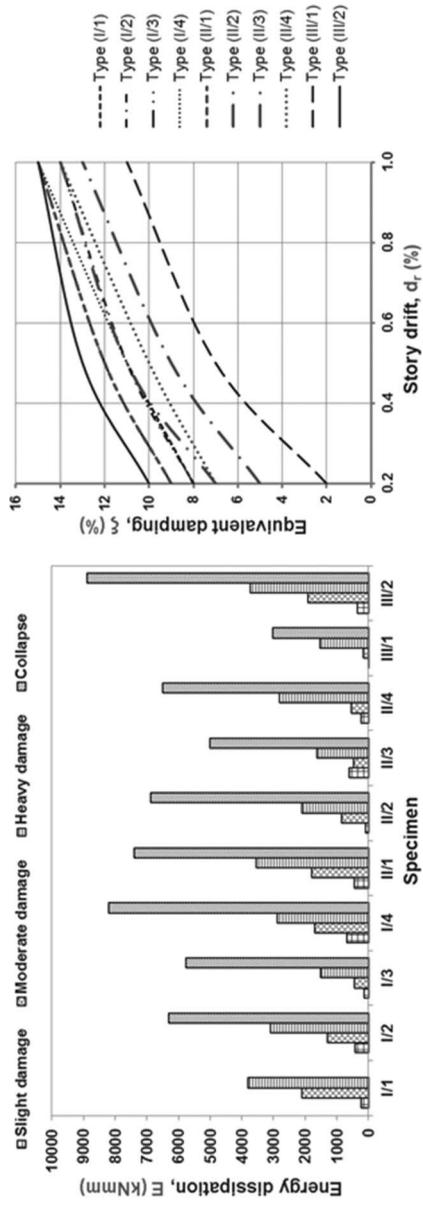
FIGURE 13 Hysteretic energy dissipated (a) and equivalent damping at different drifts (b).

Energy dissipation E (kNmm) was calculated as the sum of areas inside hysteresis loops up to a certain drift level. Calculated values and the ratio of the system's dissipated energy versus that of the bare frame ($III/1$) are given in Table 6 and in Fig. 13a. Dissipated hysteretic energy, at Slight and Moderate damage levels, of infilled specimens was between 5 and 20 times higher than that of the bare frame. The ratio decreased at heavy damage and collapse drifts to about twice as high.

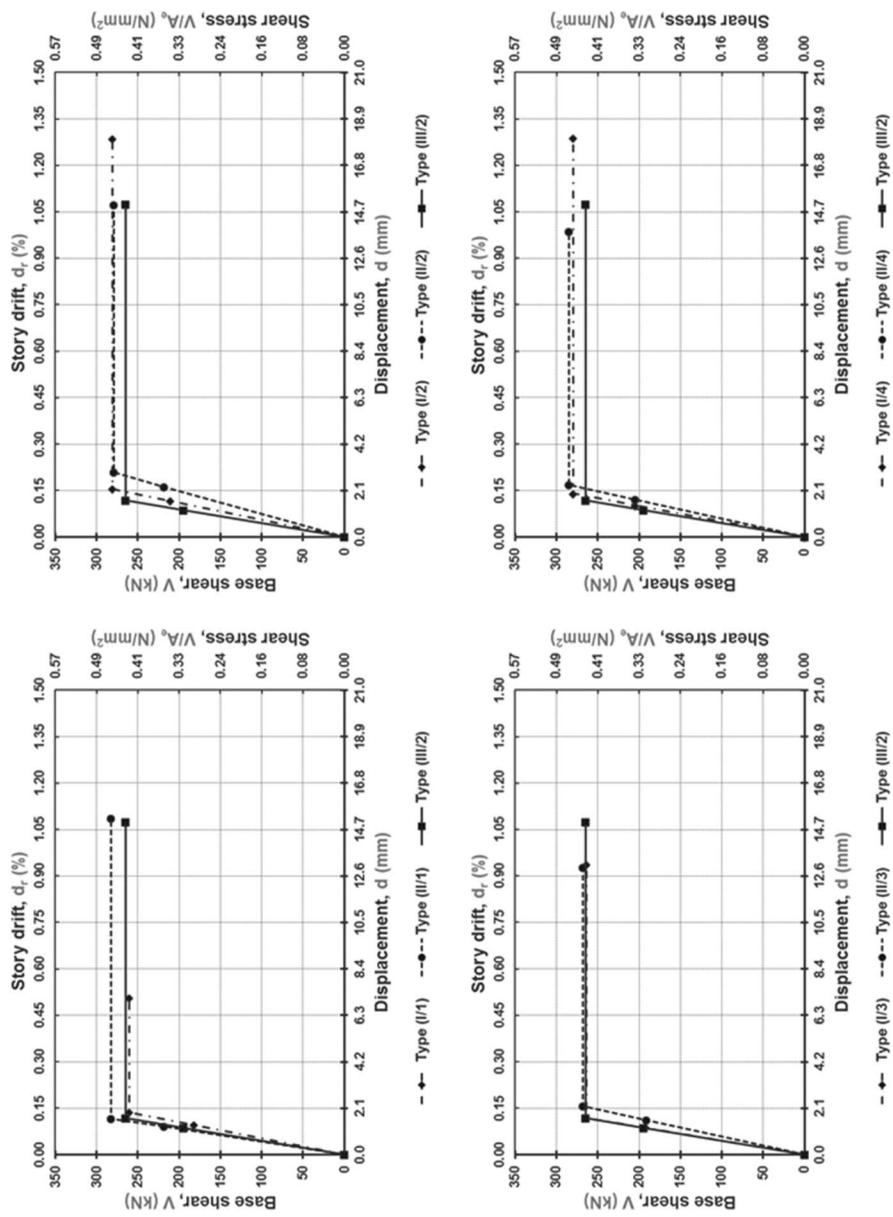
FIGURE 14 Idealized bilinear envelope curves of the specimens' weak side.

Obtained resistance envelope curve of the specimens, subjected to constant vertical and cyclic lateral load, was represented by the equivalent bilinear envelope, as given in Tomažević [1999]. The envelope was obtained by equalizing the area above- and below the primary curve for the weaker side of the specimen, as given in Fig. 14. Three limit states were defined: crack limit, determined by the resistance $V_{cr} = 0.7 \cdot V_u$ and displacement d_{cr} ; maximum resistance V_{max} and displacement d_{vmax} ; and ultimate resistance, determined by the maximum displacement d_u and corresponding resistance V_u .

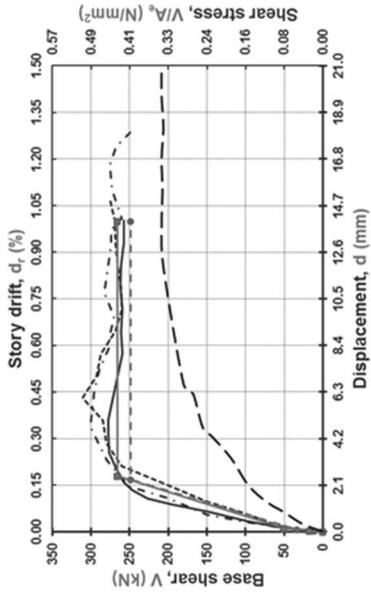
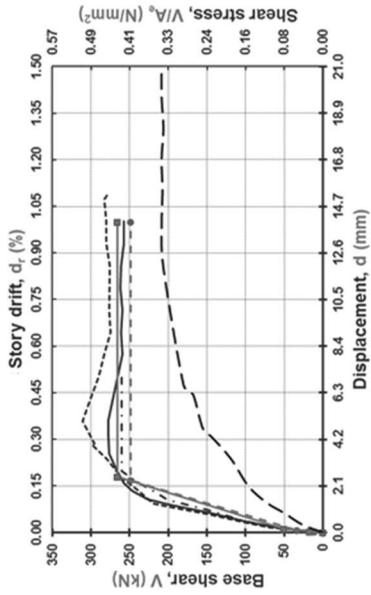
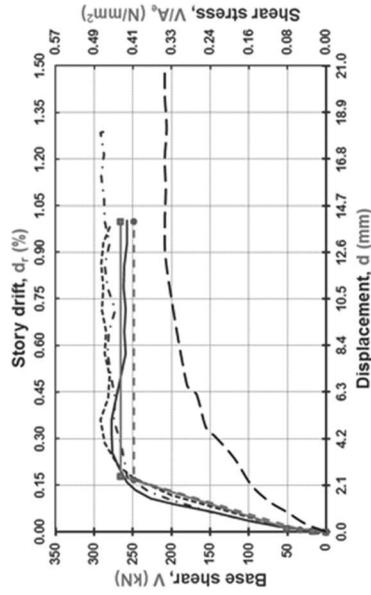
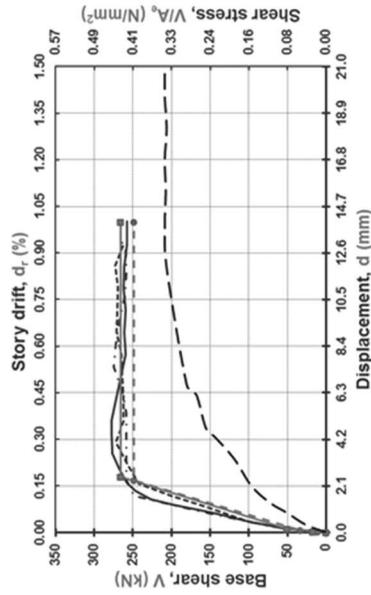
FIGURE 15 Measured and analytically estimated primary curves (weaker side).

After the ultimate resistance, the envelope extends horizontally up to drifts when the infill collapsed (1.0%). Calculated results are presented in Fig. 15 for the cases with (AWO) and without opening (AWOO), along with the measured primary curves. Differences

The cracking (V_{cr}) and yielding load (V_{Re}) correspond to the slight and moderate damage levels. These were seriously underestimated by the analytical approach. In the experiment, yielding of the bare frame occurred at drift of about 1.0%. Its contribution was overestimated at small drifts where the infill carried the major load portion. The calculated contribution of the frame at these drifts presented the major part of the Ultimate load (V_{Ru}) — in the experiments it was different. This could be verified by comparing the primary curves for framed-wall and the bare frame. Drifts calculated by the analytical approach were very low and the stiffness was overestimated for about four times. Opening type, size, position, and presence of the tie-columns had no influence on the calculated shear values.
