BACK TO THE FUTURE – ANDRIJA MOHOROVIČIĆ LECTURE (1909) & ZAGREB (2020) M5.5 EARTHQUAKE

Abstract: This review paper relates original Mohorovičić, A. lecture *DJELOVANJE POTRESA NA ZGRADE* (1909, 1911) and its English translation *EARTHQUAKE EFFECTS ON BUILDINGS* (2009) with M5.5 Zagreb 2020 earthquake damage. Mohorovičić said in Introduction of his lecture in 1909: “another strong earthquake is needed to remind people that the building techniques should be further developed and improved...”. Oliver Wendell Holmes (1809-1894) said once: “The young man knows the rules, but the old man knows the exceptions”. This should remind us that going **Back to the Future** after strong earthquake, we must go **Back to the Past**, and look after **Mohorovičić’s 15 rules how to build earthquake-resistant buildings**. He tells us how to build, and unfortunately, we were left unprepared again and didn’t listen wisdom words of an “old man”.

Review paper

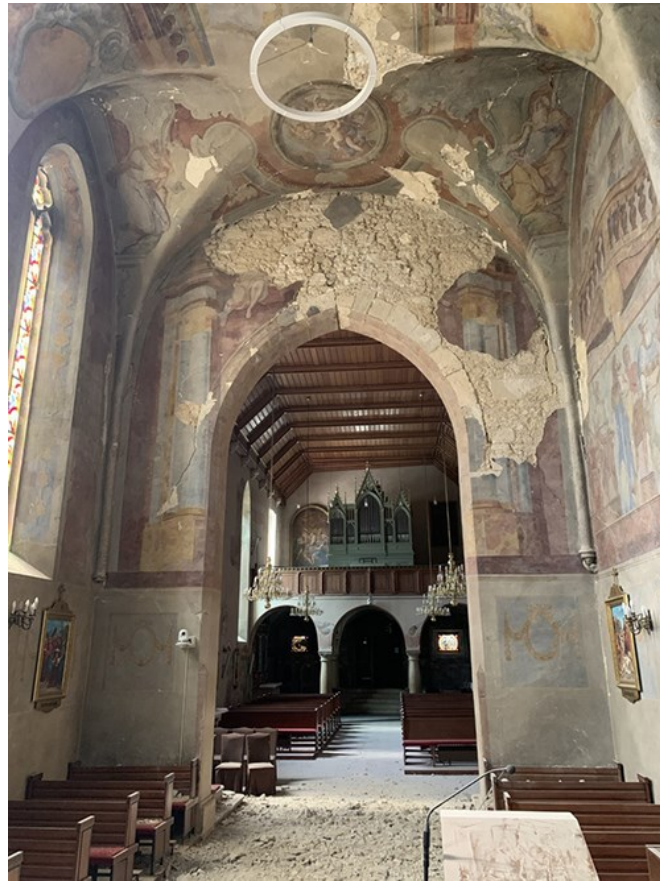
Figure 7. Damage to cultural heritage: Shrine of Saint Mary of Remete from 1786
<https://www.24sata.hr/news/pogledajte-trenutak-potresa-u-crkvi-u-remetama-u-zagrebu-682565>

The problem of building performance, as observed in **Figures 4 to 8**, lies partially in inadequate design with respect to corresponding seismic demand, and in other part in lack of implementation, or lack in general, of available research solutions for their protection (e.g. the heritage building Shrine of Saint Mary of Remete dating from 1786 shown in **Figure 7** was already once severely damaged in 1880 Zagreb earthquake). For the seismic safety purposes, it is therefore required to adopt and enforce the seismic rules and regulations (e.g. see **Table 1**), with particular attention to cultural heritage sites.

With respect to **Figures 4 to 8** and Mohorovičić's 15 advices stated in **Table 1**, one can easily correlate e.g. rules 10 to 15 with building damage in **Figure 5** or rules 6 to 9 with building damage in **Figure 8**. **The cultural heritage buildings as those in Figures 4, 6 and 7, are very sensitive and require multidisciplinary approach.** The obstacles in effective implementation of the earthquake risk reduction rules (such as those stated in **Table 1**) arise when dealing with existing built environment. The detail and degree to which building's seismic performance could be improved for expected future events, meets the technical and non-technical obstacles. The latter is related unwillingness and/or inability due to lack of initiative, lack of finances or in general the lack of proper understanding of earthquake and its consequences. The technical part i.e. knowledge on building construction
