# Seismic Damage Index Spectra Considering Site Acceleration Records: The Case Study of a Historical School in Kermanshah

**Abstract:** The frequency content and time duration of earthquakes are as effective as the peak ground acceleration on structural damage. Therefore, using rapid seismic vulnerability assessment methods that consider the earthquake acceleration time history is noticeable. Kermanshah is a historical city that is generally affected by far-field earthquakes. Therefore, it is necessary to consider the effect of the low-frequency shocks in evaluating the vulnerability of buildings in this city. Herein, a historic school in Kermanshah is assumed as a case study and two well-known damage index formulas are used for determining the damage index spectra of this structure, considered as a single degree of freedom system. Then, the effective parameters of the damage index, including ductility, relative degradation of stiffness, and dissipated energy are determined from a nonlinear analysis of the structure under the effect of the most probable earthquake acceleration records. Finally, the damage index spectra can be used for rapid seismic vulnerability assessment of maso

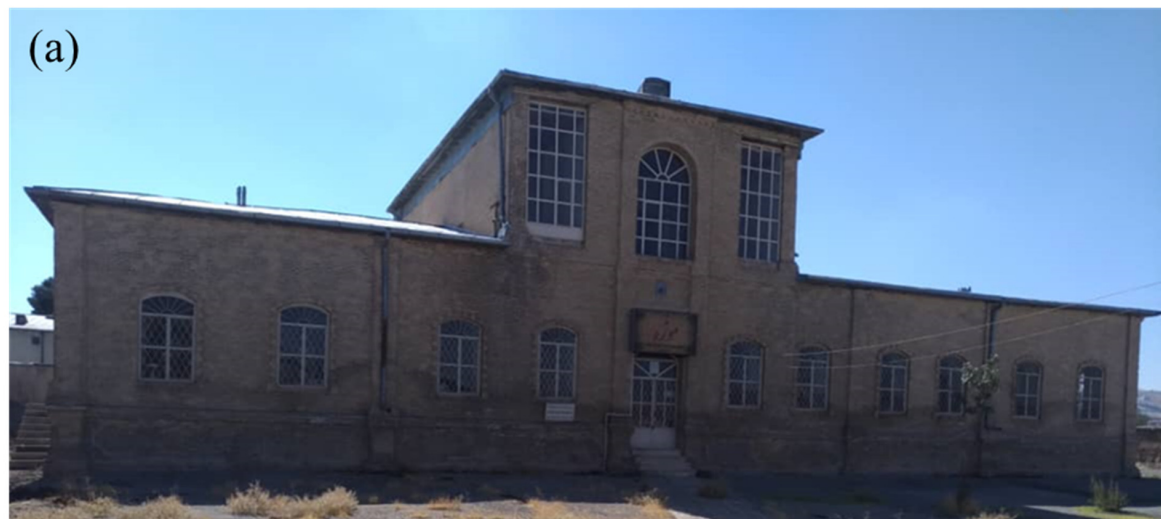
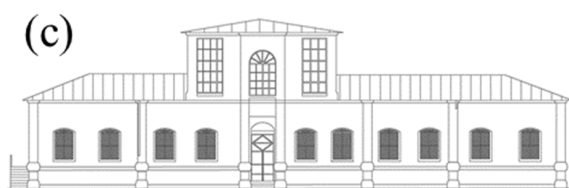
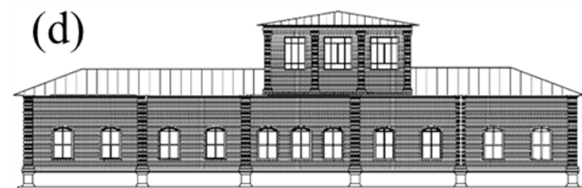
The architecture of the building is simple, and more than beautification, a rigorous appearance of the building has been preferred (Figure 1a). Only the brickwork of the facade represents an embellishment system of the building.

In 2006, during the renovation, the building plan changed, and some parts of the transverse walls of the classrooms were removed. Currently, the plan of the building is rectangular, 36 m long in the east–west direction and 16 m wide in the north–south direction (Figure 1b). A corridor with a width of 4.65 m and a length of 36 m (the whole building length) is located in the middle of the building. Classrooms are situated on both sides of this corridor. The width of the classrooms is 4 m, and their length varies from 6.15 to 12.9 m. The main entrance of the building is located on the north side, and another door is located on the east side. Figure 1c–g show the north, south, east, and west perspective views, respectively.

There is another floor in the center of the building, where there are the manager's office, the meeting hall, and the documents archive, along with two terraces on the north and south sides. The staircase is in the middle of the terrace on the north side, which, after renovation, has been surrounded by walls. The height of the first and second floors are 4.00 and 3.80 m, respectively. The wall materials are brick and lime mortar. The ceiling is made of a wooden beam and a gable roof placed on a wooden truss.

**Figure 1.** Kazazi High School: (a) north-view photo, (b) first-floor and second-floor plan (dimensions in centimeter), (c) north-view, (d) south-view, (e) east-view, (f) west-view, and (g) building perspective.
