Source / Izvornik: **Tehnički vjesnik, 2010, 17, 209 - 215**

TESTING OF PHYSICAL AND MECHANICAL PROPERTIES OF BRICKS AND MORTAR IN HISTORIC STRUCTURES

Mirjana Bošnjak-Klečina, Silva Lozančić

Preliminary notes

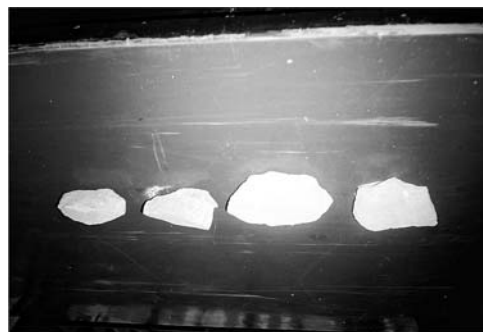
The samples are presented in Figures 4 and 5.

Figure 4 The samples removed from the building
Slika 4. Uzorci izvađeni iz građevine

Figure 5 Samples prepared for testing
Slika 5. Uzorci pripremljeni za ispitivanje

The old mortar samples were taken from the 18th century structure located at the Tvrdja in Osijek, built at the same time and with the same material as the observed structures. Because of the difficulties connected with finding the right undisturbed samples the scope of investigation has been limited. The samples were obtained by removing the mortar from the existing building.
