*Source / Izvornik:* **Tehnički vjesnik, 2010, 17, 209 - 215**

# TESTING OF PHYSICAL AND MECHANICAL PROPERTIES OF BRICKS AND MORTAR IN HISTORIC STRUCTURES

Preliminary notes

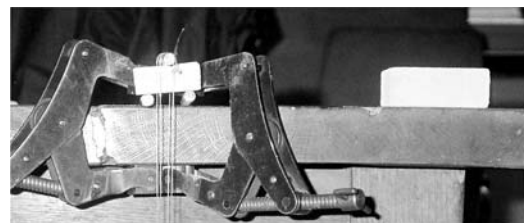
**Figure 5** Samples prepared for testing  
**Slika 5.** Uzorci pripremljeni za ispitivanje

The samples are presented in Figures 4 and 5.

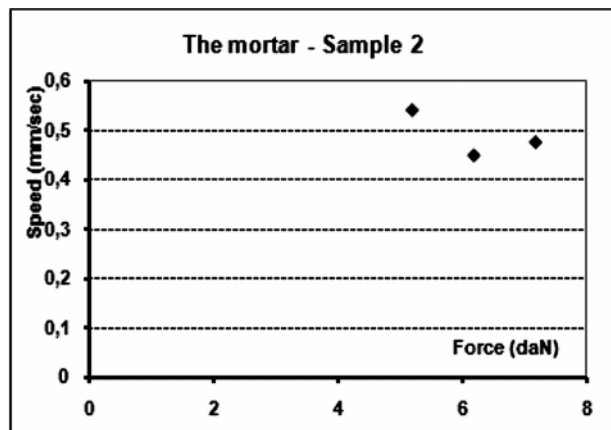
Figure 17 The mortar of strength 1,80 MPa  
Slika 17. Mort čvrstoće 1,80 MPa

samples), the total number of drillings being 72. Selected rotational speed of power drill was 600 rpm, the diameter of drilling bit was 6 mm (drilling bit for concrete, tempered steel tip). The expected drill depth was 40 mm. Time was measured for this depth of drilling at constant speed and force for all three holes (the number of holes on one sample was restricted by the size of the sample). It was evident that in tests on the samples of great strength there were almost no differences in the depth of drilling regarding the changes in applied force, while on the samples of compressive strength the samples failed because of their very small tensile strength. On the samples of medium strength, the functional relation of force (the added weight) and drilling time (Figures 16 and 17) may be foreseen. The shown penetration speeds correspond to the mean values in three measurements.
