*Source / Izvornik:* **Tehnički vjesnik, 2010, 17, 209 - 215**

# TESTING OF PHYSICAL AND MECHANICAL PROPERTIES OF BRICKS AND MORTAR IN HISTORIC STRUCTURES

*Mirjana Bošnjak-Klečina, Silva Lozančić*

Preliminary notes

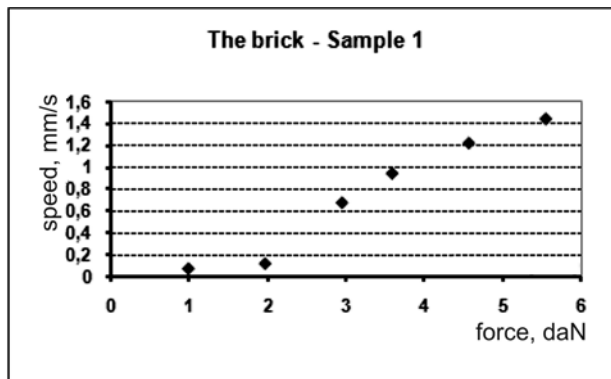
Figure 13 The brick of strength 14,50 MPa  
Slika 13. Opeka čvrstoće 14,50 MPa

force (penetration speed) was measured for each hole. The results are shown on the two samples of bricks from different manufactures. It is evident (Figures 13 and 14) that the relationship between the applied force and depth of drilling may be determined, and that it is almost linear. The shown penetration speeds for different weights are the mean values of five measurements.
