Source / Izvornik: **Tehnički vjesnik, 2009, 16, 45 - 50**

EXPERIMENTAL EXAMINATION OF EROSION THREATENED WATERFALLS ON TUFF BEDS PROTECTION – NATURAL LANDSCAPE, HISTORICAL AND CULTURAL VALUES ON THE EXAMPLE OF THE TOWN JAJCE

Vedran Ivanković, Zvonko Sigmund, Tomislav Ivanković

Preliminary notes

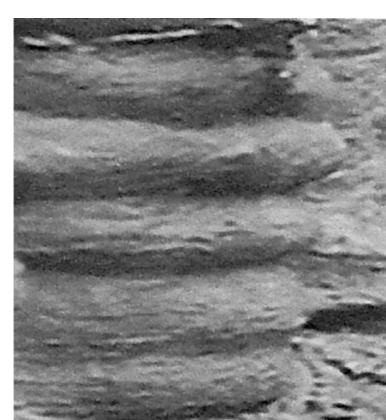
For tuff sand and dust jet grouting with one-fluid-direct injecting can be used, which for uses flow of cement suspension destruction and bonding of the ground. This technique is used for materials that closely represent the composition and granulation of tuff sand and dust. The body of injected mass that was dug resembled hard tuff with homogenous texture (Figure 10).

Figure 10 Ground after jet grouting
Slika 10. Tlo injektirano mlaznim postupkom

Comparing the samples injected with micro-cement to the samples after jet grouting it is easy to see that jet grouting leaves larger amount of pure cement. In extremely heterogeneous tuff sediments, though, jet grouting is questionable in regions with caverns and hard tuff.
