# BACK TO THE FUTURE – ANDRIJA MOHOROVIČIĆ LECTURE (1909) & ZAGREB (2020) M5.5 EARTHQUAKE

**Abstract:** This review paper relates original Mohorovičić, A. lecture *DJELOVANJE POTRESA NA ZGRADE* (1909, 1911) and its English translation *EARTHQUAKE EFFECTS ON BUILDINGS* (2009) with M5.5 Zagreb 2020 earthquake damage. Mohorovičić said in Introduction of his lecture in 1909: “another strong earthquake is needed to remind people that the building techniques should be further developed and improved...”. Oliver Wendell Holmes (1809-1894) said once: “The young man knows the rules, but the old man knows the exceptions”. This should remind us that going **Back to the Future** after strong earthquake, we must go **Back to the Past**, and look after **Mohorovičić’s 15 rules how to build earthquake-resistant buildings**. He tells us how to build, and unfortunately, we were left unprepared again and didn’t listen wisdom words of an “old man”.

Review paper

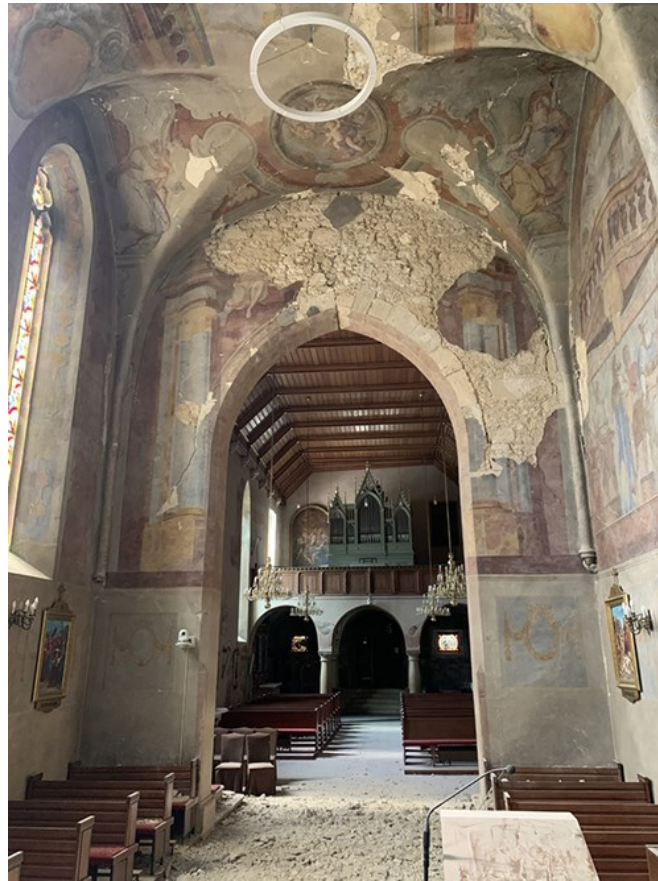
The problem of building performance, as observed in **Figures 4 to 8**, lies partially in inadequate design with respect to corresponding seismic demand, and in other part in lack of implementation, or lack in general, of available research solutions for their protection (e.g. the heritage building Shrine of Saint Mary of Remete dating from 1786 shown in **Figure 7** was already once severely damaged in 1880 Zagreb earthquake). For the seismic safety purposes, it is therefore required to adopt and enforce the seismic rules and regulations (e.g. see **Table 1**), with particular attention to cultural heritage sites.

**Figure 7.** Damage to cultural heritage: Shrine of Saint Mary of Remete from 1786  
<https://www.24sata.hr/news/pogledajte-trenutak-potresa-u-crkvi-u-remetama-u-zagrebu-682565>

With respect to **Figures 4 to 8** and Mohorovičić's 15 advices stated in **Table 1**, one can easily correlate e.g. rules 10 to 15 with building damage in **Figure 5** or rules 6 to 9 with building damage in **Figure 8**. **The cultural heritage buildings as those in Figures 4, 6 and 7, are very sensitive and require multidisciplinary approach.** The obstacles in effective implementation of the earthquake risk reduction rules (such as those stated in **Table 1**) arise when dealing with existing built environment. The detail and degree to which building's seismic performance could be improved for expected future events, meets the technical and non-technical obstacles. The latter is related unwillingness and/or inability due to lack of initiative, lack of finances or in general the lack of proper understanding of earthquake and its consequences. The technical part i.e. knowledge on building construction
