Analysis of the effects of a wastewater treatment plant failure on the Drava river water quality

Source / Izvornik: **E-GFOS, 2016, 7, 57 - 65**

Abstract: 1D model of the Drava River, between 00 + 543 rkm and 69 +118 rkm, was created by the MIKE 11 river-modeling tool. The aim of this model was to analyze the river water quality (WQ). Compared to the real Drava River section, the model was simplified to exclude any tributaries for the purpose of the water quality analysis. The inflow boundary was specified upstream, in addition to the WQ parameters (dissolved oxygen (DO), temperature, ammonia nitrogen, nitrate nitrogen, total phosphorus and orthophosphate, and five-day biochemical oxygen demand (BOD₅)). The water level and open boundary conditions were specified at the downstream end of section. The WQ parameters, mentioned earlier, were also defined at the Belišće wastewater treatment plant (WWTP) (54 + 373 rkm) and at the wastewater outlet near Osijek (14 + 580 rkm). The model was then used to simulate the effect on the WQ of the Drava River in a hypothetical extreme scenario: the 2-day failure of the Belišće WWTP. It was assumed that during this time untreated wastewater would

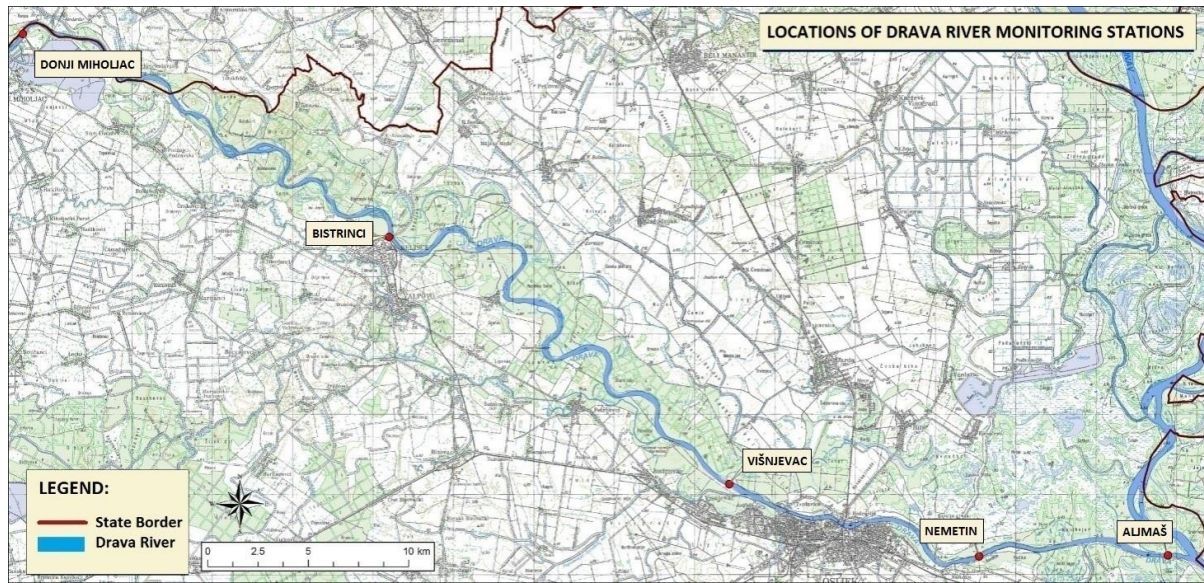
Figure 1 Locations of the gauging and water quality monitoring stations of the analyzed Drava River section

From a spatial point of view, modeling was conducted on the Drava River section between 69 + 118 and 00 + 543 rkm. In this section, the Drava flows through a number of cities such as Donji Miholjac, Bistrinci, Osijek, and Nemetin, where gauging stations for monitoring the water level and water quality of the river are also situated. The characteristic discharges recorded by the Donji Miholjac gauging station were $Q_{\min} = 152 \text{ m}^3/\text{s}$, $Q_{\text{av}} = 535 \text{ m}^3/\text{s}$, and $Q_{\max} = 2288 \text{ m}^3/\text{s}$ (1950 - 2013). Besides the wastewater treatment plant in Belišće, which is the main focus of this article (54 - 373 rkm), the other wastewater treatment plant in this Drava River section is located near Donji Miholjac. The wastewater discharge of the Osijek sewage system flows into the Drava River, downstream of the town, without any treatment. The locations of the gauging and water quality monitoring stations are presented in Figure 1.

Since the aim of this work was to model the water quality, it was necessary to specify the concentrations of substances entering the modeled area as well. At the upper boundary profile, input water quality parameters were entered as C90 values, measured by the Donji Miholjac monitoring station (Figure 1), i.e. the values of the quality indicators corresponding to the 90% quantile of not exceeding probability (exceeding for oxygen, O₂) of the monitored substance concentrations in the river. The MIKE 11 software offers the possibility to choose between six model levels for water quality modeling, corresponding to different sets of state variables for the water quality and/or different descriptions of the transformation of the state variables in the river [8]. Model level 4 was used for this simulation, which allowed for the modeling of the concentrations of dissolved oxygen (O₂), ammonia nitrogen (NH₄-N), nitrate nitrogen (NO₃-N), five day biochemical oxygen demand (BOD₅), and optional phosphorus (P) in dissolved and particular form. The values of the inserted water quality parameters are presented in Table 1.

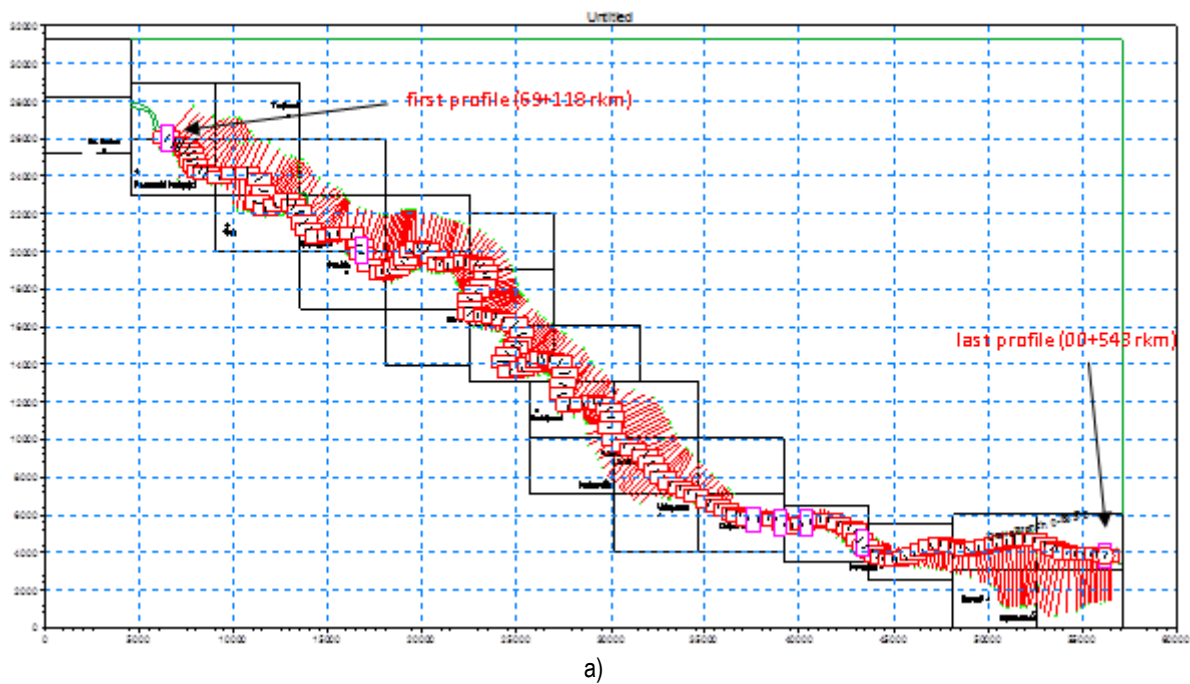
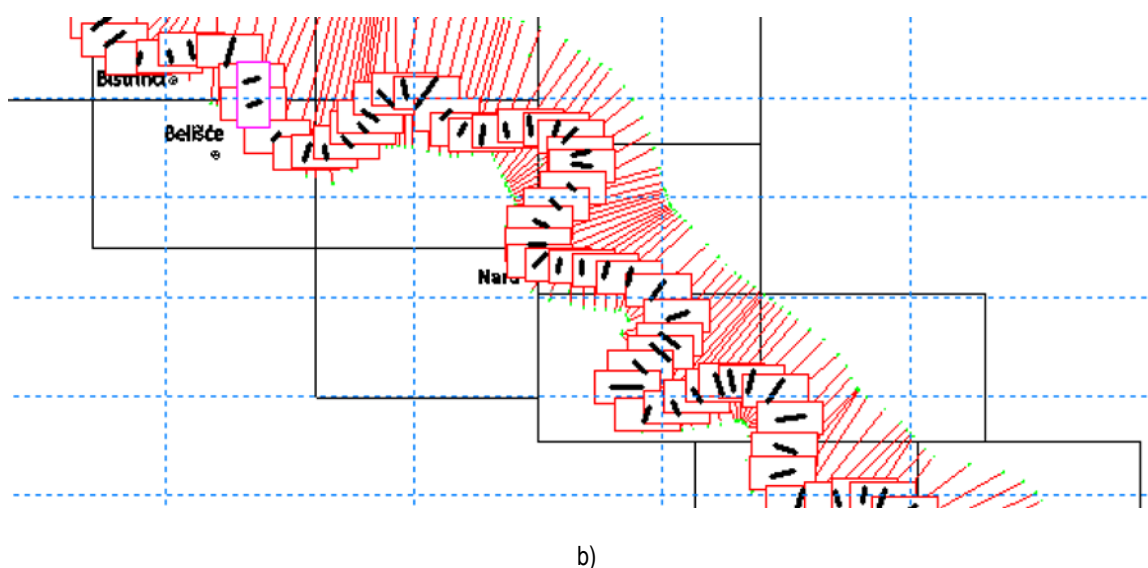
Figure 2 Ground plan of the modeled reach of the Drava River, with the locations of the defined cross-sections in the MIKE 11 software package (a) and Detail of the modeled reach of the Drava River with the locations of the defined cross-sections in the MIKE 11 software package (b)

The definition of the riverbed was made by the graphic editor of the MIKE 11 modeling software. Digital maps, in DWG format, were used as a basis for entering all the riverbed direction points and pollution points. Cross-sectional profiles were defined approximately every 400 m using a local coordinate system (width and depth) (Figure 2). It was also necessary to enter the absolute elevation and river chainage (river kilometer, rkm) of each particular cross-section.

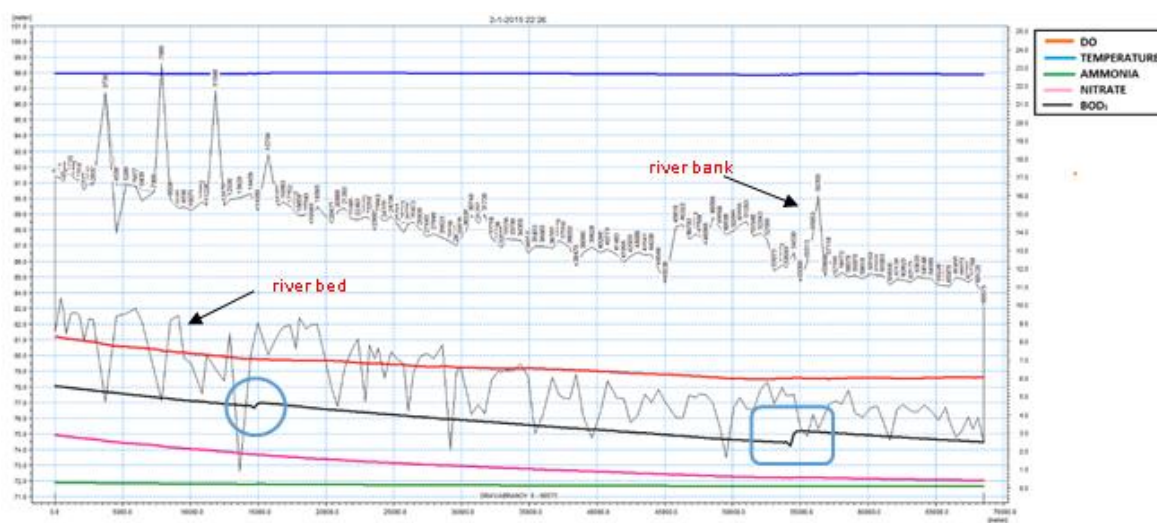
Figure 3 presents the behavior of the modeled water quality parameters after calibration across the longitudinal profile. The water temperature maintains its value throughout the longitudinal profile, with a downstream value of approximately 22.7 °C. The concentration of dissolved oxygen at the downstream end is 6.0 mg/l. The five-day biological oxygen demand rises when treated wastewater from the Belišće WWTP is released into the river (circle) and at the untreated wastewater outlet, downstream of Osijek (rectangle). By the end of the analyzed river section, it had dropped to a value of 2.5 mg/l. The nitrate nitrogen values and ammonia nitrogen downstream values were 0.5 mg/l and 0.01 mg/l, respectively. The calibration of these parameters was not conducted, therefore their values dropped towards zero (open boundary condition).

Figure 3 Time series window showing the longitudinal profile of the modeled reach, with concentration values of the modeled water quality parameters after calibration

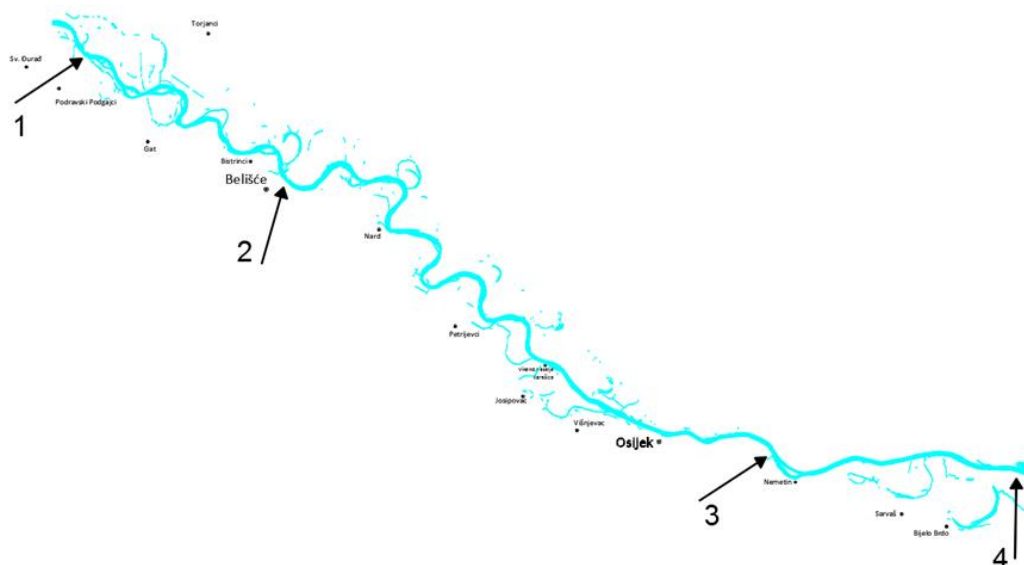
Figure 4 presents a schematic of the analyzed Drava River section. Numbers 1, 2, 3, and 4 represent cross-sections of the boundary conditions (1 and 4) and pollution sources (2 and 3) defined for the chosen modeling scenario:

- 1 ~ Upstream boundary condition → discharge and water quality parameters defined at 69 + 118 rkm
- 2 ~ Discharge and water quality parameters of the untreated sewage wastewater from the Beliše WWTP (54 + 373 rkm)
- 3 ~ Osijek sewage wastewater outlet (downstream of Osijek) (14 + 580 rkm)
- 4 ~ Downstream boundary condition → water level and open boundary condition defined at 00 + 543 rkm

Figure 4 Schematic of the Drava River section showing the specified input locations

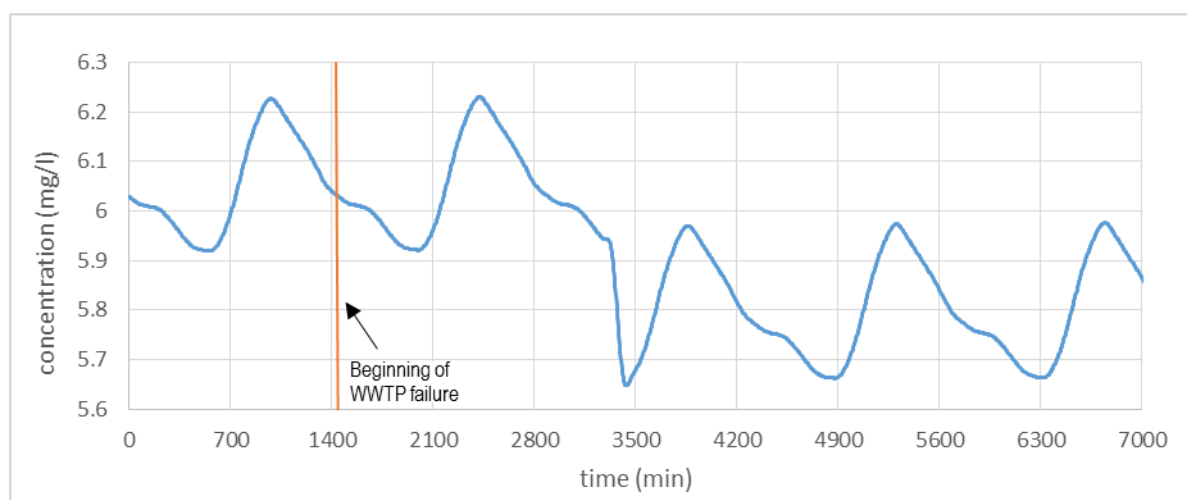
Figure 5 Change in dissolved oxygen concentration at 00 + 543 rkm in the period between January 14, 2015 (11:59 p.m.) and January 19, 2015 (11:59 p.m.)

Figure 5 illustrates the behavior of the dissolved oxygen concentration at the end of the analyzed river section (00 + 543 rkm) during a four-day period: a day before the failure, the two days during the failure, and one day after repair. A rapid decrease in dissolved oxygen can be noticed after approximately a day and a half, 2000 minutes after the failure (Figure 5). Because the observed cross-section is at the downstream end, 54 km away from the WWTP, it is logical to presume it took a certain amount of time for the lower quality wastewater to reach and flow

through the analyzed cross-section. The graph also shows oscillations in dissolved oxygen concentrations as a result of mixing with and transportation by natural river water.

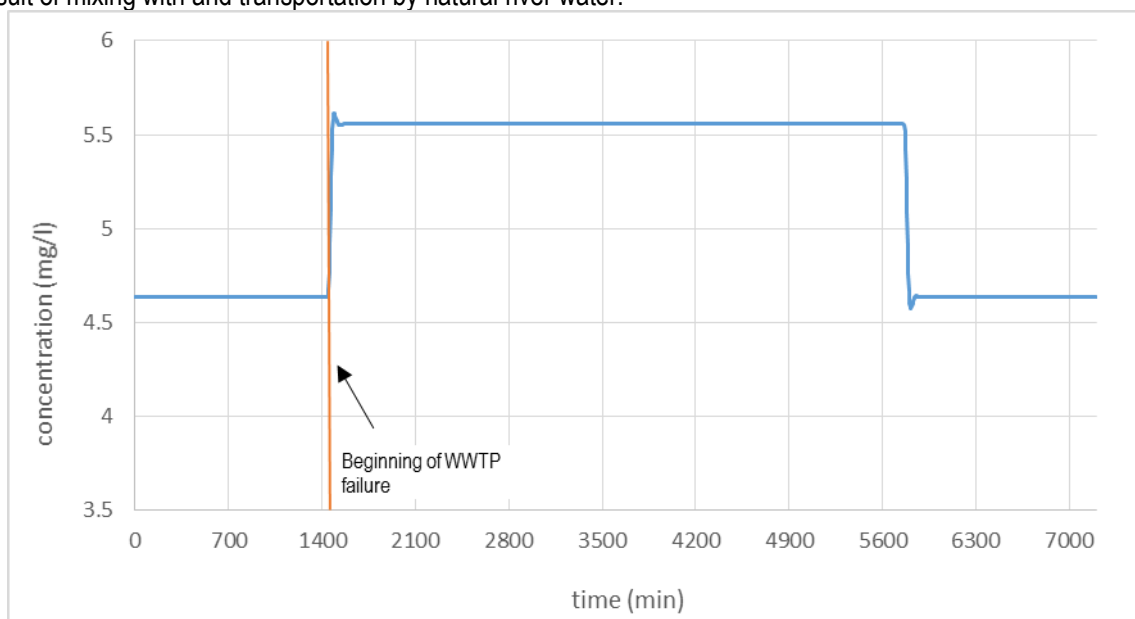
Figure 6 Change in BOD₅ concentration at 53 + 360 rkm in the period between January 14, 2015 (11:59 p.m.) and January 19, 2015 (11:59 p.m.)

Figure 6 presents the BOD₅ concentration change during a four-day period: a day before the failure, the two days during the failure, and one day after. There is a sharp increase in BOD₅ concentration at 1441 min, which is the time when failure occurred (midnight of January 16, 2015). Concentrations changed from 4.633 mg/l, prior to failure, to 5.556 mg/l, during failure. When the WWTP was repaired, the concentration immediately returned to the values observed before the failure. Although the WWTP failure caused an untreated wastewater flow with BOD₅ as high as 1867.64 mg/l, the concentrations of this parameter only increased by 0.923 mg/l in the river, since the WWTP is only discharging a small volume of water compared to that of the Drava River.

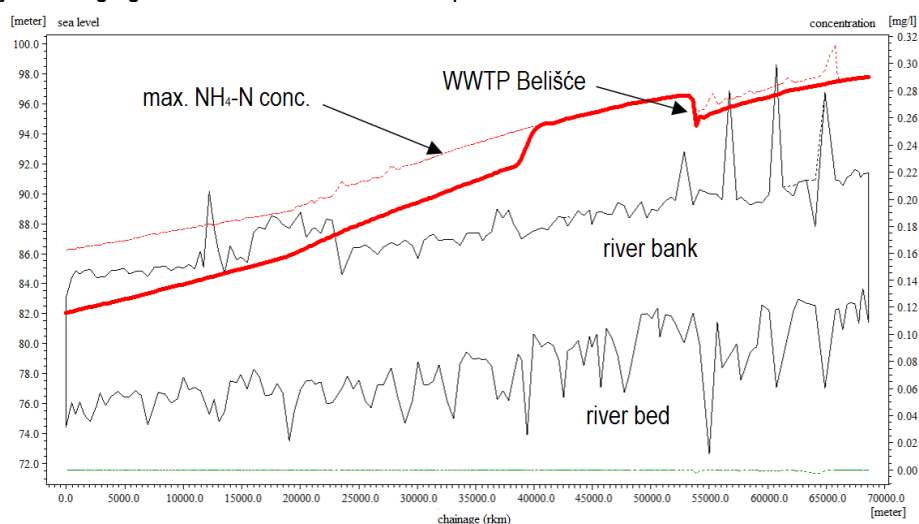
Figure 7 Spatial distribution of ammonia nitrogen concentration (NH₃-N) (mg/l) after the Beliše WWTP failure

Figure 7 shows the situation on January 17, 2015, at 7:39 a.m., more than 7 h after the WWTP failure. The increase of the ammonia nitrogen concentration has already been distributed in the river section downstream of the WWTP (approximately from 40 + 000 rkm to 55 + 000 rkm). The increased pollution concentration was then spread out across the whole downstream river section from the Beliše WWTP (see the line of maximum concentrations shown in Figure 7).
