Experimental examination of erosion threatened waterfalls on tuff beds protection : natural landscape, historical and cultural values on the example of the town Jajce

EXPERIMENTAL EXAMINATION OF EROSION THREATENED WATERFALLS ON TUFF BEDS PROTECTION – NATURAL LANDSCAPE, HISTORICAL AND CULTURAL VALUES ON THE EXAMPLE OF THE TOWN JAJCE

Preliminary notes

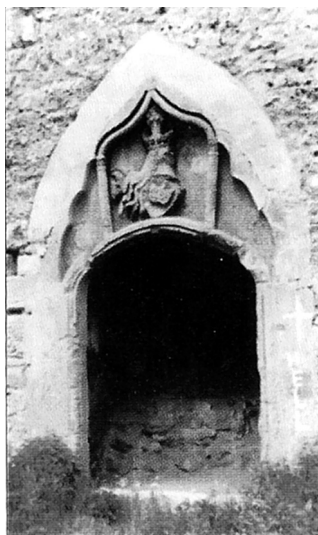
Figure 3 The Royal portal and emblem
Slika 3. Kraljevski portal i grb

- The Royal port with the shield of Kotromanić from 15th century. The emblem was shaped in tuff in Gothic style and is composed of a crown shaped like lily. The Crown, armor and flower bouquet are placed in the middle. The emblem was shaped in tuff in Gothic style, [2].
- The Banjaluka gate, earlier known as Franciscan doors, dating from the bricklaying time of Jajce. The main construction material is shaped tuff, [2].
