Source / Izvornik: **Journal of Earthquake Engineering, 2014, 18, 113 - 146**

Influence of Openings, With and Without Confinement, on Cyclic Response of Infilled R-C Frames — An Experimental Study

V. Sigmund & D. Penava

Faculty of Civil Engineering Osijek, Josip Juraj Strossmayer University of Osijek, Osijek, Croatia

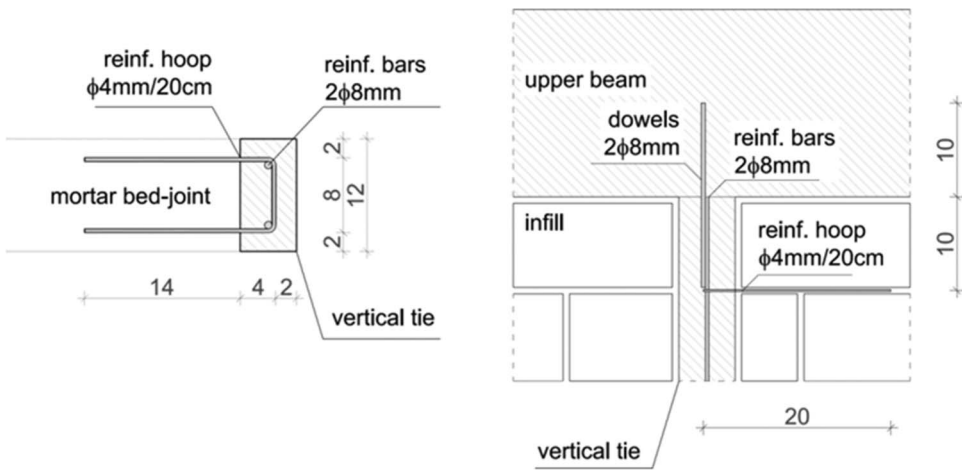
FIGURE 2 Tie-reinforcement details in the cross-section (left) and in elevation (right).

Vertical ties were reinforced with two longitudinal reinforcement bars, each of $\phi 8$ mm. These were anchored into the beams by dowels nailed 10 cm into previously drilled holes. Dowel stirrups, $\phi 4$ mm, were anchored into every second horizontal mortar joint. Reinforcing details are presented in Fig. 2. The lintel above the opening was reinforced by four longitudinal bars of $\phi 6$ mm with stirrups of $\phi 6$ mm placed at intervals of 9 cm.

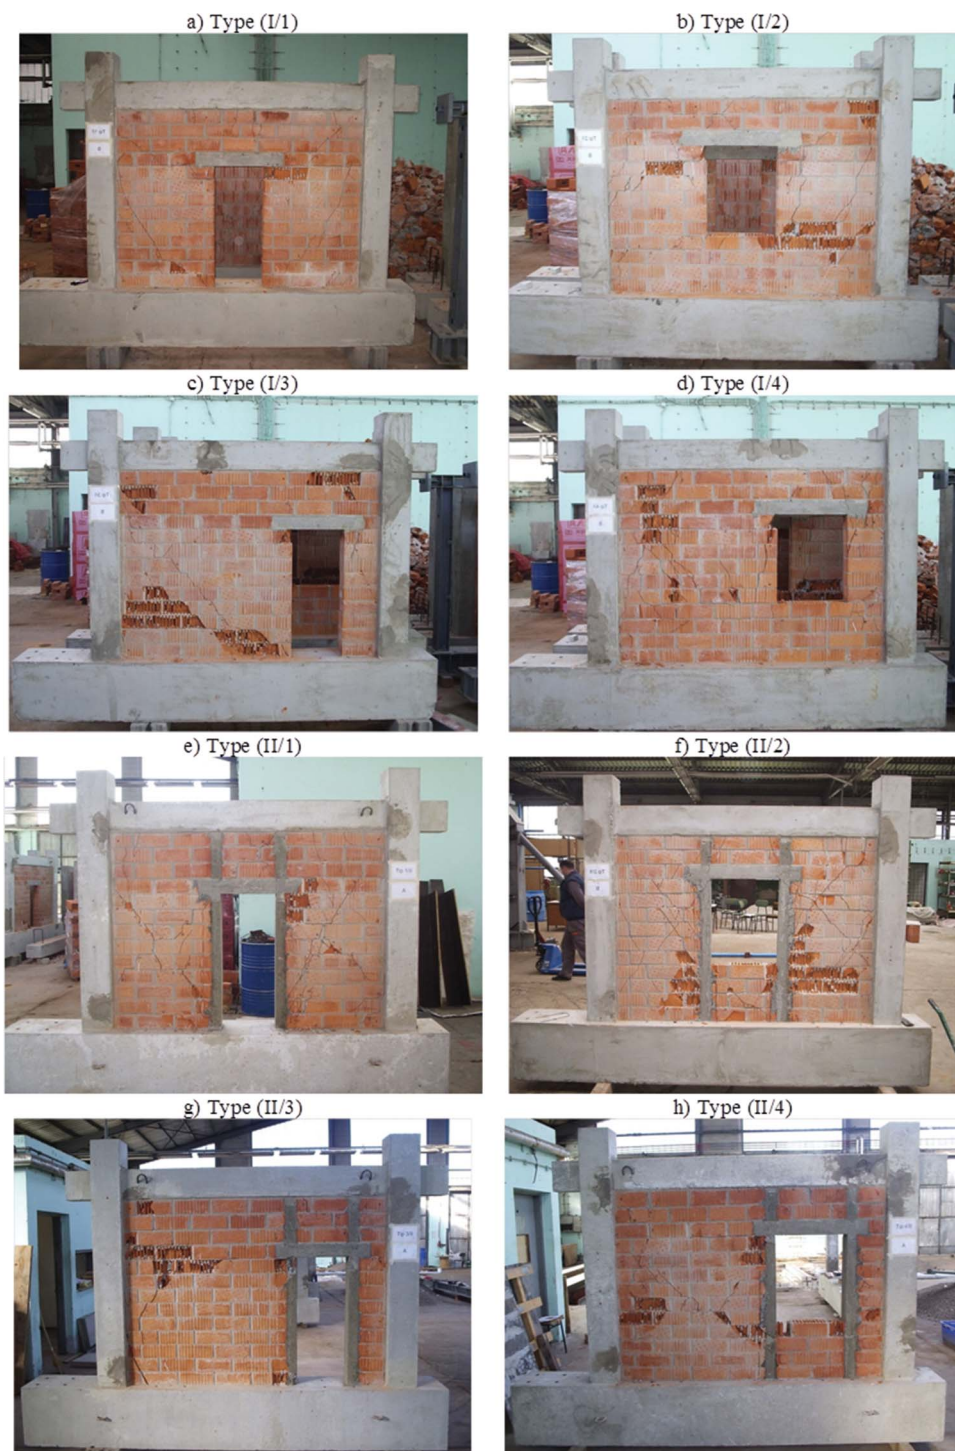
FIGURE 5 Specimens after the test (color figure available online).

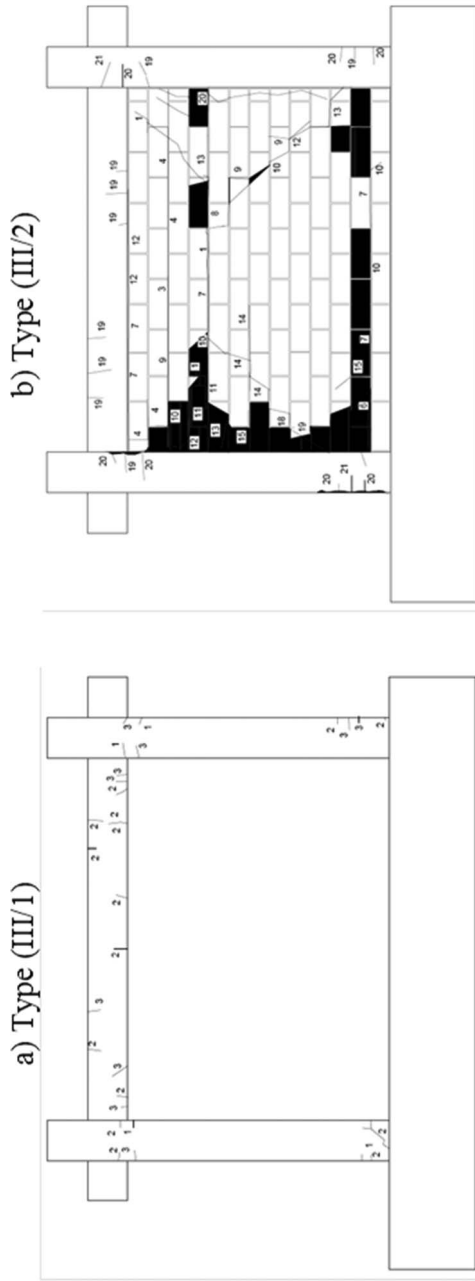
FIGURE 8 Group III specimens' crack patterns.

The reinforced-concrete frame yielded at a lateral displacement of ± 14.00 mm (drift $d_r = 1.00\%$) and horizontal load of 209 kN. Plastic hinges were formed at columns' bottoms and beam's ends. After-yield stiffness was about 5% of the initial value. The frame structure was able to carry the vertical load up to drifts of 2% without degradation. Strong column-weak beam flexural failure was dominant, and the observed crack pattern is shown in Fig. 8a.

The infill wall collapsed at lateral displacement ± 15.24 mm ($d_r = 1.09\%$) and horizontal load 254 kN. Diagonal tension cracks extended from the corners and bed-joint sliding occurred in the mid plane of the masonry infill. At the infill-column interface significant crushing of the masonry units occurred (Fig. 8b) and horizontal shear failure was dominant.

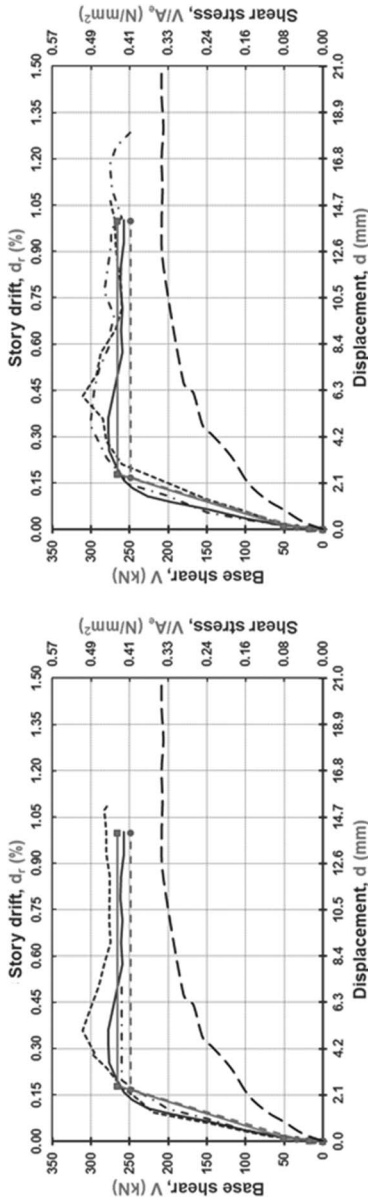
FIGURE 15 Measured and analytically estimated primary curves (weaker side).

After the ultimate resistance, the envelope extends horizontally up to drifts when the infill collapsed (1.0%). Calculated results are presented in Fig. 15 for the cases with (AWO) and without opening (AWOO), along with the measured primary curves. Differences

The cracking (V_{cr}) and yielding load (V_{Re}) correspond to the slight and moderate damage levels. These were seriously underestimated by the analytical approach. In the experiment, yielding of the bare frame occurred at drift of about 1.0%. Its contribution was overestimated at small drifts where the infill carried the major load portion. The calculated contribution of the frame at these drifts presented the major part of the Ultimate load (V_{Ru}) — in the experiments it was different. This could be verified by comparing the primary curves for framed-wall and the bare frame. Drifts calculated by the analytical approach were very low and the stiffness was overestimated for about four times. Opening type, size, position, and presence of the tie-columns had no influence on the calculated shear values.
