Source / Izvornik: **Journal of Earthquake Engineering, 2014, 18, 113 - 146**

Influence of Openings, With and Without Confinement, on Cyclic Response of Infilled R-C Frames — An Experimental Study

V. Sigmund & D. Penava

Keywords Infilled R-C Frames; Masonry Infill; Opening Type and Position; Confinement; Quasi-static Cyclic Loading; Analytical Verification

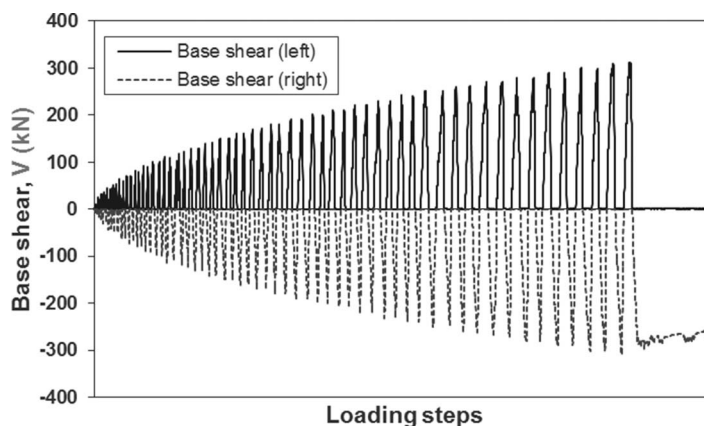
FIGURE 4 Recorded loading history.

The specimen's foundation beam was fixed to the steel frame and the floor. Four hydraulic actuators were fixed to the frame in order to simulate constant vertical and quasi-static lateral loadings. Vertical load, simulating loading from the upper floors, was applied to the specimen's columns' tops by means of two vertical hydraulic actuators of 500 kN capacity and ± 150 mm stroke. The load was kept constant at $N = 365$ kN by means of the pressure valves mounted on the actuators. Vertical hydraulic actuators were placed on carriage wheels that enabled the horizontal column's displacement and prevented its rotation. Two hydraulic actuators, of 350 kN capacity and stroke ± 150 mm, were fixed to the frame at beam level in order to simulate the cyclic in plane lateral load. It was applied quasi-statically and cyclically, first as force (at the initial stage up to yielding) and then as displacement controlled (after yielding), according to [FEMA 461, 2007]. The load was increased stepwise in a series of increments of 10 kN, repeating each step twice, until the structural system yielded. Then displacements were increased by increments of 1 mm until the drift of 1.0–1.2% was reached, or the masonry wall came out of plane. When the masonry infill wall was extensively damaged, lateral loading was applied from one side only, up to the infill's total failure. Recorded loading history is presented in Fig. 4.

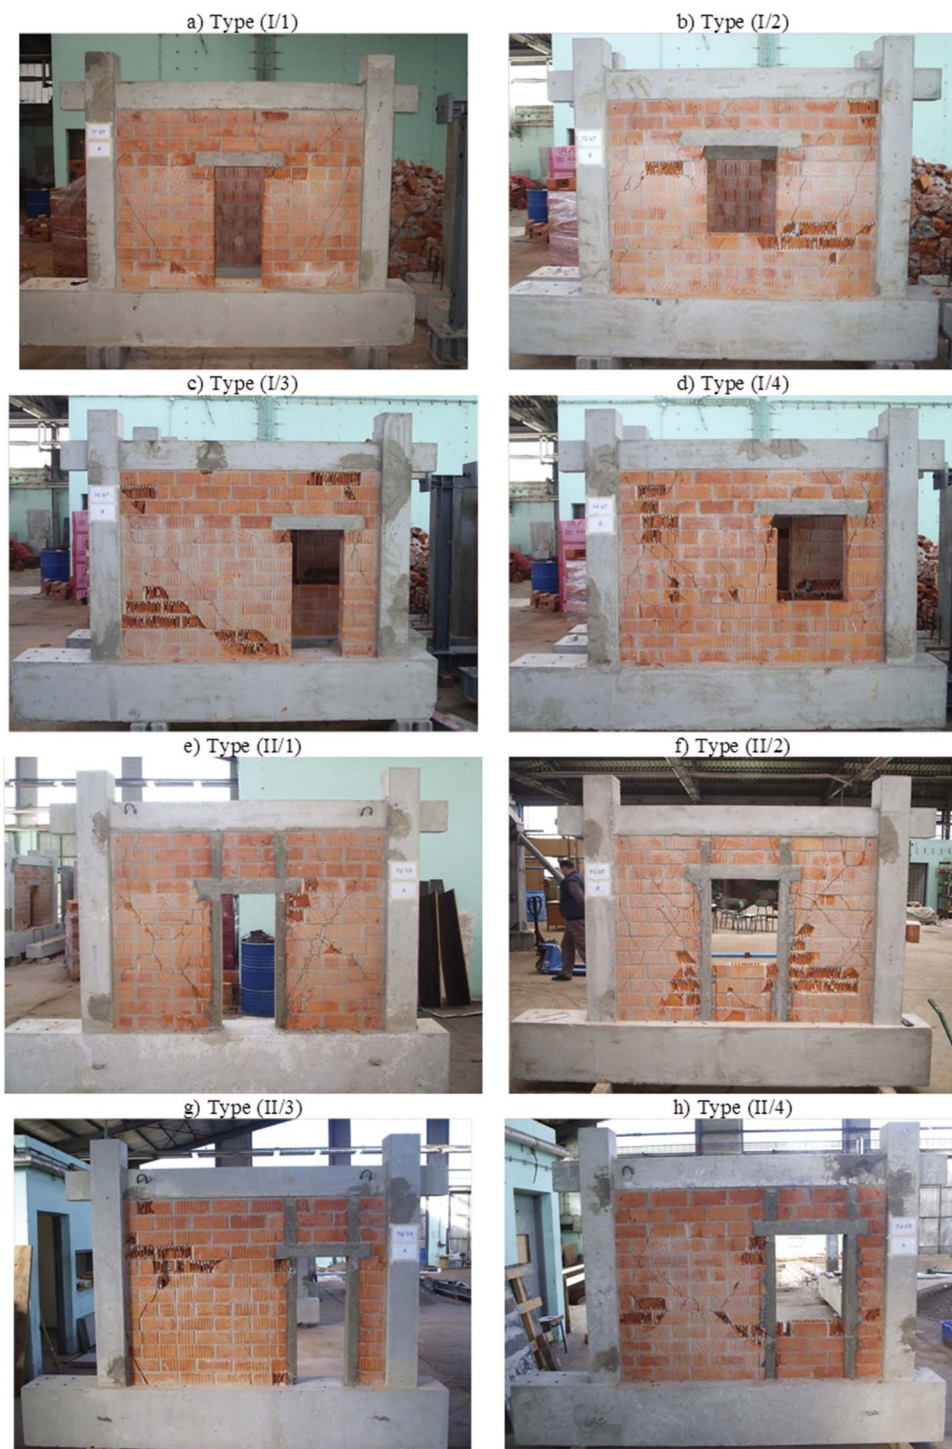
FIGURE 5 Specimens after the test (color figure available online).
