# Influence of Openings, With and Without Confinement, on Cyclic Response of Infilled R-C Frames — An Experimental Study

V. SIGMUND and D. PENAVA

**Keywords** Infilled R-C Frames; Masonry Infill; Opening Type and Position; Confinement; Quasi-static Cyclic Loading; Analytical Verification

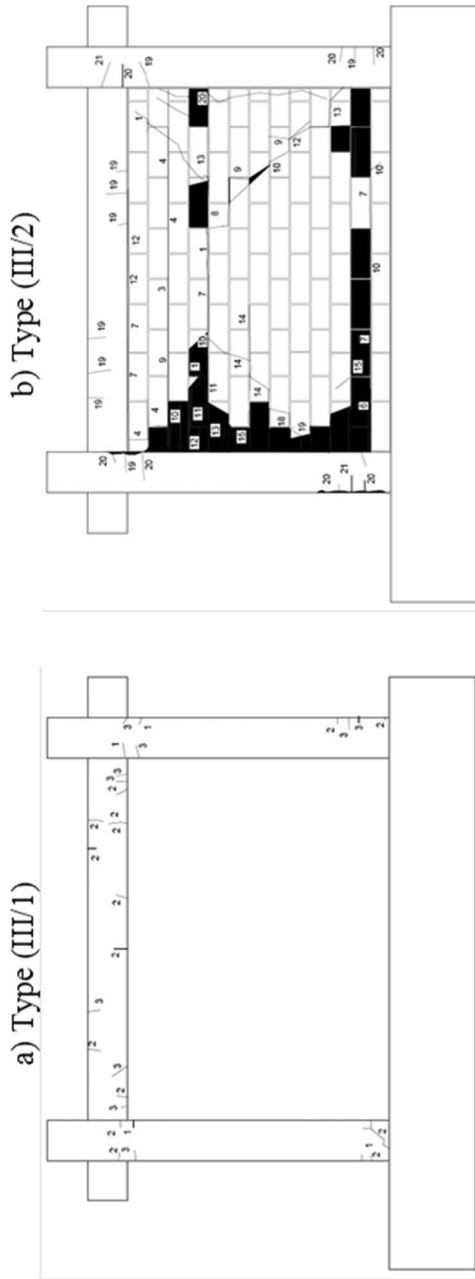
**FIGURE 8** Group III specimens' crack patterns.

The reinforced-concrete frame yielded at a lateral displacement of  $\pm 14.00$  mm (drift  $d_r = 1.00\%$ ) and horizontal load of 209 kN. Plastic hinges were formed at columns' bottoms and beam's ends. After-yield stiffness was about 5% of the initial value. The frame structure was able to carry the vertical load up to drifts of 2% without degradation. Strong column-weak beam flexural failure was dominant, and the observed crack pattern is shown in Fig. 8a.

The infill wall collapsed at lateral displacement  $\pm 15.24$  mm ( $d_r = 1.09\%$ ) and horizontal load 254 kN. Diagonal tension cracks extended from the corners and bed-joint sliding occurred in the mid plane of the masonry infill. At the infill-column interface significant crushing of the masonry units occurred (Fig. 8b) and horizontal shear failure was dominant.
