BACK TO THE FUTURE – ANDRIJA MOHOROVIČIĆ LECTURE (1909) & ZAGREB (2020) M5.5 EARTHQUAKE

Davor Stanko^{1*}, Snježana Markušić² & Davorin Penava³

Abstract: This review paper relates original Mohorovičić, A. lecture *DJELOVANJE POTRESA NA ZGRADE* (1909, 1911) and its English translation *EARTHQUAKE EFFECTS ON BUILDINGS* (2009) with M5.5 Zagreb 2020 earthquake damage. Mohorovičić said in Introduction of his lecture in 1909: “another strong earthquake is needed to remind people that the building techniques should be further developed and improved...”. Oliver Wendell Holmes (1809-1894) said once: “The young man knows the rules, but the old man knows the exceptions”. This should remind us that going **Back to the Future** after strong earthquake, we must go **Back to the Past**, and look after **Mohorovičić’s 15 rules how to build earthquake-resistant buildings**. He tells us how to build, and unfortunately, we were left unprepared again and didn’t listen wisdom words of an “old man”.

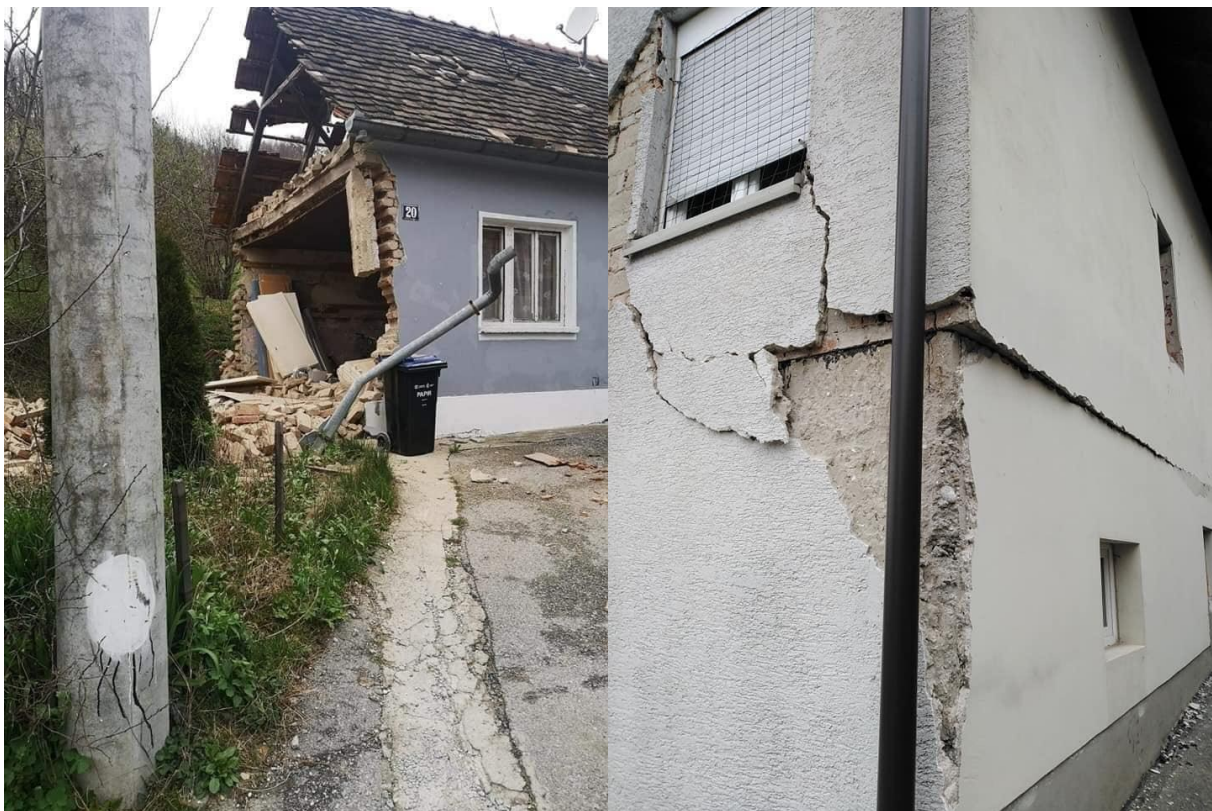
Figure 8. Heavily damaged family house near the epicenter.
<https://dnevnik.hr/vijesti/hrvatska/potres-u-zagrebu-ostali-bez-domova---598777.html>

The main shock was the strongest earthquake in Zagreb since the "Great Zagreb 1880 earthquake" and caused substantial damage in the historical city center. All were stunned with the damage of the top of the Cathedral's south tower (Figure 4). A numerous damage to the cultural and historical architectural heritage of the City of Zagreb have been reported (Figure 5). Many churches were heavily damaged (Figures 6 & 7) as well as the Croatian Parliament building. Most of the museums and theatres in the city's centre suffered also serious damage (e.g., the Museum of Arts and Crafts, the Croatian History Museum, the Schools Museum, Komedija Theatre, the Croatian National Theatre). Over 1,900 buildings (up to now) are reported to have become uninhabitable by the earthquake damage, particularly buildings built before 1964. In places around the epicenter, the situation was very bad because of the destroyed houses (Figure 8) (Markušić et al. 2020).

The problem of building performance, as observed in **Figures 4 to 8**, lies partially in inadequate design with respect to corresponding seismic demand, and in other part in lack of implementation, or lack in general, of available research solutions for their protection (e.g. the heritage building Shrine of Saint Mary of Remete dating from 1786 shown in **Figure 7** was already once severely damaged in 1880 Zagreb earthquake). For the seismic safety purposes, it is therefore required to adopt and enforce the seismic rules and regulations (e.g. see **Table 1**), with particular attention to cultural heritage sites.

With respect to **Figures 4 to 8** and Mohorovičić's 15 advices stated in **Table 1**, one can easily correlate e.g. rules 10 to 15 with building damage in **Figure 5** or rules 6 to 9 with building damage in **Figure 8**. **The cultural heritage buildings as those in Figures 4, 6 and 7, are very sensitive and require multidisciplinary approach.** The obstacles in effective implementation of the earthquake risk reduction rules (such as those stated in **Table 1**) arise when dealing with existing built environment. The detail and degree to which building's seismic performance could be improved for expected future events, meets the technical and non-technical obstacles. The latter is related unwillingness and/or inability due to lack of initiative, lack of finances or in general the lack of proper understanding of earthquake and its consequences. The technical part i.e. knowledge on building construction
