*Source / Izvornik:* **Environmental Engineering - Inženjerstvo okoliša, 2020, 7, 1 - 10**

## BACK TO THE FUTURE – ANDRIJA MOHOROVIČIĆ LECTURE (1909) & ZAGREB (2020) M5.5 EARTHQUAKE

Review paper

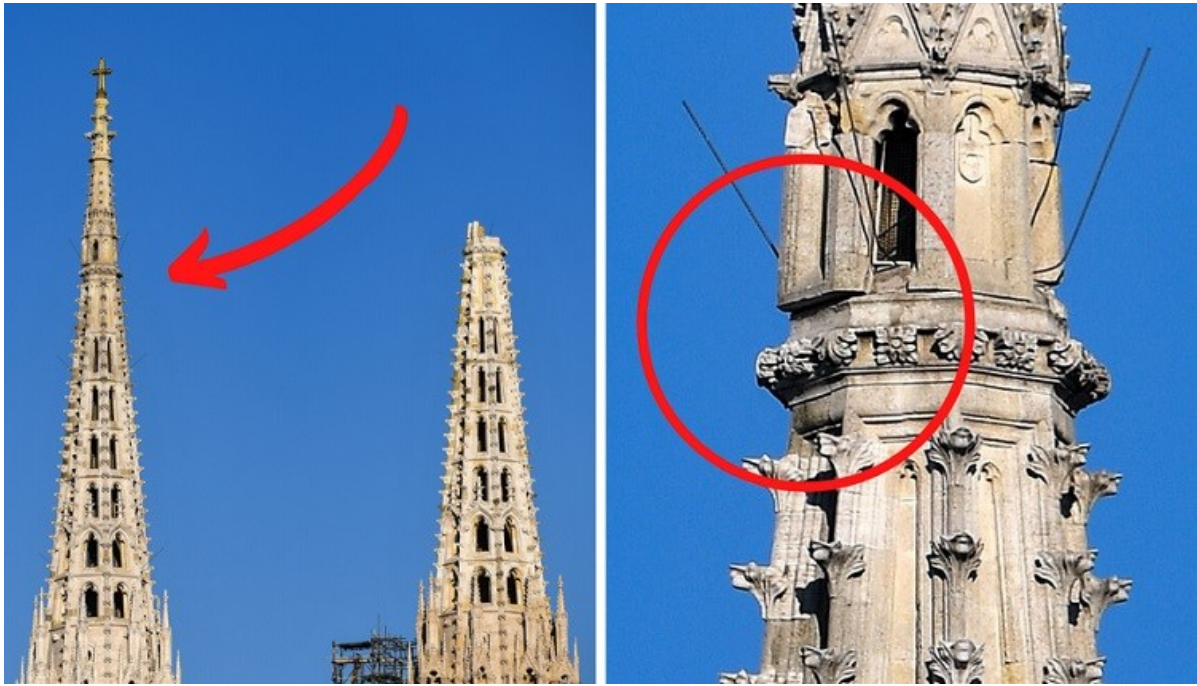
**Figure 4.** Damage of the top of the Cathedral's south tower. North tower was removed to limit further damage from aftershocks on 17 April 2020.

The main shock was the strongest earthquake in Zagreb since the "Great Zagreb 1880 earthquake" and caused substantial damage in the historical city center. All were stunned with the damage of the top of the Cathedral's south tower (Figure 4). A numerous damage to the cultural and historical architectural heritage of the City of Zagreb have been reported (Figure 5). Many churches were heavily damaged (Figures 6 & 7) as well as the Croatian Parliament building. Most of the museums and theatres in the city's centre suffered also serious damage (e.g., the Museum of Arts and Crafts, the Croatian History Museum, the Schools Museum, Komedia Theatre, the Croatian National Theatre). Over 1,900 buildings (up to now) are reported to have become uninhabitable by the earthquake damage, particularly buildings built before 1964. In places around the epicenter, the situation was very bad because of the destroyed houses (Figure 8) (Markušić et al. 2020).

The problem of building performance, as observed in **Figures 4 to 8**, lies partially in inadequate design with respect to corresponding seismic demand, and in other part in lack of implementation, or lack in general, of available research solutions for their protection (e.g. the heritage building Shrine of Saint Mary of Remete dating from 1786 shown in **Figure 7** was already once severely damaged in 1880 Zagreb earthquake). For the seismic safety purposes, it is therefore required to adopt and enforce the seismic rules and regulations (e.g. see **Table 1**), with particular attention to cultural heritage sites.

With respect to **Figures 4 to 8** and Mohorovičić's 15 advices stated in **Table 1**, one can easily correlate e.g. rules 10 to 15 with building damage in **Figure 5** or rules 6 to 9 with building damage in **Figure 8**. **The cultural heritage buildings as those in Figures 4, 6 and 7, are very sensitive and require multidisciplinary approach.** The obstacles in effective implementation of the earthquake risk reduction rules (such as those stated in **Table 1**) arise when dealing with existing built environment. The detail and degree to which building's seismic performance could be improved for expected future events, meets the technical and non-technical obstacles. The latter is related unwillingness and/or inability due to lack of initiative, lack of finances or in general the lack of proper understanding of earthquake and its consequences. The technical part i.e. knowledge on building construction

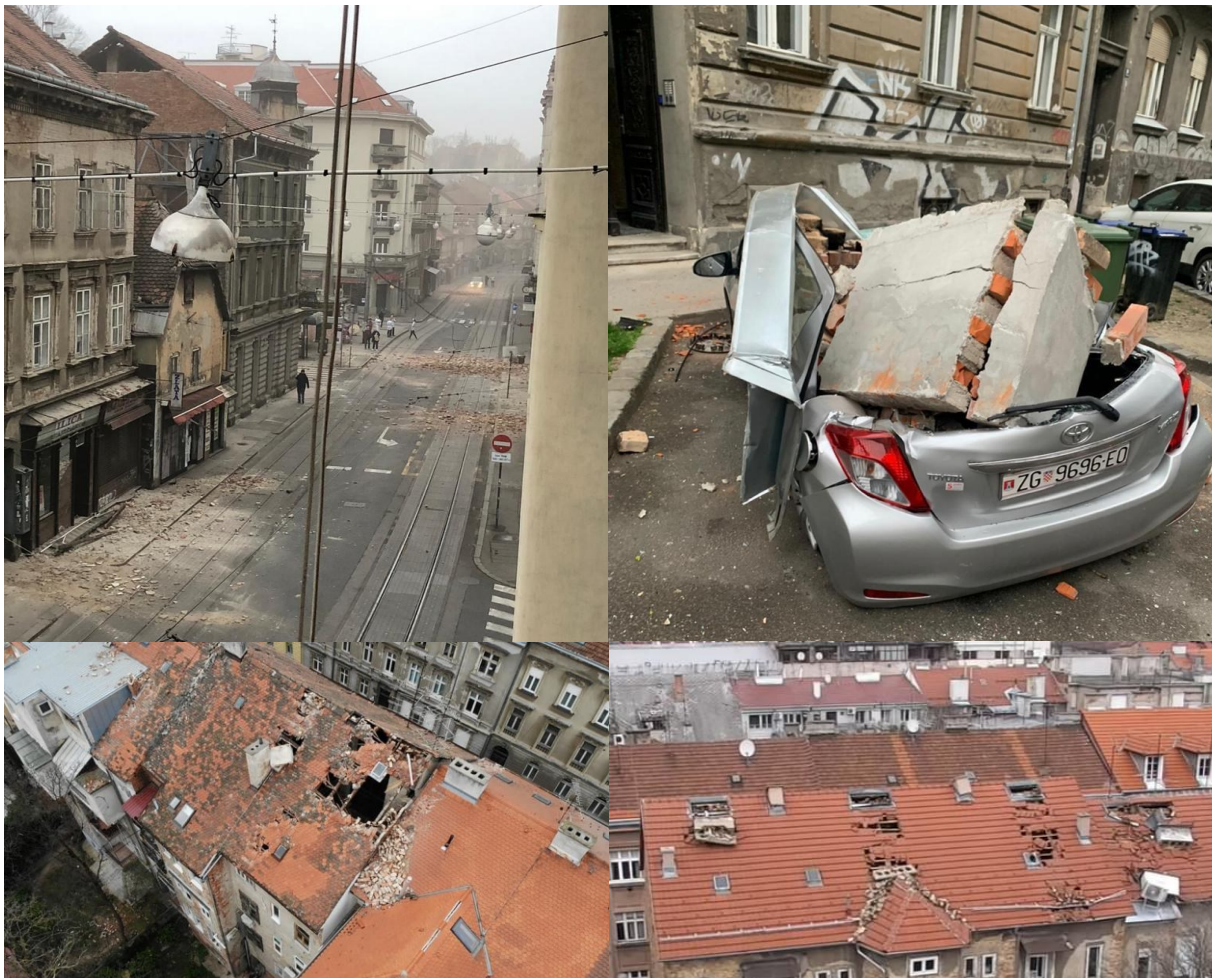
**Figure 5.** Damage in Zagreb after 22 March M5.5 earthquake. Noticeable roof tile loss and chimney collapse

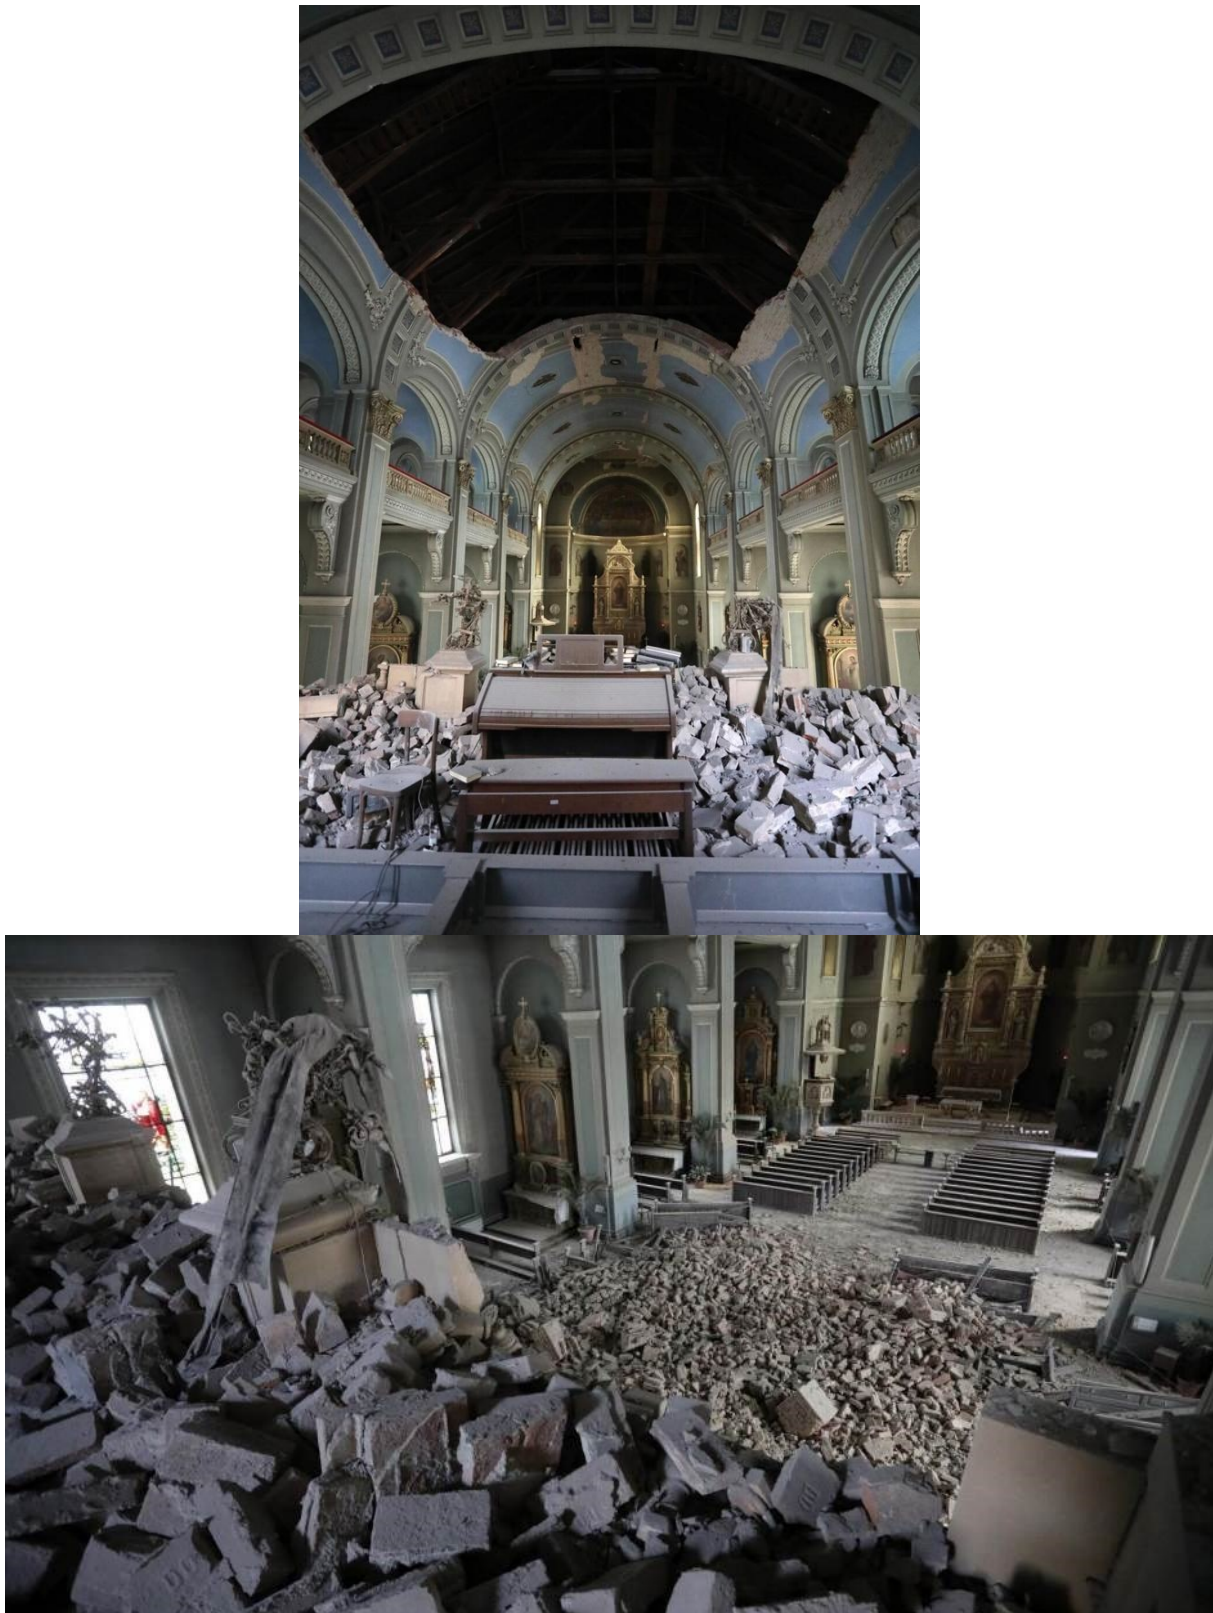
**Figure 6.** Damage to cultural heritage: Basilica of the Heart of Jesus from 1902  
<https://www.24sata.hr/news/crkva-u-palmiticevoj-unistena-urudio-se-strop-iznad-ulaza-682556>

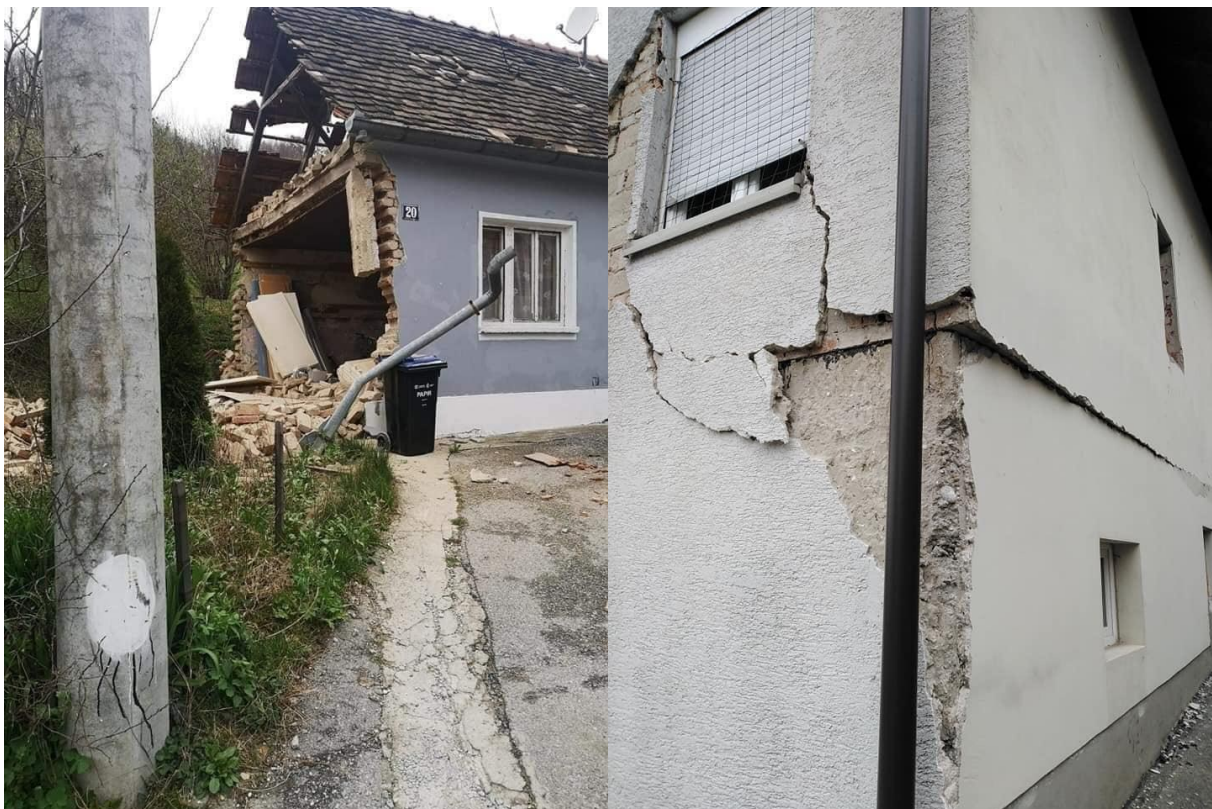
**Figure 8.** Heavily damaged family house near the epicenter.  
<https://dnevnik.hr/vijesti/hrvatska/potres-u-zagrebu-ostali-bez-domova---598777.html>
