BACK TO THE FUTURE – ANDRIJA MOHOROVIČIĆ LECTURE (1909) & ZAGREB (2020) M5.5 EARTHQUAKE

Davor Stanko^{1*}, Snježana Markušić² & Davorin Penava³

Abstract: This review paper relates original Mohorovičić, A. lecture *DJELOVANJE POTRESA NA ZGRADE* (1909, 1911) and its English translation *EARTHQUAKE EFFECTS ON BUILDINGS* (2009) with M5.5 Zagreb 2020 earthquake damage. Mohorovičić said in Introduction of his lecture in 1909: “another strong earthquake is needed to remind people that the building techniques should be further developed and improved...”. Oliver Wendell Holmes (1809-1894) said once: “The young man knows the rules, but the old man knows the exceptions”. This should remind us that going **Back to the Future** after strong earthquake, we must go **Back to the Past**, and look after **Mohorovičić’s 15 rules how to build earthquake-resistant buildings**. He tells us how to build, and unfortunately, we were left unprepared again and didn’t listen wisdom words of an “old man”.

Review paper

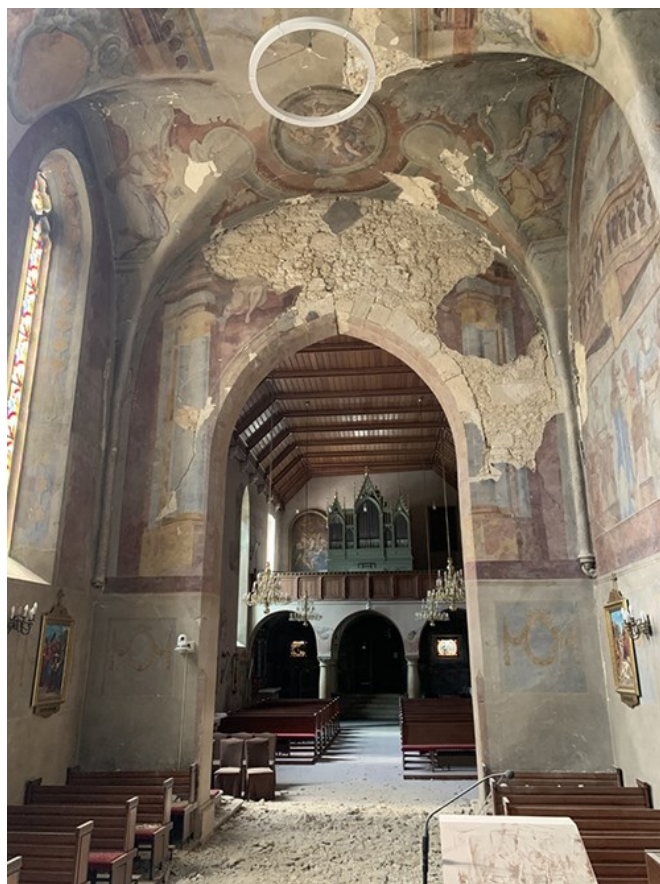
Figure 7. Damage to cultural heritage: Shrine of Saint Mary of Remete from 1786
<https://www.24sata.hr/news/pogledajte-trenutak-potresa-u-crkvi-u-remetama-u-zagrebu-682565>

The problem of building performance, as observed in **Figures 4 to 8**, lies partially in inadequate design with respect to corresponding seismic demand, and in other part in lack of implementation, or lack in general, of available research solutions for their protection (e.g. the heritage building Shrine of Saint Mary of Remete dating from 1786 shown in **Figure 7** was already once severely damaged in 1880 Zagreb earthquake). For the seismic safety purposes, it is therefore required to adopt and enforce the seismic rules and regulations (e.g. see **Table 1**), with particular attention to cultural heritage sites.

With respect to **Figures 4 to 8** and Mohorovičić's 15 advices stated in **Table 1**, one can easily correlate e.g. rules 10 to 15 with building damage in **Figure 5** or rules 6 to 9 with building damage in **Figure 8**. **The cultural heritage buildings as those in Figures 4, 6 and 7, are very sensitive and require multidisciplinary approach.** The obstacles in effective implementation of the earthquake risk reduction rules (such as those stated in **Table 1**) arise when dealing with existing built environment. The detail and degree to which building's seismic performance could be improved for expected future events, meets the technical and non-technical obstacles. The latter is related unwillingness and/or inability due to lack of initiative, lack of finances or in general the lack of proper understanding of earthquake and its consequences. The technical part i.e. knowledge on building construction

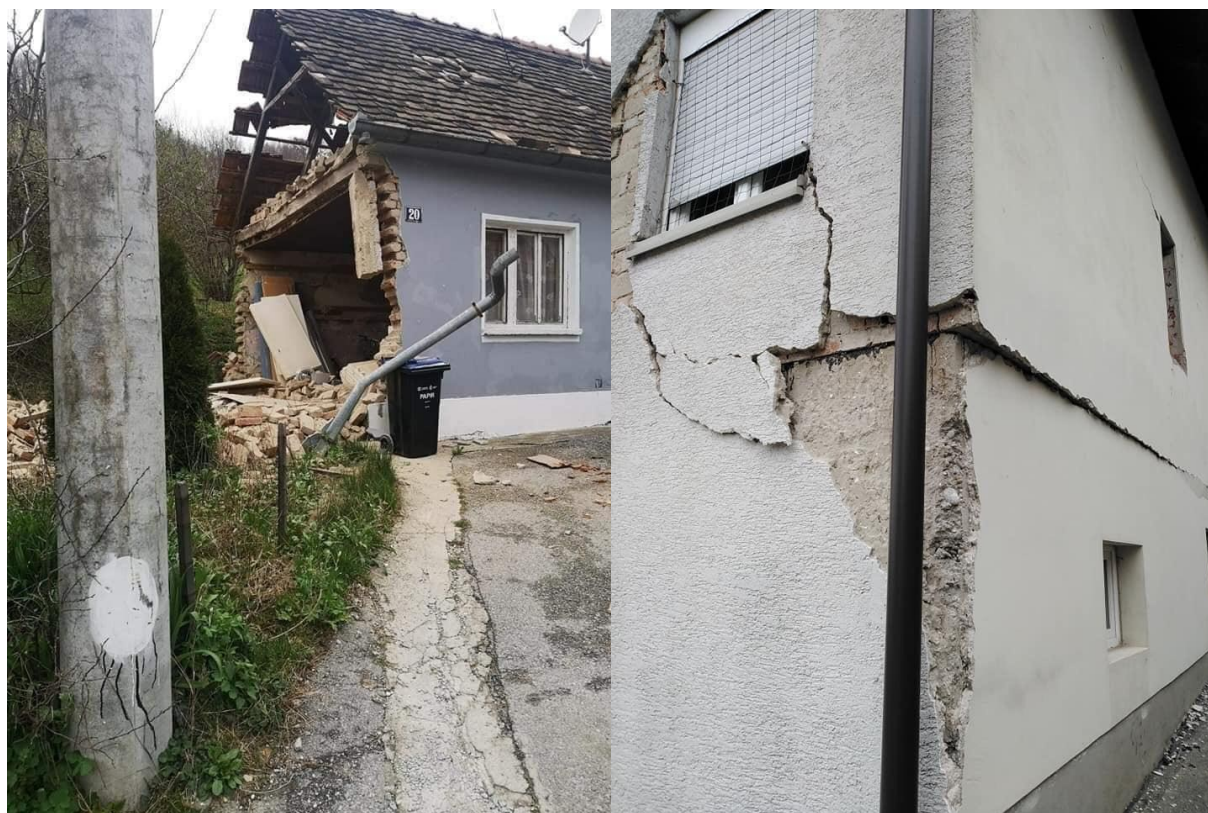
Figure 8. Heavily damaged family house near the epicenter.
<https://dnevnik.hr/vijesti/hrvatska/potres-u-zagrebu-ostali-bez-domova---598777.html>

The main shock was the strongest earthquake in Zagreb since the "Great Zagreb 1880 earthquake" and caused substantial damage in the historical city center. All were stunned with the damage of the top of the Cathedral's south tower (Figure 4). A numerous damage to the cultural and historical architectural heritage of the City of Zagreb have been reported (Figure 5). Many churches were heavily damaged (Figures 6 & 7) as well as the Croatian Parliament building. Most of the museums and theatres in the city's centre suffered also serious damage (e.g., the Museum of Arts and Crafts, the Croatian History Museum, the Schools Museum, Komedia Theatre, the Croatian National Theatre). Over 1,900 buildings (up to now) are reported to have become uninhabitable by the earthquake damage, particularly buildings built before 1964. In places around the epicenter, the situation was very bad because of the destroyed houses (Figure 8) (Markušić et al. 2020).
