# **Experimental Investigation of Cross Laminated Timber Elements with Holes or Notches at In-Plane Beam Loading Conditions**

# Article Experimental Investigation of Cross Laminated Timber Elements with Holes or Notches at In-Plane Beam Loading Conditions

Abstract: Environmental and urbanisation challenges have encouraged steady growth of mass timber structures where cross laminated timber (CLT) stands out in applications as full-size wall, floor, or beam elements. Beam elements are used mainly in situations where cross layers have a reinforcing effect on the tensile stress perpendicular to the beam axis, such as when introducing holes or notches, which is common practice in beams, due to engineering, installation, or architectural requirements. This paper presents experimental investigations of CLT beams with holes or notches for comparison and validation of an analytical model provided in the literature. Different sizes of holes and notches as well as different placements of the holes were considered in the experiments. All relevant failure modes were analysed and discussed in detail. Two predominant failure modes were indicated, i.e., bending failure and shear failure in cross

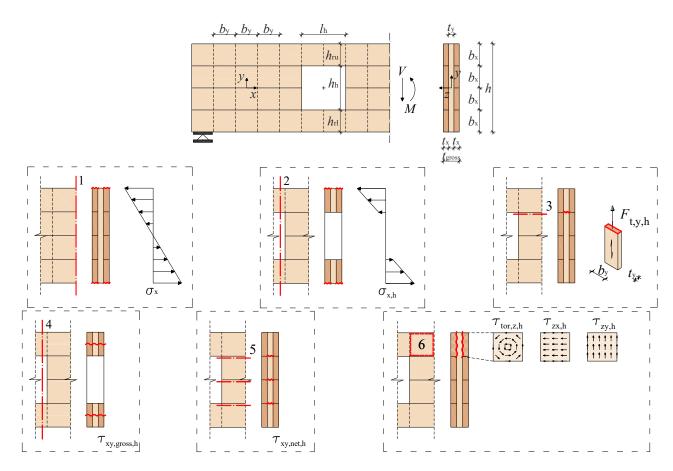
Figure 2. Geometry and locations of possible failure modes in CLT beam with a hole.

Several failure modes must be considered in the design of CLT beams with holes or notches, see numbered sections (1–6) in Figures 2 and 3, as follows: (1) bending, (2) bending at the edge of a hole or notch, (3) tension perpendicular to the beam axis, (4) gross shear failure (mode I), (5) net shear failure (mode II), and (6) shear failure in crossing areas (mode III).

Failure modes (2–3) are more specific and should be verified at the edges of holes or notches; see Figures 2 and 3. For failure mode (2) and the case of the beam with a prismatic hole, the maximum normal stress  $\sigma_{x,h}$  should be calculated as the sum of the bending stress of the full cross-section and a contribution from the additional local bending of the parts above and below the hole. For notched beams and failure mode (2), the maximum normal stress  $\sigma_{x,n}$  should be calculated based on the effective or reduced beam height at the notch.

The introduction of a hole or notch in a beam also implies the introduction of tensile and compressive forces perpendicular to the beam axis; see Figures 2 and 3. The verification of these forces and the corresponding stresses at the edge of the hole or notch is covered by the failure mode (3). Due to the cross-wise structure of CLT and the high ratio between the stiffness parallel and perpendicular to the grain, it is assumed that the tensile stresses  $\sigma_{t,h}$ and  $\sigma_{t,n}$  are carried only by the transverse laminations, which represent the tensile stresses parallel to the grain in them.

For beams with a symmetrically arranged hole in the beam height (y) direction, length of  $l_h$  and height  $h_h$ , the maximum normal stress at the edge of the hole (Figure 2) may be calculated as follows:

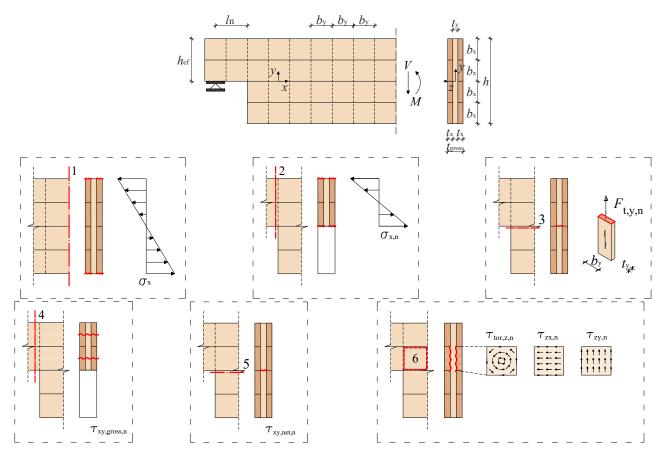
Figure 3. Geometry and locations of possible failure modes in CLT beam with an end-notch.

For notched beams, the maximum normal stress at the notched corner (Figure 3) may be calculated as follows:

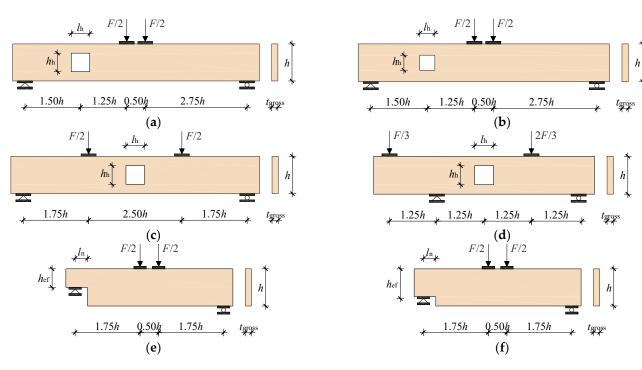
**Figure 4.** Geometry and test setups for test series with holes (H1 to H4) and notched test series (N1 and N2). (a) Test series H1 ( $l_h = h_h = 0.50h$ ; M/V = 1.50h); (b) Test series H2 ( $l_h = h_h = 0.40h$ ; M/V = 1.50h); (c) Test series H3 ( $l_h = h_h = 0.50h$ ;  $M/V = \infty$ ); (d) Test series H4 ( $l_h = h_h = 0.50h$ ; M/V = 0); (e) Test series N1 ( $h_{ef}/h = 0.50$ ;  $M/V = l_n = 0.33h$ ); (f) and Test series N2 ( $h_{ef}/h = 0.75$ ;  $M/V = l_n = 0.33h$ ).

A square centre-placed hole with a side length of 300 mm was placed in test series H1, H3, and H4, and 240 mm in test series H2. Thus, the hole height to beam height ratio is  $h_h/h = 0.50$  in test series H1, H3, and H4, and  $h_h/h = 0.40$  in test series H2, which is slightly higher or corresponds to the maximum proposed ratio ( $h_h/h = 0.40$ ) for reinforced glulam and solid wood members in the German and Austrian NA to EC5 [21]. In the test series H1 and H2, the hole was placed at a location subjected to combined shear force and bending moment loading (M/V = 1.50h). In test series H3, the centre of the hole was in a position without shear force and thus in a pure bending condition ( $M/V = \infty$ ), and in test series H4, the hole was in a position without bending moment and thus in a pure shear condition (M/V = 0). These test series, H3 and H4, represent idealised stress states used only to validate an existing analytical model.

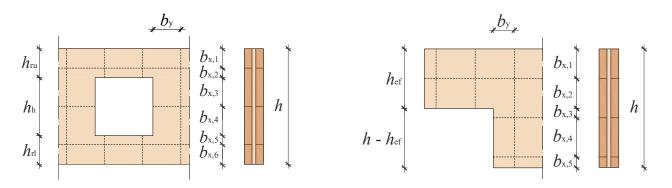
**Figure 5.** The cross-sectional dimensions of individual laminations for test series with holes (**left**) and notched test series (**right**).

All beam specimens were cut from larger CLT 3s panels fabricated of equal lamination width of  $b_x = b_y = 198$  mm, without considering the location of individual lamination with respect to beam edges, holes, or notches. The number and position of the laminations within the beam elements hence varied between test specimens and within a single test series. The cross-sectional dimensions of the individual laminations were measured for all beams and small deviations compared with the nominal dimensions were found; see Figure 5 and Table 3.

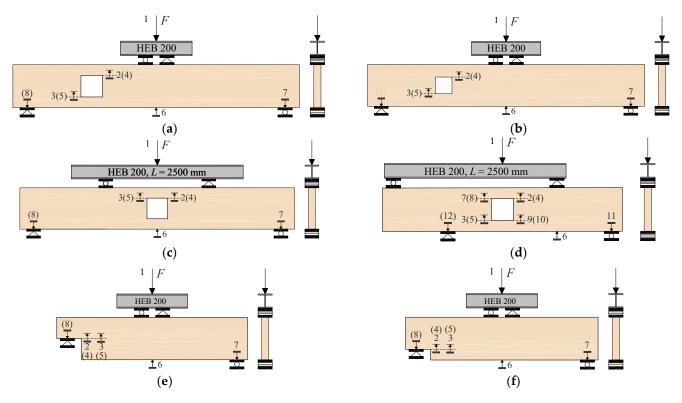
**Figure 6.** Test arrangements and position of measurement devices for all test series. (**a**) Test series H1; (**b**) Test series H2; (**c**) Test series H3; (**d**) Test series H4; (**e**) Test series N1; (**f**) and Test series N2.

All static laboratory tests were carried out using a 600 kN Zwick/Roell dynamic hydraulic actuator and the loading was applied in displacement-controlled mode. The displacement rate was 0.01 mm/s for all test series, resulting in a test duration of approximately 15–20 min and allowing careful observations of critical locations where cracks were expected. The positions and labels of displacement measuring devices (LVDTs) are shown schematically in Figure 6, with the labels in brackets referring to the back side of the beam. In addition to the mid-span and the beam supports, the devices were also positioned at the tensile corners where the first cracks were expected to occur; see Figure 7. In the test series, the measurement length (vertical distance) was set to 100 mm. The intention was to measure the displacement within a single longitudinal lamination. Therefore, the devices were positioned depending on the reduced lamination width, see Table 3, and the location of gaps near the hole and notch. The devices were positioned at a horizontal distance of 50 mm from the edge of the hole or 15 mm from the notched edge. The horizontal distance between two devices in the notched test series was 70 mm.

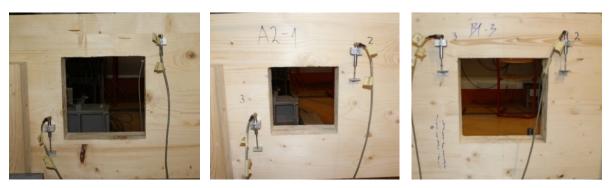
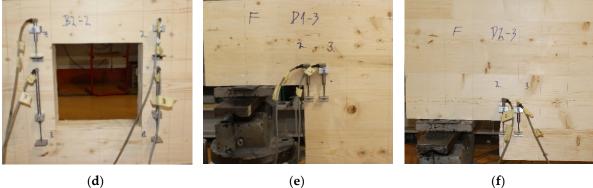
**Figure 7.** Photos of measurement devices for all test series. (a) Test series H1; (b) Test series H2; (c) Test series H3; (d) Test series H4; (e) Test series N1; (f) and Test series N2.

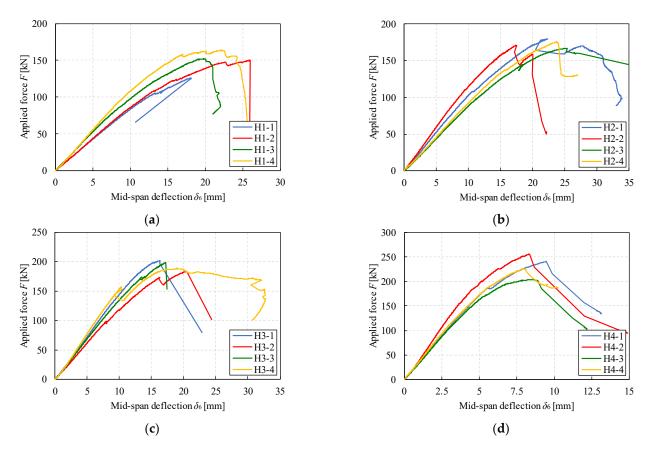
**Figure 8.** Applied force *F* vs. global deflection  $\delta_6$  for test series with holes. (**a**) Test series H1; (**b**) Test series H2; (**c**) Test series H3; (**d**) and Test series H4.

The failure modes for test series H1 and H2 are categorized as a combination of failure due to bending and shear failure in the crossing areas (mode III). The plots of applied load vs. deflection (Figure 8) show an almost linear relation up to about 80% of the maximum load. Thereafter, the decrease in stiffness indicates initial shear damage in the crossing areas with significant sliding between the laminations and increased beam deflection. At the maximum load, cracking and failure of the longitudinal laminations occurred at finger

joints, corresponding to almost pure bending of the individual laminations. The relatively small coefficient of variation (CoV) of 2.8% for test series H2 indicates reliable test results and a small influence of reduced lamination widths near the hole, see Table 3. However, in specimen H1-1, the global failure was initiated by a premature bending failure, resulting in a higher CoV of 9.4% in test series H1.

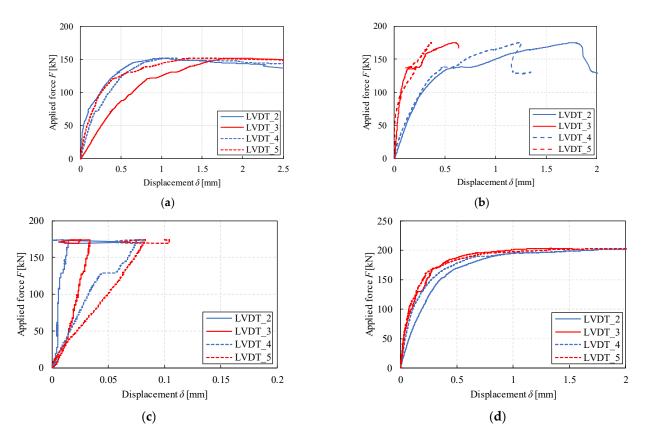
**Figure 9.** Applied force *F* vs. local displacements  $\delta_{2-5}$  for test series with holes. (a) Test series H1 (H1-3); (b) Test series H2 (H2-4); (c) Test series H3 (H3-1); (d) and Test series H4 (H4-3).

The failure mode for test series H3 is categorized as failure due to bending, except for specimen H3-4, where a combination of bending and shear in the crossing areas govern the global failure. In this specimen, a decrease in stiffness was observed with significant sliding between laminations and increased beam deflection after reaching the maximum load; see Figure 8. The relatively low CoV of 3.7% again indicates the minor influence of reduced lamination widths near the hole, see Table 3. The global failure of test series H4 was induced by shear stresses in the crossing area (mode III). At maximum load, cracks occurred simultaneously at the two corners of the hole subjected to tensile stress perpendicular to the beam axis; see Figure 10. Cracks also occurred parallel to the grain direction in both longitudinal and transverse laminations, indicating secondary gross shear failure (mode I). A slightly higher CoV of 8.4% results from the lower capacity of specimen H4-3 due to premature shrinkage cracks detected prior to testing. Visual observations indicate that none of the tested series failed with holes, at least not as the primary failure mode due to gross (mode I) and net shear (mode II) or due to tensile stresses perpendicular to the beam axis.

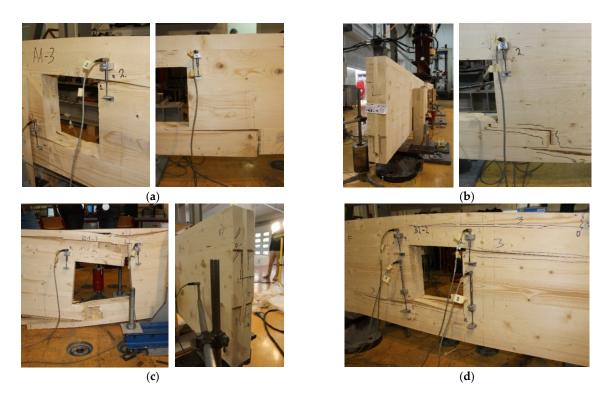
Figure 10. Photos of fractured test series with holes. (a) Test series H1; (b) Test series H2; (c) Test series H3; (d) and Test series H4.

The results for the test series with holes in terms of maximum load  $F_{\text{max}}$  and corresponding global deflection at maximum load  $\delta_{6,\text{Fmax}}$  are presented in Table 4. The plots of applied load F vs. global deflection  $\delta_6$  and of applied load F vs. local displacements  $\delta_{2-5}$  are shown in Figures 8 and 9, respectively. The global and local displacements were measured as described in Section 3 at the positions shown in Figures 6 and 7. Photos of the fractured specimens are shown in Figure 10.

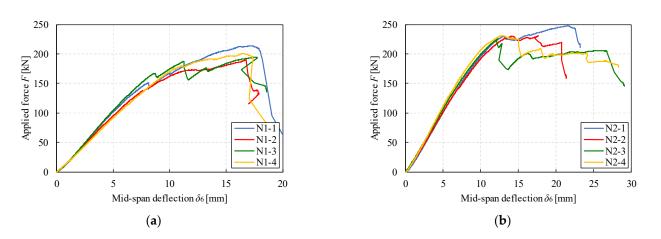
**Figure 11.** Applied force *F* vs. global deflection  $\delta_6$  for notched test series. (**a**) Test series N1; (**b**) and Test series N2.

The results for the notched test series in terms of maximum load  $F_{max}$  and corresponding global deflection at maximum load  $\delta_{6,Fmax}$  are presented in Table 5. The plots of applied load F vs. global deflection  $\delta_6$  and of applied load F vs. local displacements  $\delta_{2-5}$  are shown in Figures 11 and 12, respectively. The global and local displacements were measured as described in Section 3 at the positions shown in Figures 6 and 7. Photos of the fractured specimens are shown in Figure 13.

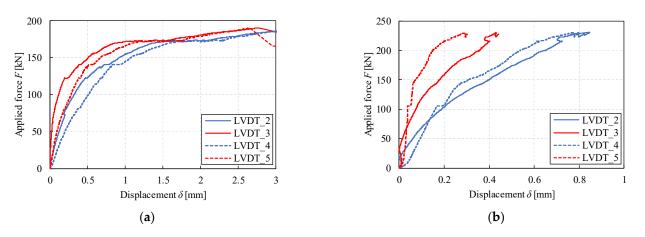
**Figure 12.** Applied force *F* vs. local displacements  $\delta_{2-5}$  for notched test series. (**a**) Test series N1 (N1-2); (**b**) and Test series N2 (N2-2).

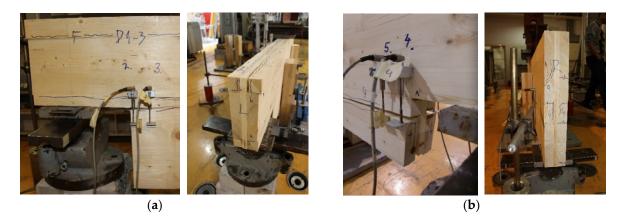
Figure 13. Photos of fractured notched test series. (a) Test series N1; (b) and Test series N2.

As for most test series with holes, the failure modes for both notched test series N1 and N2 are also categorized as a combination of failure due to bending and shear failure in the crossing areas (mode III). The plots of applied load vs. deflection (Figure 11) show a decrease in stiffness with significant sliding between the laminations and increased beam deflection, indicating initial shear damage in the crossing areas. At the final stage after reaching maximum load and shear capacity, cracking and failure of the longitudinal laminations occurred at finger joints at the notch, corresponding to almost pure bending of the individual laminations. However, it is interesting to note that in test series N2, shear failure in the crossing areas also occurred on the non-notched side of the beam, indicating that notch depth of  $h_{\rm ef}/h = 0.75$  did not actually reduce the load capacity in this test series. One possible reason for this can be the fact that the stress component perpendicular to the beam axis  $\tau_{zv}$  on the notched side was much lower compared with the stress component parallel to the beam axis  $\tau_{zx}$  on the un-notched side of the beam, as will be discussed more below. The relatively small CoV of 4.5 and 3.6% indicate reliable test results and a small influence of reduced lamination widths near the notch, see Table 3. Visual observations indicate that none of the notched test series failed, at least as a primary failure mode, due to gross (mode I) and net shear (mode II) or due to tensile stresses perpendicular to the beam axis.

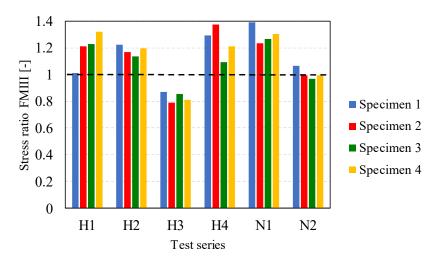
Figure 14. Stress ratios for shear failure in crossing areas (FM III) for all test series.

The shear stress components relevant for shear failure mode III,  $\tau_{zx}$ ,  $\tau_{zy}$ , and  $\tau_{tor,z}$ , are provided for the most stressed crossing areas, i.e., at the corner of the hole or notch, but also at the outermost crossing areas in beam height direction for the complete cross-section of test series H3, N1, and N2. Calculated stress ratios are presented for all test series in Figure 14 according to the critical stress interaction failure criteria, as higher values between Equations (23) and (24), assuming  $f_{v,tor}/f_R \approx 2.3$  with mean rolling shear strength  $f_R = 1.50$  MPa and mean torsional shear strength as  $f_{v,tor} = 3.50$  MPa, see Section 2.4.

Obtained experimental results indicate the conservative side of the analytical model by predicting higher stress ratios and underestimating the shear capacity regarding FM III. However, it should be noted that several simplifications and assumptions were implemented into the model discussed in Section 2 and that it is closely related to the original analytical model for prismatic beams presented in [6,11]. Several previous studies [16–20] indicate that the assumed stress distributions in the beam height and beam width directions according to the original model do not agree with the results of 3D-FE, as mentioned in the introduction. The model reviewed in Section 2 is also based on a 1D-FE analysis, which is quite a simplification compared with the real condition including the geometric and material heterogeneity of the CLT elements. This is particularly evident in test series N2, where the shear failure in the crossing areas also occurred on the non-notched side of the beam, but not in the lowermost crossing area as expected according to the original model [6,11], but in the crossing area near the centre line of the beam according to the improved model [16,17,20]; see Figure 13. The stress distribution in the beam width direction is even more pronounced for prismatic CLT 5s and CLT 7s elements and must be considered accordingly. Improved analytical model and design proposals that take into account the stress distribution in beam height and width direction according to the 3D-FE results were

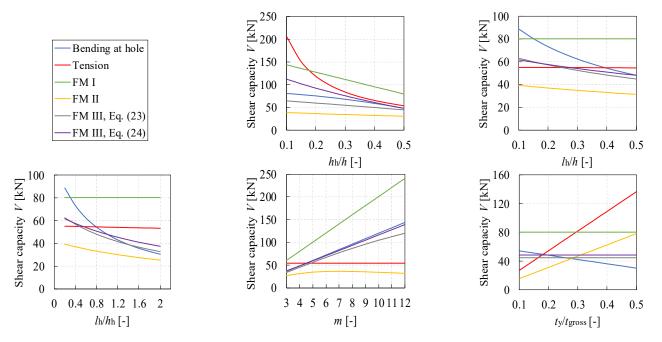
Figure 15. Parameter study of shear strength capacities for CLT beams with holes.

The relative comparison between failure modes presented in Section 2.2 in terms of the shear force capacities *V* is presented by the parametric study shown in Figures 15 and 16 for beams with holes and notched beams, respectively. The strength capacities are compared based on characteristic strength values for each failure mode, see Section 2.4, except for bending in the mid-span, since this failure mode depends on the span of the beam, which is not relevant for the other considered modes. The characteristic strength values were used since they are included in design strength values commonly used in design verification. The results are presented only for CLT 3s elements based on reference geometry of test series H1 and N1, see Table 2, but similar relations are expected also for CLT 5s and 7s elements.

In each graph presented in Figures 15 and 16, only one parameter was varied while all others were kept constant. The presented results show that in most cases the net shear (FM II) and the stress perpendicular to the beam axis are critical, which is not consistent with obtained experimental results or previous test results [5–7], where none of the tested series with holes or notches failed, at least not as the primary failure mode, due to these failure modes. These results lead to the same conclusion as in Section 4, that the proposed equations for stress calculations may be overestimated and that the capacities for such failure modes are correspondingly underestimated. However, these conclusions should be further validated using a more comprehensive experimental test database that includes CLT 5s and 7s beam elements.

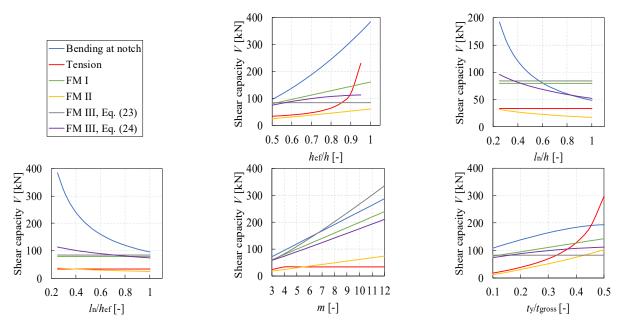
Figure 16. Parameter study of shear strength capacities for notched CLT beams.
