Seismic Damage Index Spectra Considering Site Acceleration Records: The Case Study of a Historical School in Kermanshah

Source / Izvornik: **Buildings, 2022, 12**

2. Kazazi High School

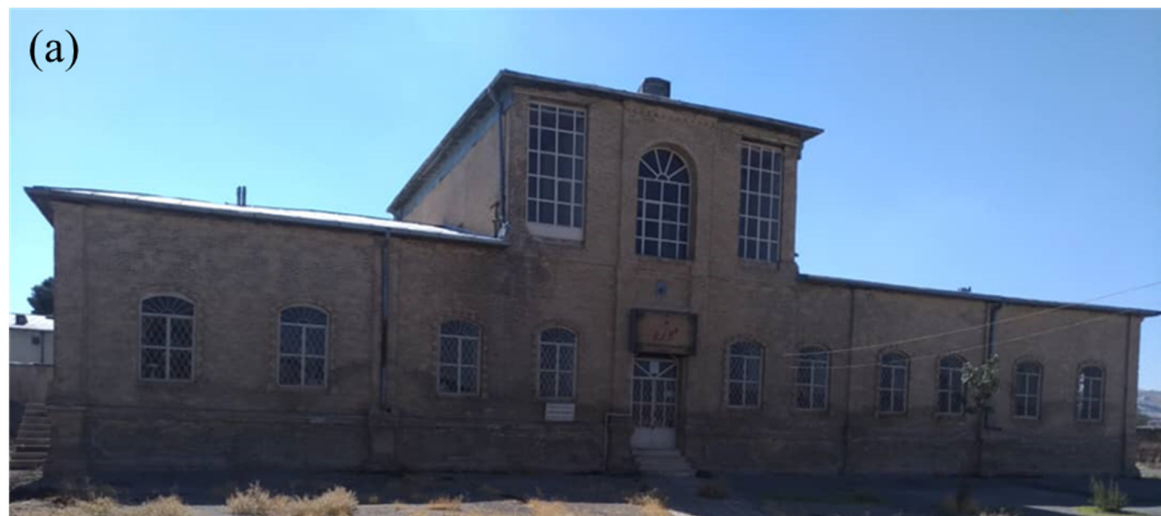
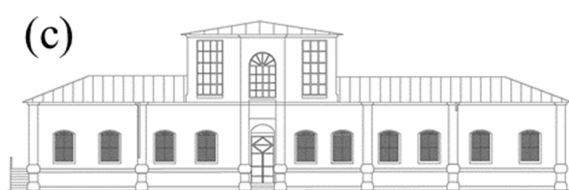
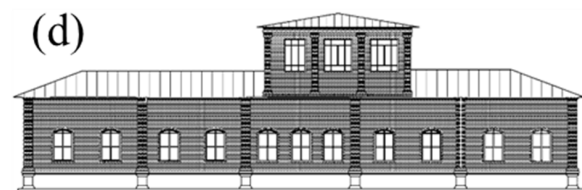
The architecture of the building is simple, and more than beautification, a rigorous appearance of the building has been preferred (Figure 1a). Only the brickwork of the facade represents an embellishment system of the building.

In 2006, during the renovation, the building plan changed, and some parts of the transverse walls of the classrooms were removed. Currently, the plan of the building is rectangular, 36 m long in the east–west direction and 16 m wide in the north–south direction (Figure 1b). A corridor with a width of 4.65 m and a length of 36 m (the whole building length) is located in the middle of the building. Classrooms are situated on both sides of this corridor. The width of the classrooms is 4 m, and their length varies from 6.15 to 12.9 m. The main entrance of the building is located on the north side, and another door is located on the east side. Figure 1c–g show the north, south, east, and west perspective views, respectively.

There is another floor in the center of the building, where there are the manager's office, the meeting hall, and the documents archive, along with two terraces on the north and south sides. The staircase is in the middle of the terrace on the north side, which, after renovation, has been surrounded by walls. The height of the first and second floors are 4.00 and 3.80 m, respectively. The wall materials are brick and lime mortar. The ceiling is made of a wooden beam and a gable roof placed on a wooden truss.

Figure 1. Kazazi High School: (a) north-view photo, (b) first-floor and second-floor plan (dimensions in centimeter), (c) north-view, (d) south-view, (e) east-view, (f) west-view, and (g) building perspective.
