# Seismic Damage Index Spectra Considering Site Acceleration Records: The Case Study of a Historical School in Kermanshah

*Source / Izvornik:* **Buildings, 2022, 12**

**Keywords:** seismic vulnerability; damage index spectra; historical masonry building; nonlinear analysis

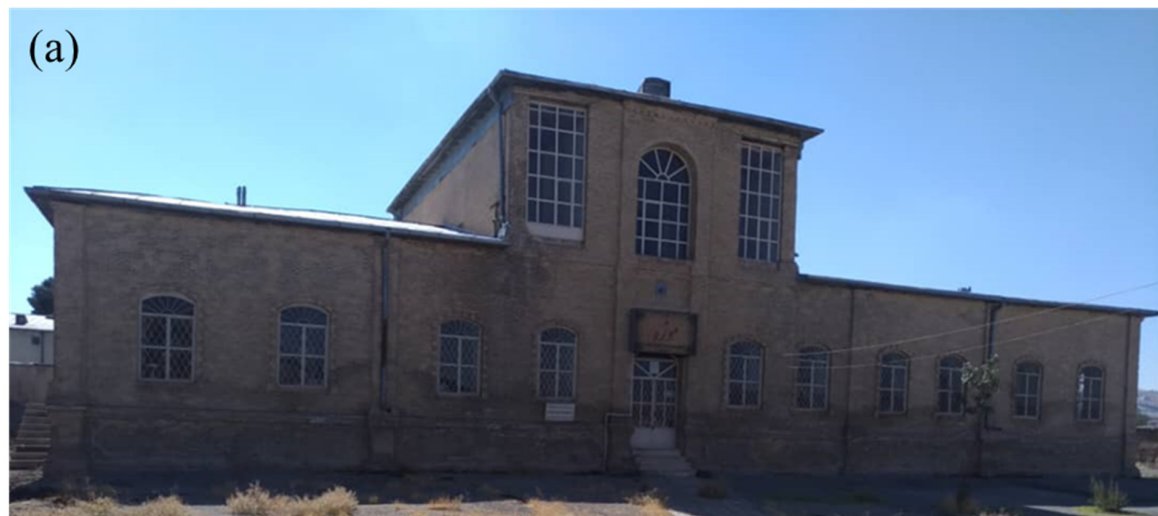
**Figure 1.** Kazazi High School: (a) north-view photo, (b) first-floor and second-floor plan (dimensions in centimeter), (c) north-view, (d) south-view, (e) east-view, (f) west-view, and (g) building perspective.

The architecture of the building is simple, and more than beautification, a rigorous appearance of the building has been preferred (Figure 1a). Only the brickwork of the facade represents an embellishment system of the building.

In 2006, during the renovation, the building plan changed, and some parts of the transverse walls of the classrooms were removed. Currently, the plan of the building is rectangular, 36 m long in the east–west direction and 16 m wide in the north–south direction (Figure 1b). A corridor with a width of 4.65 m and a length of 36 m (the whole building length) is located in the middle of the building. Classrooms are situated on both sides of this corridor. The width of the classrooms is 4 m, and their length varies from 6.15 to 12.9 m. The main entrance of the building is located on the north side, and another door is located on the east side. Figure 1c–g show the north, south, east, and west perspective views, respectively.

There is another floor in the center of the building, where there are the manager's office, the meeting hall, and the documents archive, along with two terraces on the north and south sides. The staircase is in the middle of the terrace on the north side, which, after renovation, has been surrounded by walls. The height of the first and second floors are 4.00 and 3.80 m, respectively. The wall materials are brick and lime mortar. The ceiling is made of a wooden beam and a gable roof placed on a wooden truss.
