Source / Izvornik: **Tehnički vjesnik, 2010, 17, 209 - 215**

TESTING OF PHYSICAL AND MECHANICAL PROPERTIES OF BRICKS AND MORTAR IN HISTORIC STRUCTURES

Mirjana Bošnjak-Klečina, Silva Lozančić

Preliminary notes

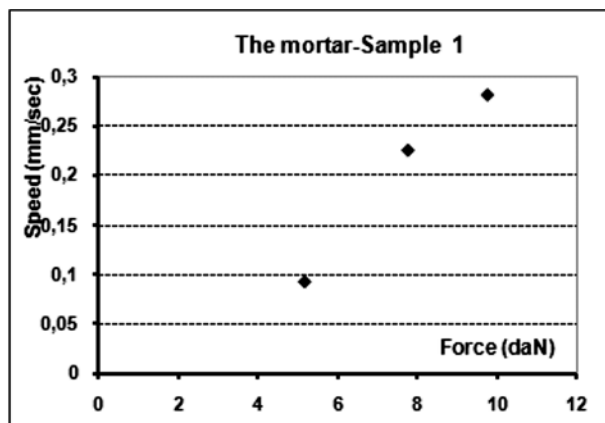
Figure 16 The mortar of strength 10,00 MPa
Slika 16. Mort čvrstoće 10,00 MPa

samples), the total number of drillings being 72. Selected rotational speed of power drill was 600 rpm, the diameter of drilling bit was 6 mm (drilling bit for concrete, tempered steel tip). The expected drill depth was 40 mm. Time was measured for this depth of drilling at constant speed and force for all three holes (the number of holes on one sample was restricted by the size of the sample). It was evident that in tests on the samples of great strength there were almost no differences in the depth of drilling regarding the changes in applied force, while on the samples of compressive strength the samples failed because of their very small tensile strength. On the samples of medium strength, the functional relation of force (the added weight) and drilling time (Figures 16 and 17) may be foreseen. The shown penetration speeds correspond to the mean values in three measurements.
