TESTING OF PHYSICAL AND MECHANICAL PROPERTIES OF BRICKS AND MORTAR IN HISTORIC STRUCTURES

Bošnjak-Klečina, Mirjana; Lozančić, Silva

Source / Izvornik: **Tehnički vjesnik, 2010, 17, 209 - 215**

Preliminary notes

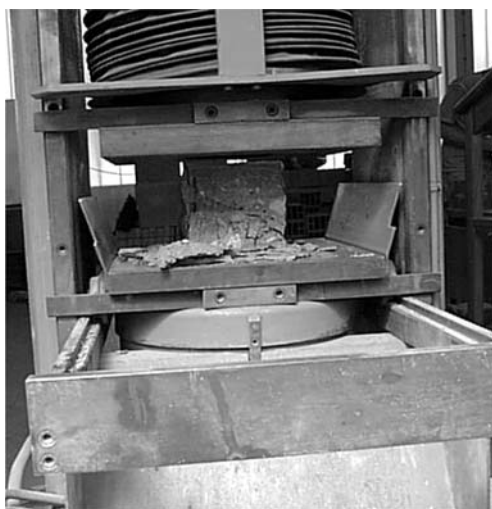
Figure 3 Compression failure of the brick
Slika 3. Tlačni slom opeke

Compressive strength. The compressive strength of brick elements has been tested by gradual increase of the compressive force up to the failure of sample, according to the procedure described in the norm [8]. The tests were performed on a sample made by joining two halves of the same brick. The test is shown in Figures 2 and 3. Results of tests are shown in Tab. 5.

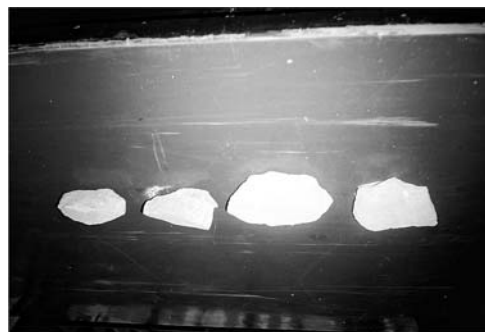
Figure 4 The samples removed from the building
Slika 4. Uzorci izvađeni iz građevine

The old mortar samples were taken from the 18th century structure located at the Tvrdja in Osijek, built at the same time and with the same material as the observed structures. Because of the difficulties connected with finding the right undisturbed samples the scope of investigation has been limited. The samples were obtained by removing the mortar from the existing building.

The samples are presented in Figures 4 and 5.
