*Source / Izvornik:* **Tehnički vjesnik, 2010, 17, 209 - 215**

# TESTING OF PHYSICAL AND MECHANICAL PROPERTIES OF BRICKS AND MORTAR IN HISTORIC STRUCTURES

*Mirjana Bošnjak-Klečina, Silva Lozančić*

Preliminary notes

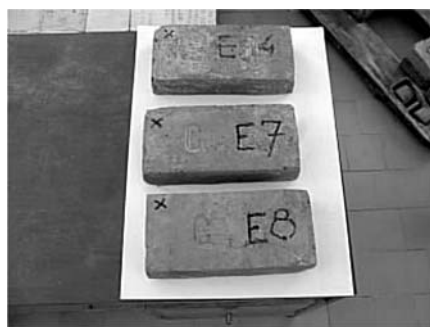
Figure 1 Tested brick samples  
Slika 1. Uzorci ispitanih opeka

The testing has been carried out in accordance with the valid European standards. The samples of old bricks have been taken from three locations: St. Michael's church in Osijek, St. Philip and Jacob's church in Vukovar and Eltz's manor house in Vukovar. The bricks were made in 18<sup>th</sup> century, most likely in brickyards near the mentioned structures. The samples are shown in Fig. 1. The new brick is solid masonry unit manufactured in a modern Slavonian brickyard. Each testing has been carried out on one sample

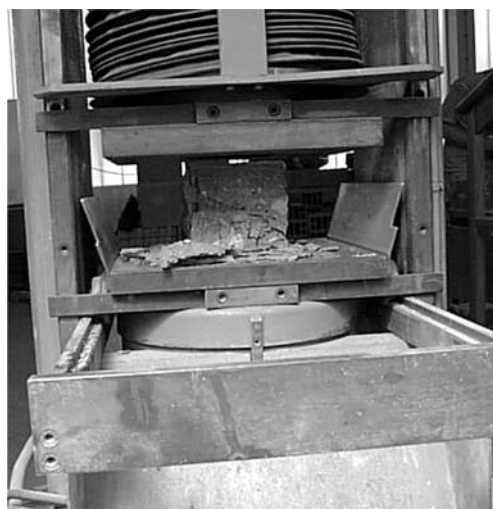
**Figure 3** Compression failure of the brick  
**Slika 3.** Tlačni slom opeke

**Compressive strength.** The compressive strength of brick elements has been tested by gradual increase of the compressive force up to the failure of sample, according to the procedure described in the norm [8]. The tests were performed on a sample made by joining two halves of the same brick. The test is shown in Figures 2 and 3. Results of tests are shown in Tab. 5.

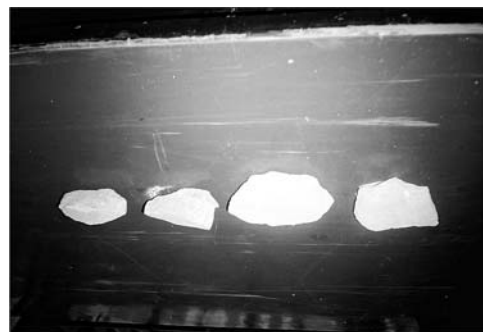
**Figure 4** The samples removed from the building  
**Slika 4.** Uzorci izvađeni iz građevine

The old mortar samples were taken from the 18<sup>th</sup> century structure located at the Tvrdja in Osijek, built at the same time and with the same material as the observed structures. Because of the difficulties connected with finding the right undisturbed samples the scope of investigation has been limited. The samples were obtained by removing the mortar from the existing building.

The samples are presented in Figures 4 and 5.

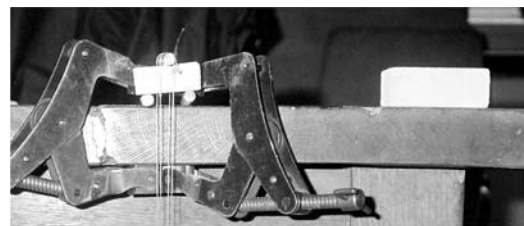
**Figure 5** Samples prepared for testing  
**Slika 5.** Uzorci pripremljeni za ispitivanje

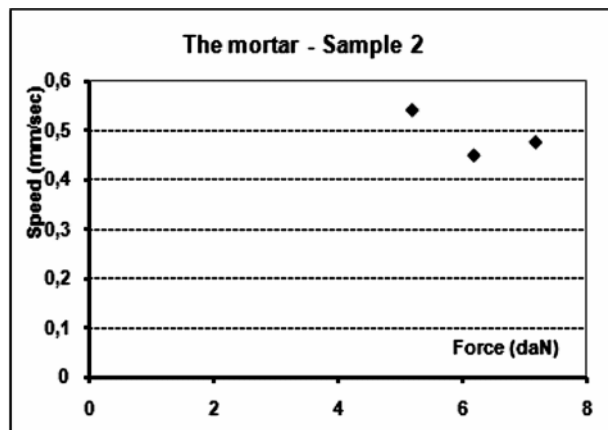
Figure 17 The mortar of strength 1,80 MPa  
Slika 17. Mort čvrstoće 1,80 MPa

samples), the total number of drillings being 72. Selected rotational speed of power drill was 600 rpm, the diameter of drilling bit was 6 mm (drilling bit for concrete, tempered steel tip). The expected drill depth was 40 mm. Time was measured for this depth of drilling at constant speed and force for all three holes (the number of holes on one sample was restricted by the size of the sample). It was evident that in tests on the samples of great strength there were almost no differences in the depth of drilling regarding the changes in applied force, while on the samples of compressive strength the samples failed because of their very small tensile strength. On the samples of medium strength, the functional relation of force (the added weight) and drilling time (Figures 16 and 17) may be foreseen. The shown penetration speeds correspond to the mean values in three measurements.
