# Testing of physical and mechanical properties of bricks and mortar in historic structures

*Source / Izvornik:* **Tehnički vjesnik, 2010, 17, 209 - 215**

# TESTING OF PHYSICAL AND MECHANICAL PROPERTIES OF BRICKS AND MORTAR IN HISTORIC STRUCTURES

*Mirjana Bošnjak-Klečina, Silva Lozančić*

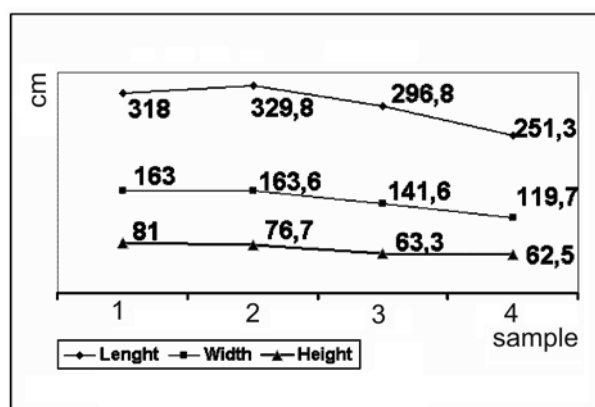
Figure 6 Bricks' dimensions, the mean values  
Slika 6. Dimenzije opeka, srednje vrijednosti

**The bricks' dimensions.** The old brick of the smallest size under present research comes from the Eltz's manor house in Vukovar. Its dimensions (the mean value) compared to nowadays size are 18 % longer and wider, and 2 % taller.

The biggest deviations from the mean value for one sample of old brick are within 6 %. The biggest deviations from the mean value for new brick samples are within 1 %. Fig. 6 indicates the mean value of the brick's dimensions for each tested sample.

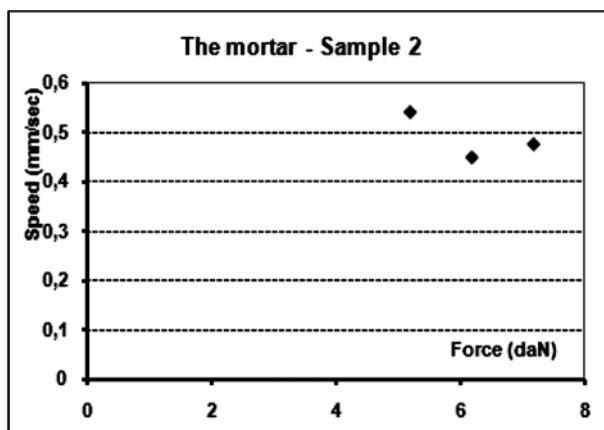
Figure 17 The mortar of strength 1,80 MPa  
Slika 17. Mort čvrstoće 1,80 MPa

samples), the total number of drillings being 72. Selected rotational speed of power drill was 600 rpm, the diameter of drilling bit was 6 mm (drilling bit for concrete, tempered steel tip). The expected drill depth was 40 mm. Time was measured for this depth of drilling at constant speed and force for all three holes (the number of holes on one sample was restricted by the size of the sample). It was evident that in tests on the samples of great strength there were almost no differences in the depth of drilling regarding the changes in applied force, while on the samples of compressive strength the samples failed because of their very small tensile strength. On the samples of medium strength, the functional relation of force (the added weight) and drilling time (Figures 16 and 17) may be foreseen. The shown penetration speeds correspond to the mean values in three measurements.
