EXPERIMENTAL ANALYSIS OF COMBINED ACTION OF BENDING, SHEAR AND TORSION ON TIMBER BEAMS

Tihomir Štefčić, Aleksandar Jurić, Pavao Marović

Preliminary notes

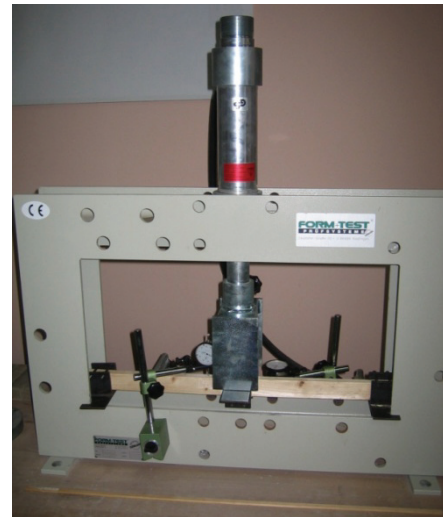
Figure 3 Testing machine

load application, points and direction of deformation measurements are shown in Fig. 2, and the boundary and load applying conditions are shown in Figs. 3, 4 and 5.

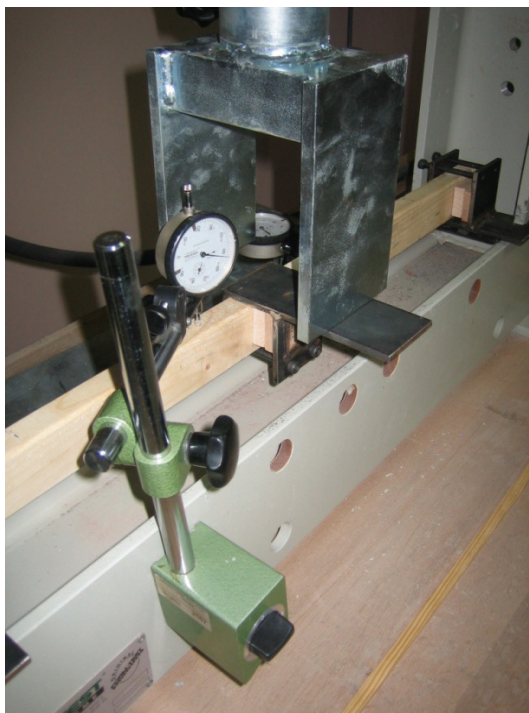
Figure 4 Measuring of deformation and applying of load

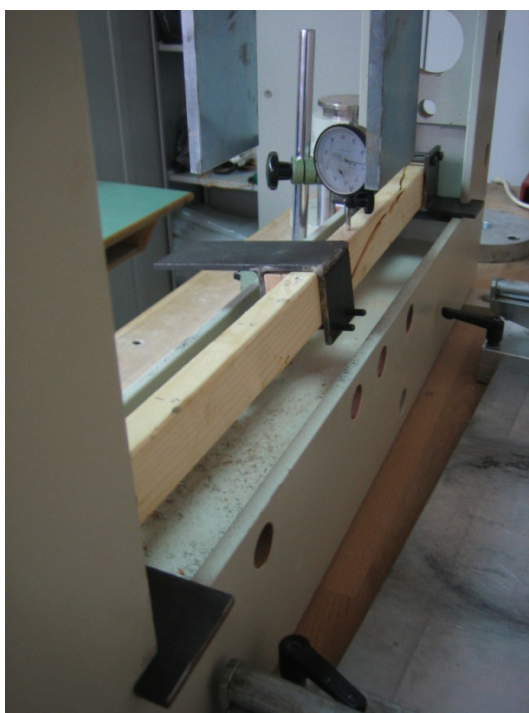
Figure 6 The failure of the sample

The failure of the tested beams occurred through a spiral longitudinal (fibre direction) crack, as shown in Figs. 6, 7 and 8. It can be assumed that the breaking happened from the influence of the combined shear stress in the longitudinal direction and normal tensile stress perpendicular to the fibres. Due to natural curvature of the fibres and sawing of wood some fibres do not extend throughout the entire beam. Because of this they cannot transfer stresses (load) further and at this point the crack begins. In this manner the cross section begins to weaken and break, as shown in Fig. 8.

It can be seen that the concentration of stresses occurs near the support (both perpendicular normal stresses and shear stresses) and that was confirmed with the results of the experiment, Figs. 6, 7 and 8, i.e., the failure of the specimen.

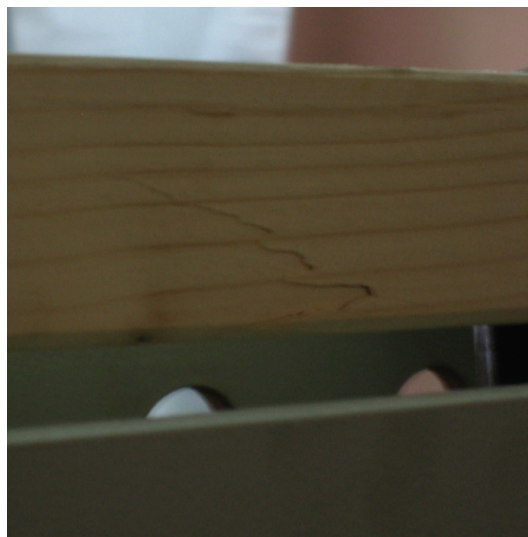
Figure 7 Failure by separation of the ends of fibres
