Cyclic testing of single-span weak frames with masonry infill

Original scientific paper

Experimental test results for fourteen samples of single-span, single-storey, non-seismically designed reinforced-concrete (weak) masonry infill frames are presented in the paper. The samples, scaled 1 to 2, were subjected to the approximately constant vertical and in-plane horizontal cyclic load. Various geometrical and mechanical properties of reinforced-concrete frames and masonry infill were considered. Equations for estimating the interstorey drift ratio at the limit states under study are proposed based on testing conducted in the paper.

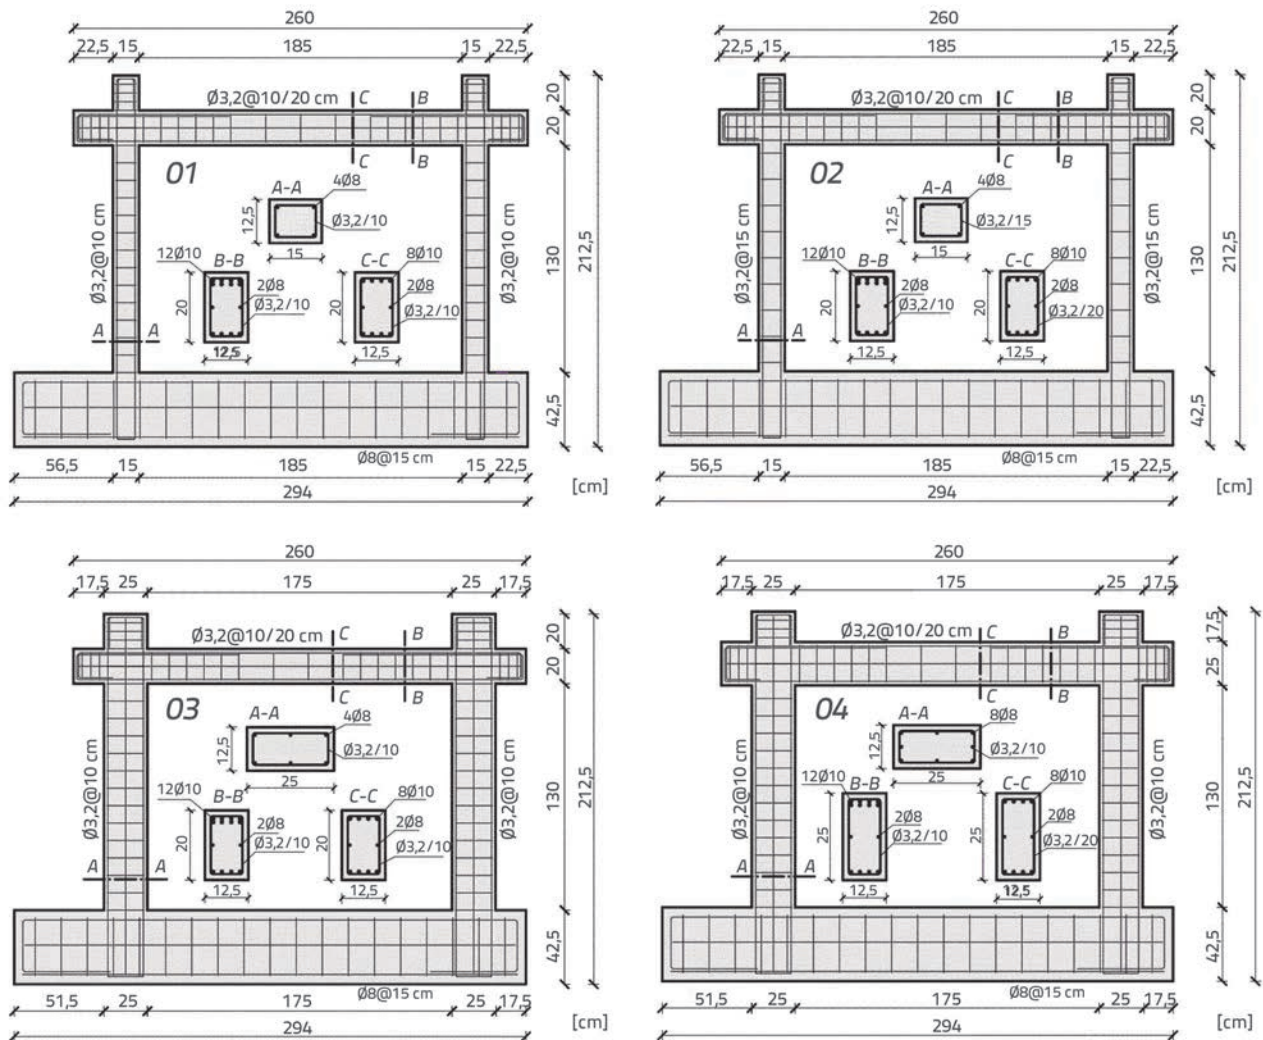
Figure 1. Frame specimens

The specimens (Table 1 and Figure 1) were grouped into four different series with the same r/c frame parameters. The same frame aspect ratio was kept, while the column to beam moment of inertia ratio, and reinforcement ratio of frame members were varied. The r/c frames were infilled with five different masonry wall types.

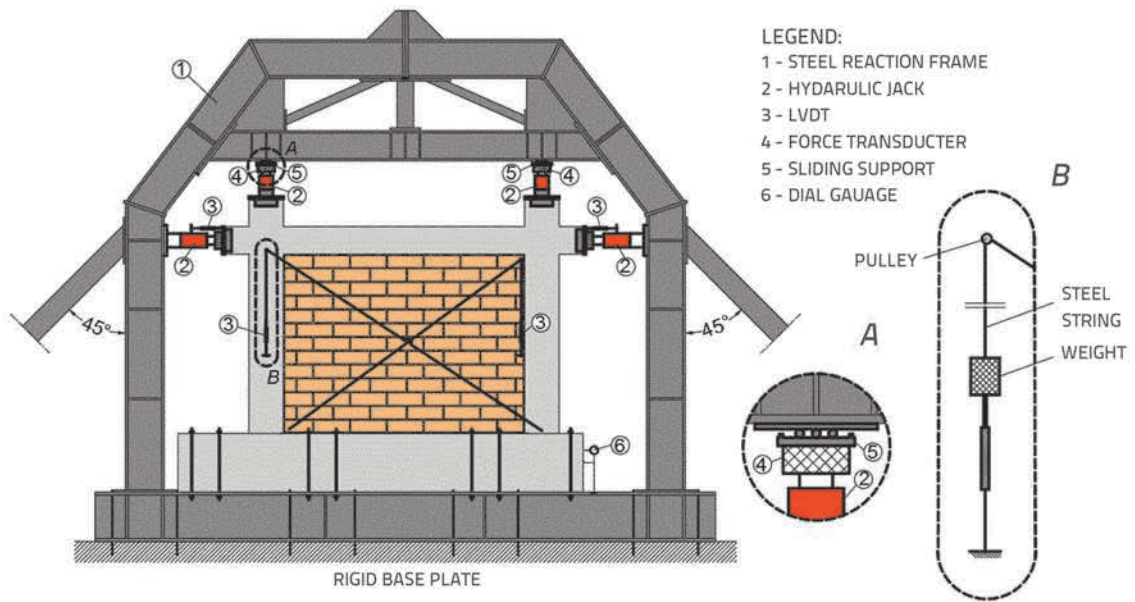
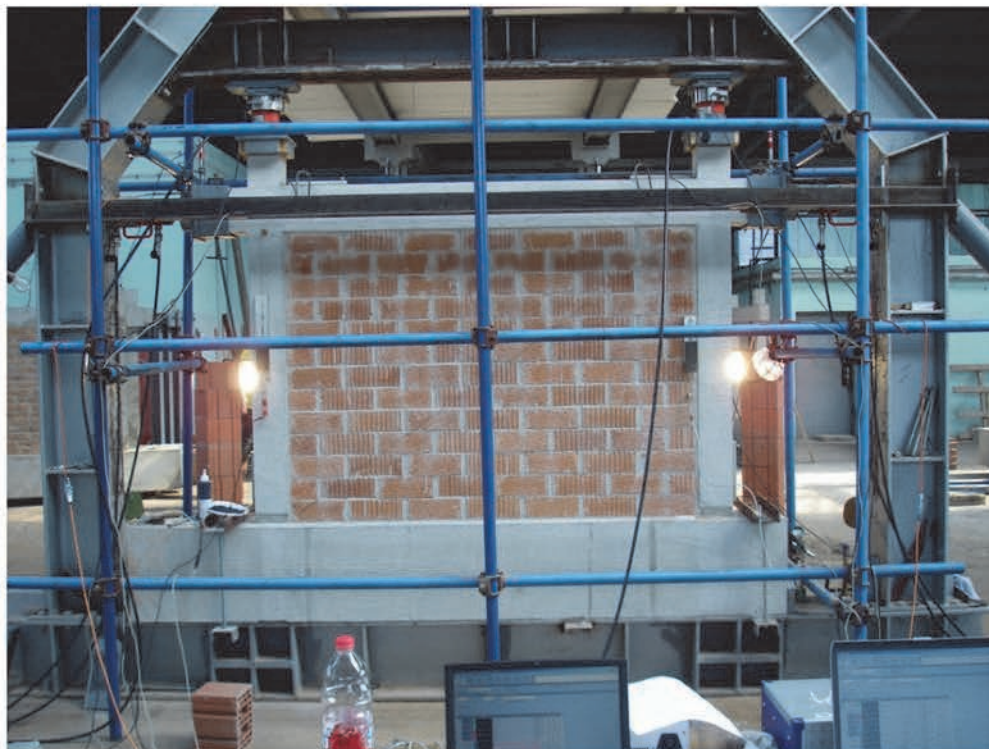
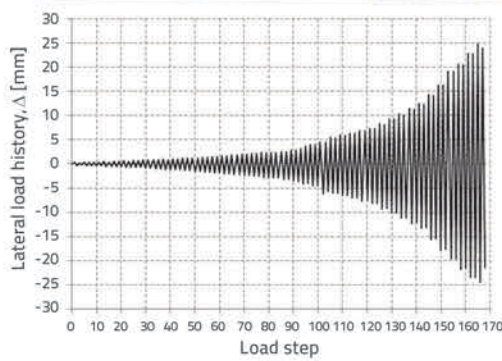
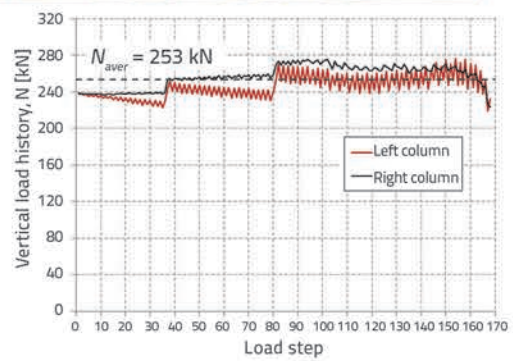
Figure 2. Test setup, instrumentation and loading history

Specimens were tested in a steel reaction frame fixed to a strong floor with lateral support. Their foundation beams were fixed to the reaction frame and sliding was prevented by steel restrainers. Tests were performed under an approximately constant vertical and in-plane cyclic lateral load up to failure. Vertical loads, corresponding to 30-40 % of the design compressive strength of concrete, were applied at each column end by hydraulic jacks placed on a sliding support, which enabled lateral displacement and prevented rotation. Cyclic lateral in-plane loading was applied at the beam end along its centroid axis by two hydraulic jacks (Figure 2).

The lateral load history consisted of the load (1) controlled in increments of 10 kN in a small deformation range, and displacement (2) controlled with gradually increasing displacements. Each loading cycle was repeated twice in order to capture the effects of stiffness and strength degradation. Loads were measured at each application point by force transducers, while horizontal displacements of the frame at both ends of the beam, and diagonal deformations of the frame and infill walls, were measured by LVDT's. A high-resolution dial gauge was used to monitor possible slippage of foundation beam. All measured data were continuously registered at a sampling rate of 0.01 sec by DEWE-30-16 system with DEWESoft ver. 6.6.7 software support. Deformations, cracks and their propagation were monitored visually and by the 3D optical measuring system ARAMIS.

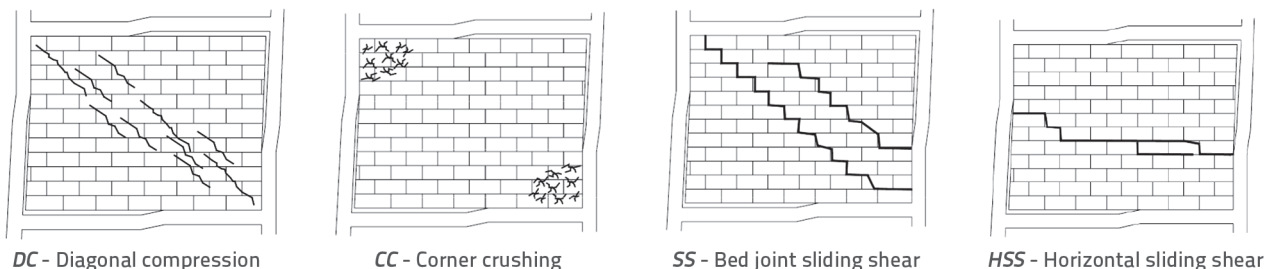
Figure 3. Damage modes of masonry infill, [32]

Possible damage modes of the masonry infill wall and r/c frame are presented in Figures 3 and 4, according to [31, 32], and are correlated with three characteristic limit states of tested specimens.

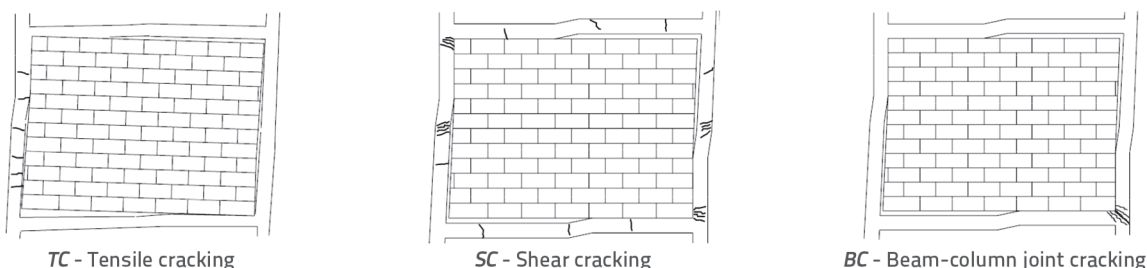
Figure 4. Damage modes of r/c frame, [32]

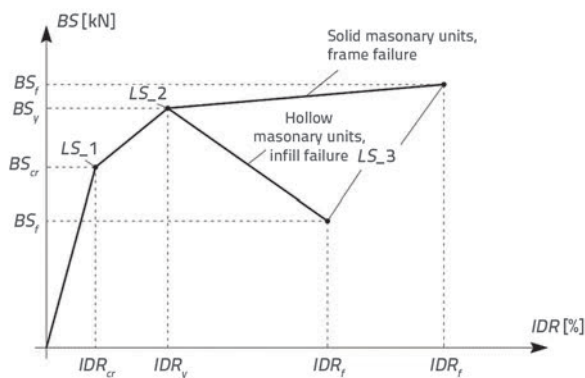
Figure 5. Primary curves and limit states of tested specimens

BS and IDR represent base-shear (lateral strength) and inter-storey drift at the corresponding LS, respectively. These limit states were noted as being the best ones for describing the observed response of specimens. Their primary curve is shown in Figure 5.

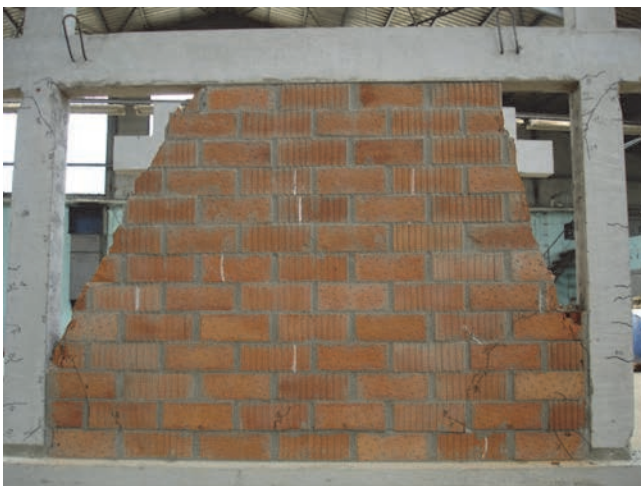
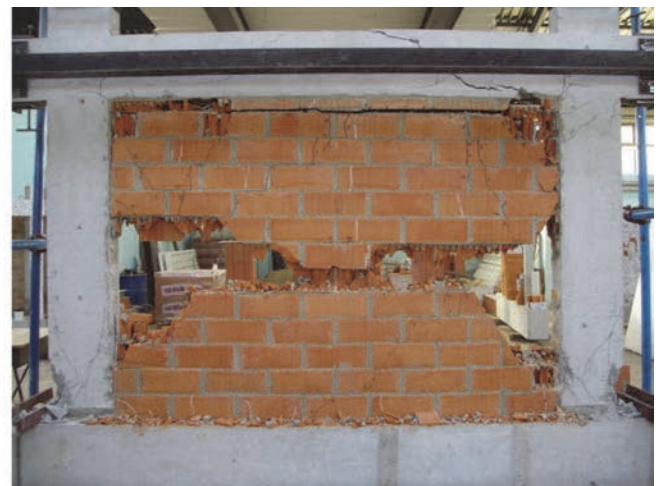
Figure 6. Failure of masonry infill walls made with hollow clay units (specimens $O1_{bpm}$ and $O3_{bpm}$)

progressed until LS_3 was reached. The central part of the infill wall remained undamaged. Although the out-of-plane tests were not performed, it can be concluded based on severity of damage (Figure 6.) that the out-of-plane stability of infill is highly questionable.

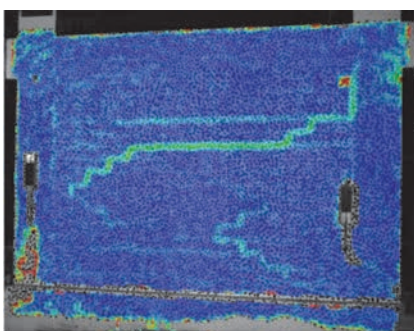
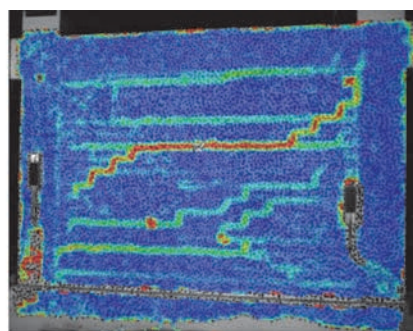
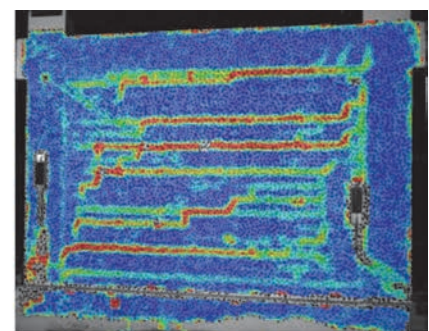
Figure 7. Transition of damage modes in masonry infill wall made of solid clay units ($O03_{cpm}$, quantitative representation of relative deformation, ARAMIS)

tests. Both limit states, LS_1 and LS_2 , were defined by the shear damage mode and only the transition from SS to HSS mode was observed, as shown in Figure 7. As the masonry infill did not crush, its participation in the lateral load resistance was maintained up to LS_3 . The appearance of LS_3 was determined by shear failure of r/c frame members. For specimens $O1$ and $O2$, failure was caused by shear failure of one of the columns, while for specimens $O3$ and $O4$, failure was caused by shear failure of beams.

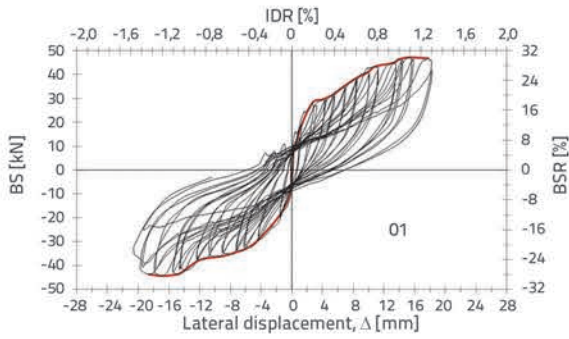
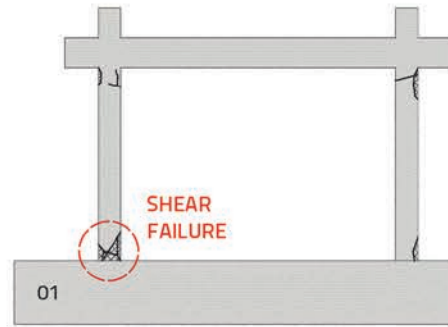
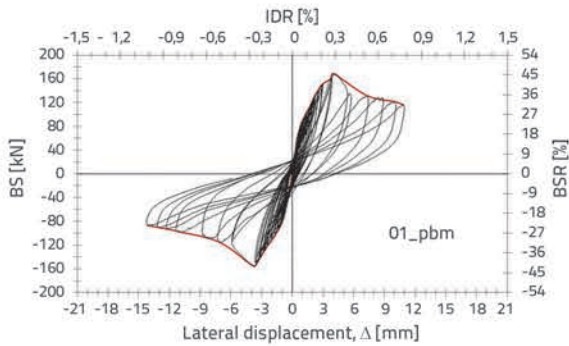
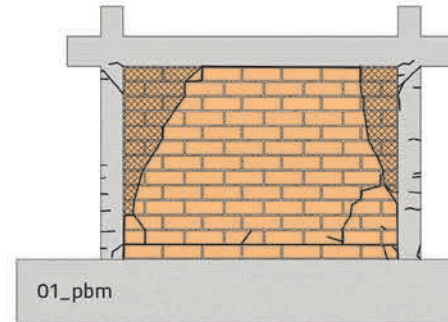
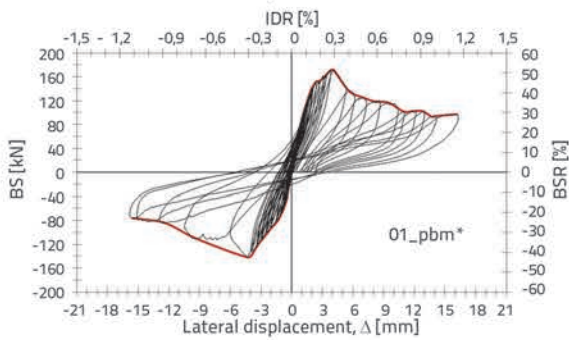
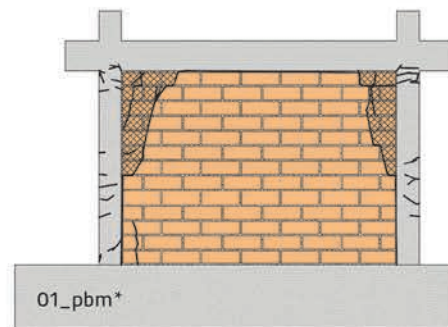
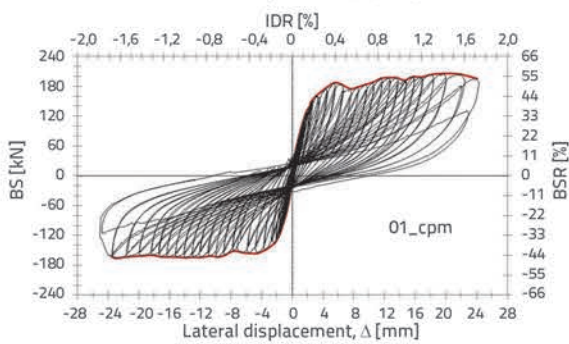
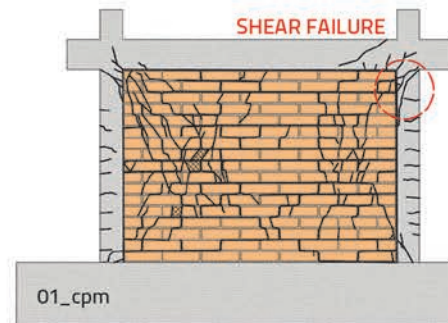
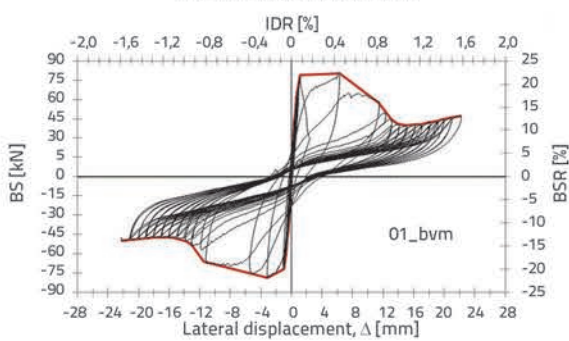
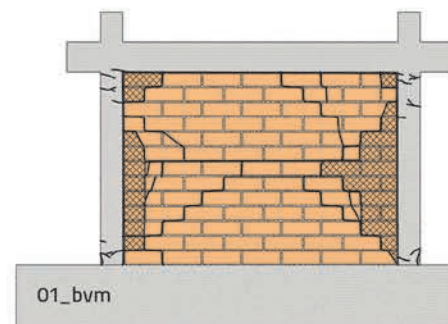
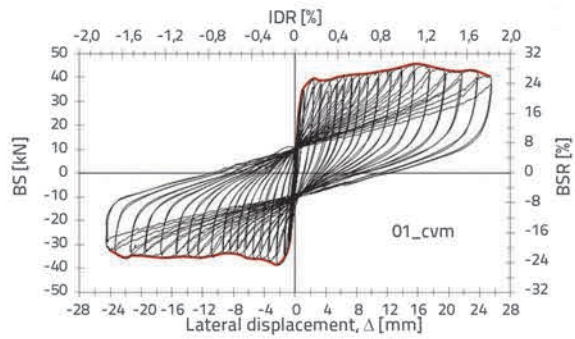
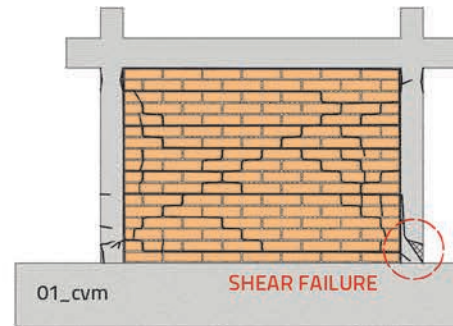
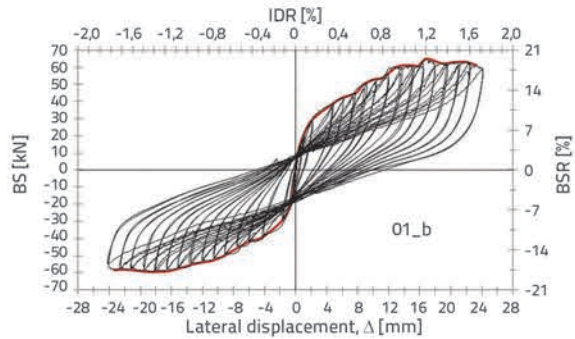
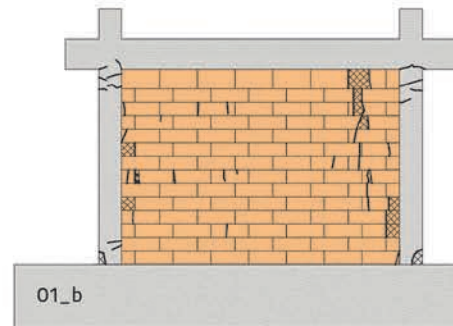
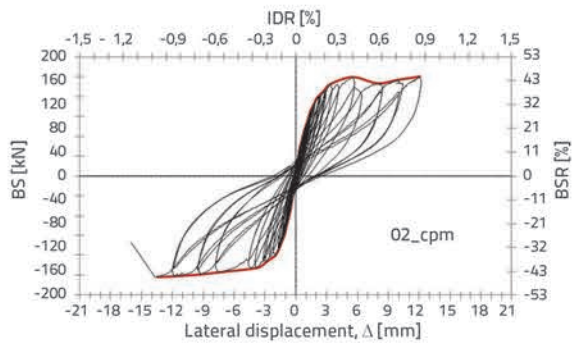
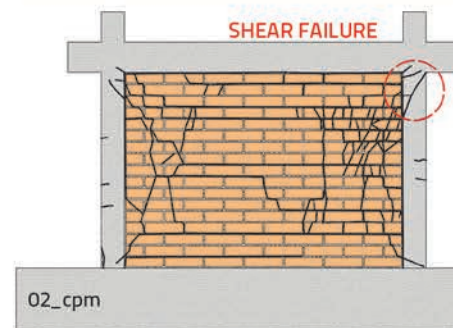
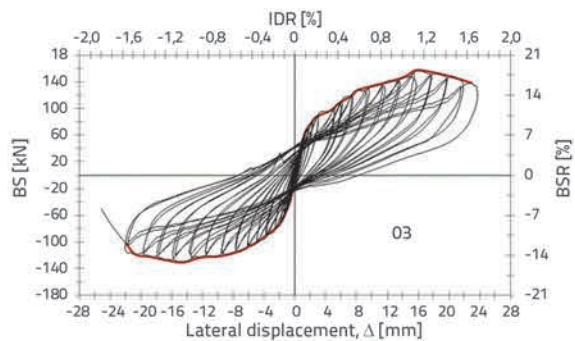
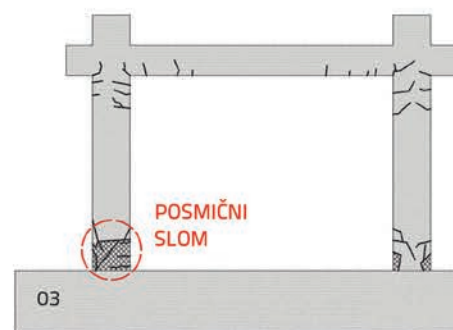
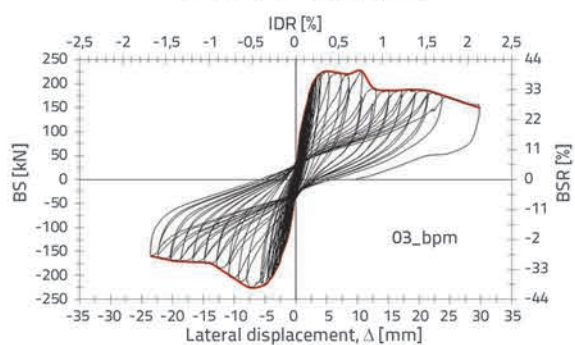
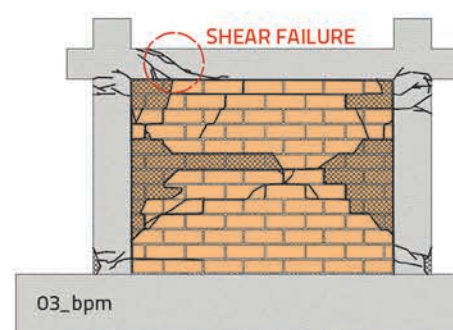
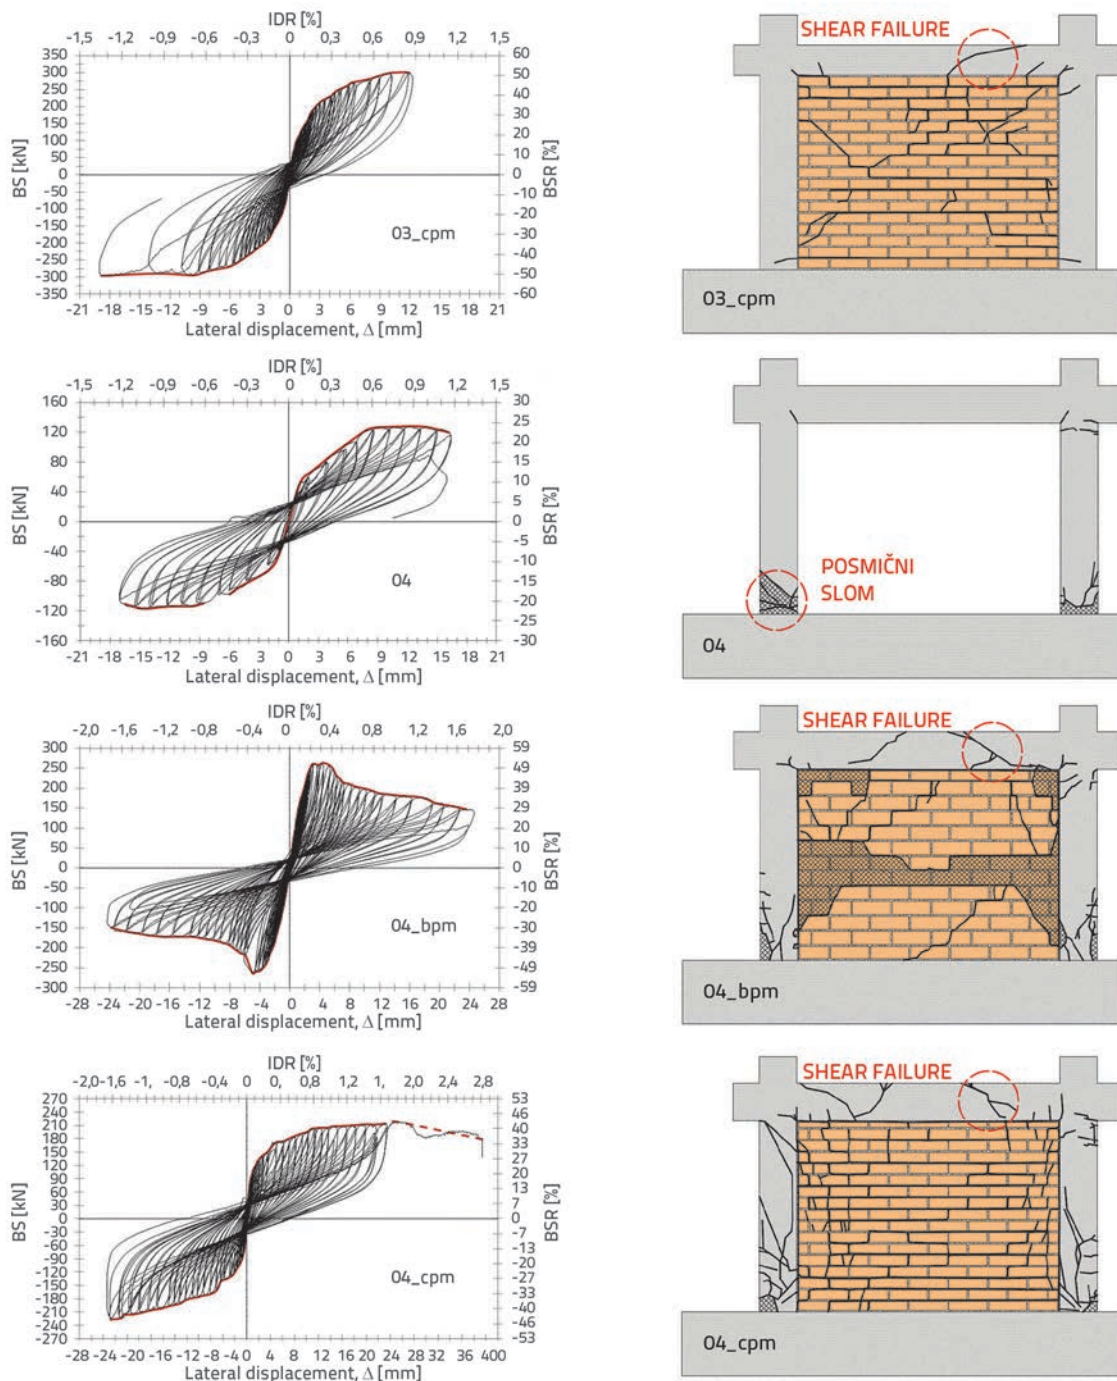
Figure 8 Hysteresis loops, response envelope curves and final crack patterns

relatively large drift of 1.7 %. Table 6 shows only representative drift values, the aim being to correlate different damage modes with limit states. The final crack patterns at maximum drifts are shown for all specimens in Figure 8. Multiple failure modes of masonry infill occurred during the testing, which depended on the achieved drift (IDR %). The masonry infill properties, namely the mortar type and robustness of masonry units, appeared to be governing parameters for the severity of infill damage and overall behaviour.

Measured hysteresis loops, response envelope curves, and crack patterns at maximum drifts are presented for all specimens in Figure 8. Lateral strengths, i.e. BS and the corresponding IDR for all specimens are presented at observed LS values in Table 7

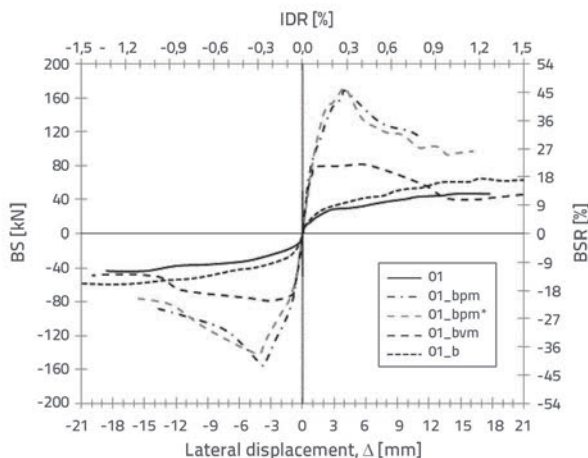
Figure 9. Influence of mortar type on lateral strength (BS) of specimens *O1*

The contribution of masonry infill to the lateral strength of bare frames was influenced by both the frame and infill properties and depended on the achieved *IDR* value. The masonry infill contribution depended on mortar type, despite the fact that none of the masonry strengths reported in Table 4 could be directly related to strength contribution, and masonry unit robustness. The influence of mortar type on the lateral strength of specimens *O1* with hollow clay units is illustrated in Figure 9.

The maximum *BS* of the specimen with cement-lime mortar was approximately 2 times greater than the maximum *BS* of the specimen with lime mortar. The difference between compressive strengths of masonry walls was approximately 5.7 times, while the difference between shear strengths (cohesion) amounted to approximately 3.2 times. The same difference in maximum *BS* was observed in the case of specimens with infill made of solid clay units (*O1_cpm* and *O1_cvm*), despite opposite trend in terms of the masonry wall compressive to shear and strengths ratio (1.5

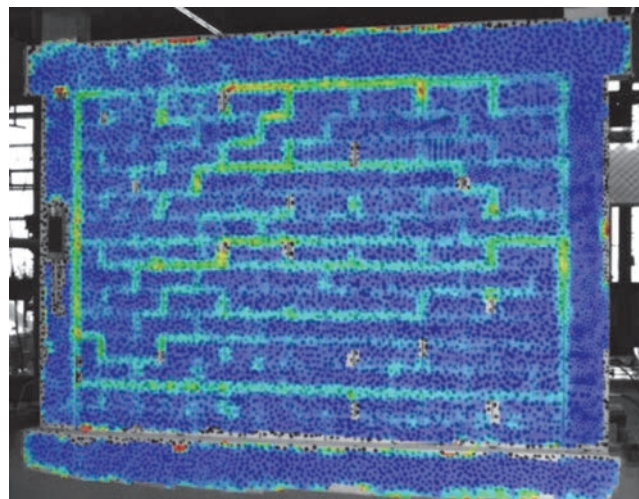
Figure 10. Strain distribution in masonry infill of specimen *O1_b* (quantitative representation, relative deformation, ARAMIS)

and 4.5, respectively). An expected increase in lateral strength and stiffness was not observed despite the densely laid infill of model *O1_b*, where a load transfer mechanism was provided by friction at the contact planes of units (as shown in Figure 10).

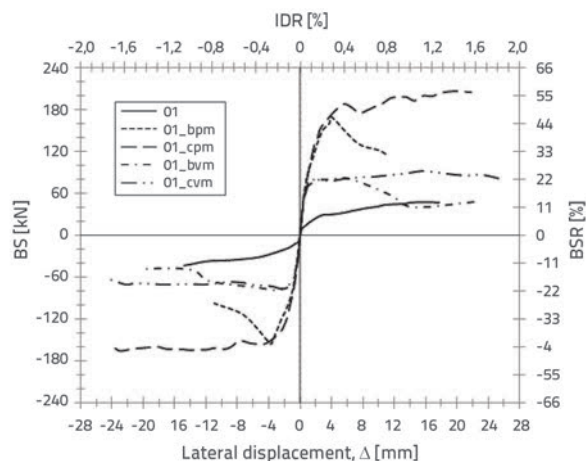
Figure 11. Influence of masonry unit robustness on lateral strength (BS) degradation of specimens *O1*

all specimens with solid clay units maintained an approximately equal lateral strength after LS_2 was reached. The influence of masonry unit robustness is illustrated by Figure 11 where lateral strengths of specimens $O1$ with hollow and solid clay units are compared.

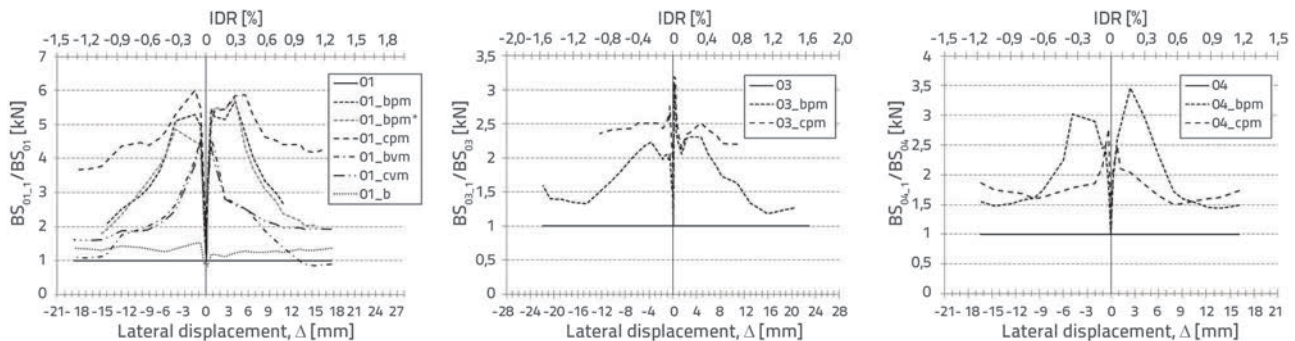
Figure 12. Lateral strength (BS) of framed-masonry specimens normalized with regard to lateral strength of bare frames

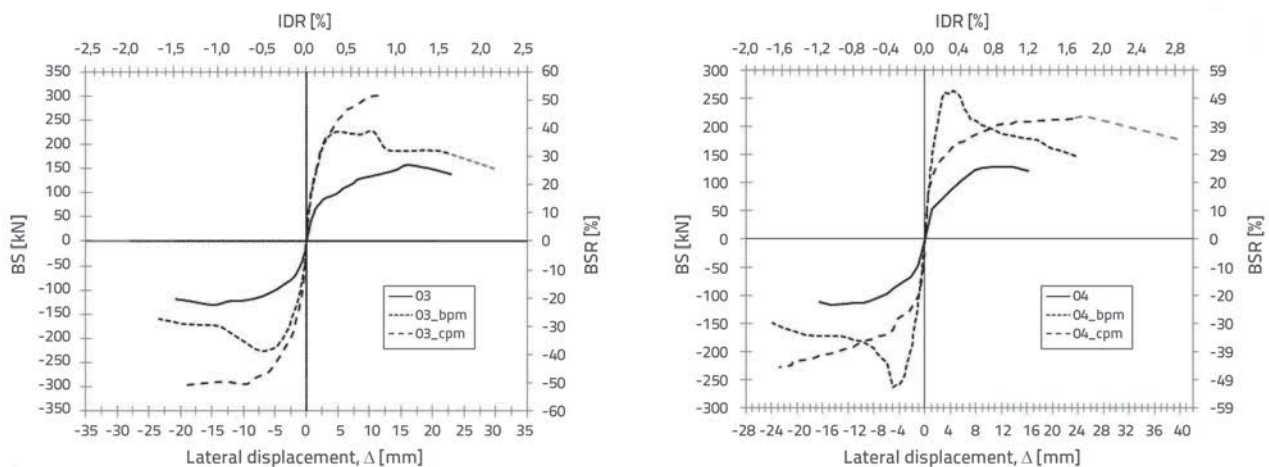
Figure 13. Response envelope curves of tested specimens

The same trend of global behaviour regarding the masonry unit robustness was observed for all tested specimens. For all types of masonry infill, except in the case of $O2_{cpm}$, the ductility of framed-masonry specimens was approximately equal to or slightly higher than that of bare frames, as shown in Figures 11 and 13.

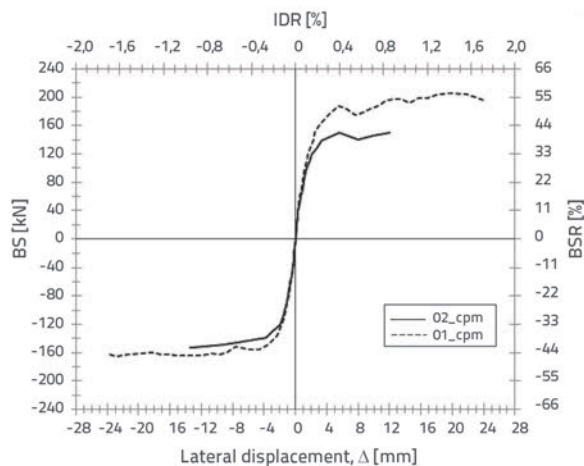
Figure 14. Response envelope curves of specimens

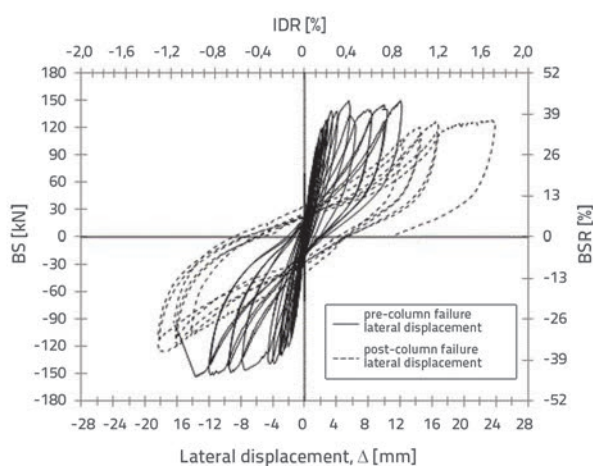
Figure 15. Hysteresis loops of specimen $O2_cpm$

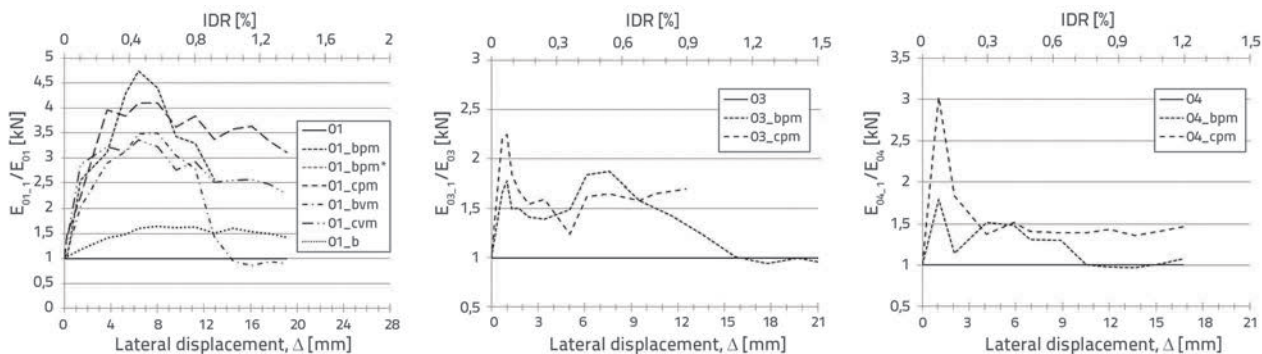
Figure 16. Energy dissipation capacity expressed per unit drift

Specimen energy dissipation capacities are shown in Figure 16. In order to obtain the energy dissipated per unit drift, the hysteretic energy dissipated at each loading cycle was computed based on the area bounded by the hysteretic loop and divided by twice the peak drift. These values were then normalized to the energy dissipation capacity of bare frames.

The energy dissipation capacity was influenced by the infill and frame properties and depended on the achieved IDR . The maximum values corresponded approximately to drifts at LS_2 . The masonry infill contribution was influenced by mortar type and masonry unit robustness. The influence of mortar type is illustrated by figure representing the energy dissipation capacity of specimens $O1$. Specimens with cement-lime mortar had a greater energy dissipation capacity than those made with lime mortar. After the LS_2 was reached, the dissipation capacity was governed by masonry unit robustness. For all specimens with hollow clay units, a gradual decrease of the energy dissipation capacity was observed up to drifts of approximately 1 %. After that, the energy dissipation capacity was approximately equal to that of bare frame. On the other hand, the infill made of robust solid clay units maintained a ductile inelastic response and provided a more stable energy dissipation after the LS_2 was reached.

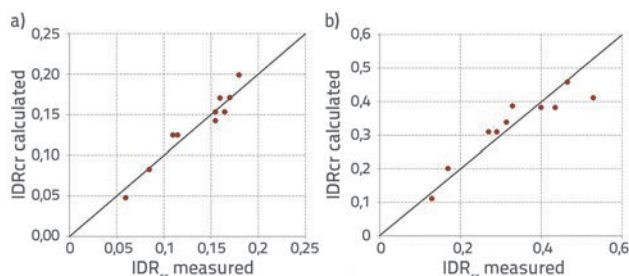
Figure 17. Comparison of experimental results and analytical predictions

Based on the observations made in Section 3, an attempt was made to define equations for the prediction of the IDR_s at limit states LS_1 and LS_2 . Since masonry strengths were influenced by mortar type and masonry unit robustness, they have caused a similar percentage of change in the IDR values. However, compared to other strengths, cohesion gave the smallest correlation coefficient when linear regression was made ($R^2 = 0.8$ for LS_1 and 0.85 for LS_2). The influence of coefficient β was examined in the same manner. Although correlation coefficients were not satisfactory, the coefficient β was considered due to its obvious influence. Two equations were proposed: (1) for drifts at LS_1 (IDR_{cr}); (2) for drifts at LS_2 (IDR_y). A comparison of the experimentally obtained values and their analytical predictions are shown in Figures 17 (a) and (b). Suggested equations match the observed drifts with a satisfactory accuracy, and they generally tend to overestimate drifts for specimens with hollow clay units and underestimate drifts for specimens with solid clay units. The highest error in case of the LS_1 amounted to -20.7% and was observed for specimen *O1_bvm*. In case of the LS_2 the highest error was observed for specimen *O3_cpm*, and it amounted to 22.6% . All other errors, for both LS s, were lower than $\pm 16\%$.
