*Source / Izvornik:* **Građevinar, 2016, 68, 617 - 633**

# Cyclic testing of single-span weak frames with masonry infill

Original scientific paper

Experimental test results for fourteen samples of single-span, single-storey, non-seismically designed reinforced-concrete (weak) masonry infill frames are presented in the paper. The samples, scaled 1 to 2, were subjected to the approximately constant vertical and in-plane horizontal cyclic load. Various geometrical and mechanical properties of reinforced-concrete frames and masonry infill were considered. Equations for estimating the interstorey drift ratio at the limit states under study are proposed based on testing conducted in the paper.

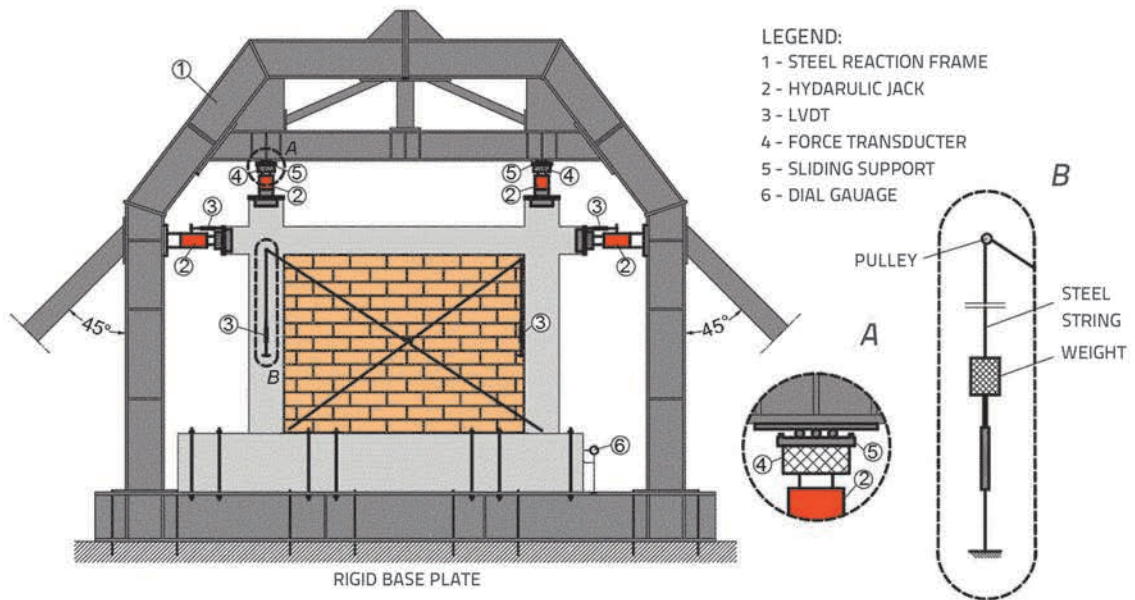
Figure 2. Test setup, instrumentation and loading history

Specimens were tested in a steel reaction frame fixed to a strong floor with lateral support. Their foundation beams were fixed to the reaction frame and sliding was prevented by steel restrainers. Tests were performed under an approximately constant vertical and in-plane cyclic lateral load up to failure. Vertical loads, corresponding to 30-40 % of the design compressive strength of concrete, were applied at each column end by hydraulic jacks placed on a sliding support, which enabled lateral displacement and prevented rotation. Cyclic lateral in-plane loading was applied at the beam end along its centroid axis by two hydraulic jacks (Figure 2).

The lateral load history consisted of the load (1) controlled in increments of 10 kN in a small deformation range, and displacement (2) controlled with gradually increasing displacements. Each loading cycle was repeated twice in order to capture the effects of stiffness and strength degradation. Loads were measured at each application point by force transducers, while horizontal displacements of the frame at both ends of the beam, and diagonal deformations of the frame and infill walls, were measured by LVDT's. A high-resolution dial gauge was used to monitor possible slippage of foundation beam. All measured data were continuously registered at a sampling rate of 0.01 sec by DEWE-30-16 system with DEWESoft ver. 6.6.7 software support. Deformations, cracks and their propagation were monitored visually and by the 3D optical measuring system ARAMIS.

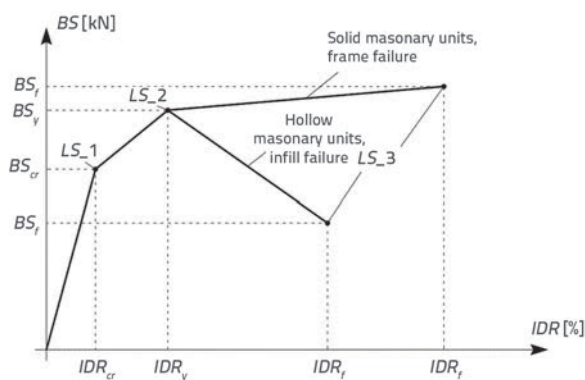
Figure 5. Primary curves and limit states of tested specimens

BS and IDR represent base-shear (lateral strength) and inter-storey drift at the corresponding LS, respectively. These limit states were noted as being the best ones for describing the observed response of specimens. Their primary curve is shown in Figure 5.

All tested specimens with hollow clay masonry units reached the maximum lateral strength at LS\_2, while those with solid clay masonry units reached this strength at LS\_3. The correlation between the limit states and damage modes is given in Table 5. Model O1\_b was omitted, since it had only LS\_1, regardless of a

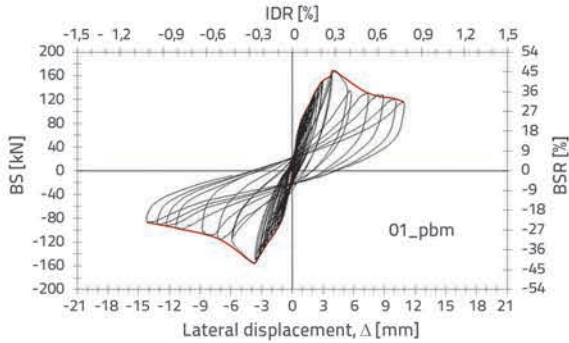
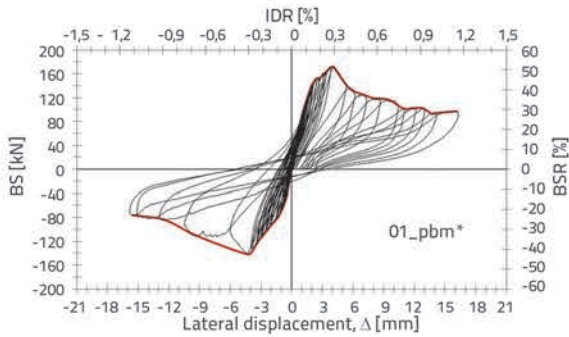
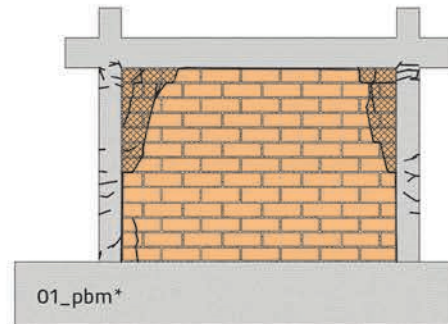
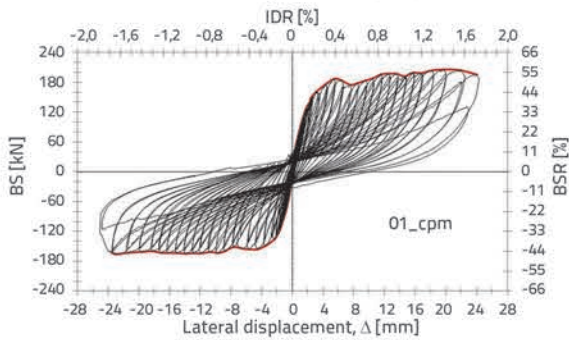
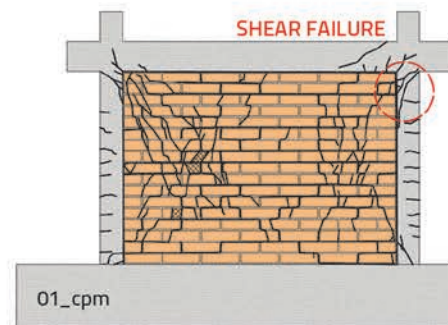
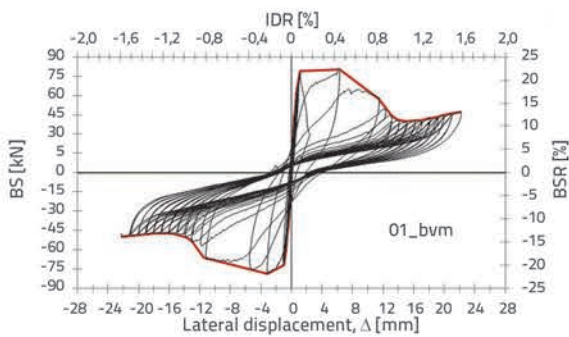
Figure 8 Hysteresis loops, response envelope curves and final crack patterns

Measured hysteresis loops, response envelope curves, and crack patterns at maximum drifts are presented for all specimens in Figure 8. Lateral strengths, i.e.  $BS$  and the corresponding  $IDR$  for all specimens are presented at observed  $LS$  values in Table 7

for both loading directions. A positive direction is defined with positive values of  $BS$  and  $IDR$ . Model  $O1_b$  was not included, since only  $LS_1$  was observed.  $BSR$  represents the base shear ratio, and was defined as the lateral to vertical load ratio.

relatively large drift of 1.7 %. Table 6 shows only representative drift values, the aim being to correlate different damage modes with limit states. The final crack patterns at maximum drifts are shown for all specimens in Figure 8. Multiple failure modes of masonry infill occurred during the testing, which depended on the achieved drift (IDR %). The masonry infill properties, namely the mortar type and robustness of masonry units, appeared to be governing parameters for the severity of infill damage and overall behaviour.

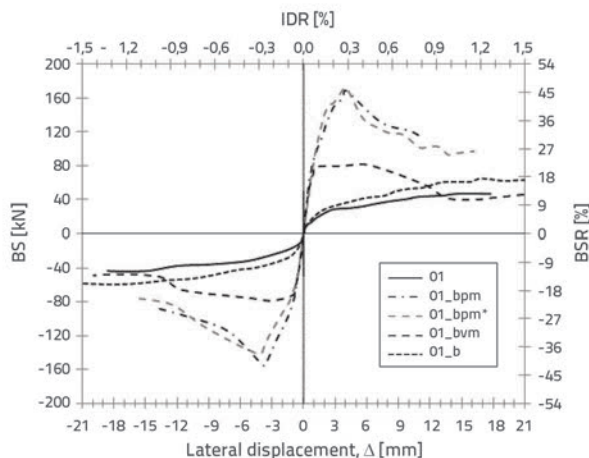
Figure 9. Influence of mortar type on lateral strength (BS) of specimens *O1*

The contribution of masonry infill to the lateral strength of bare frames was influenced by both the frame and infill properties and depended on the achieved *IDR* value. The masonry infill contribution depended on mortar type, despite the fact that none of the masonry strengths reported in Table 4 could be directly related to strength contribution, and masonry unit robustness. The influence of mortar type on the lateral strength of specimens *O1* with hollow clay units is illustrated in Figure 9.

The maximum *BS* of the specimen with cement-lime mortar was approximately 2 times greater than the maximum *BS* of the specimen with lime mortar. The difference between compressive strengths of masonry walls was approximately 5.7 times, while the difference between shear strengths (cohesion) amounted to approximately 3.2 times. The same difference in maximum *BS* was observed in the case of specimens with infill made of solid clay units (*O1\_cpm* and *O1\_cvm*), despite opposite trend in terms of the masonry wall compressive to shear and strengths ratio (1.5

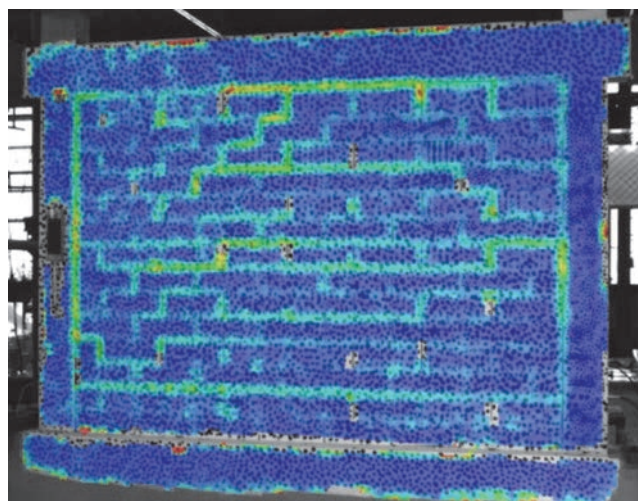
Figure 10. Strain distribution in masonry infill of specimen *O1\_b* (quantitative representation, relative deformation, ARAMIS)

and 4.5, respectively). An expected increase in lateral strength and stiffness was not observed despite the densely laid infill of model *O1\_b*, where a load transfer mechanism was provided by friction at the contact planes of units (as shown in Figure 10).

The maximum lateral strength increased by only 1.25 times and  $K_{EL}$  increased to 1.2 times the lateral strength and stiffness of the bare frame. Results indicated that the ductility increased by 1.3 times for the specimen *O1\_b* with regard to the bare frame. The model *O1\_b* was not subjected to load until failure.
